Aircraft proximity event between two Cessna 172s, VH-EOE and VH-LWX

Moorabbin Airport, Victoria, 19 March 2013

ATSB Transport Safety Report
Aviation Occurrence Investigation
AO-2013-053
Final – 17 September 2013

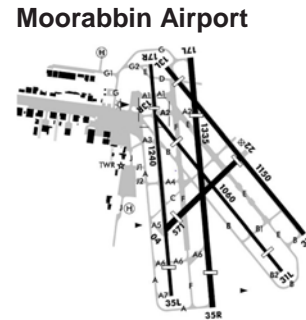
On the evening¹ of Tuesday 19 March 2013, up to eight aircraft were operating under the visual flight rules (VFR)² in the circuit at Moorabbin Airport, Victoria in Class D³ airspace. The numbers were typical for periods of night training at Moorabbin and fluctuated as some aircraft landed and others joined the circuit. At 2025 Eastern Daylight-saving Time,⁴ there were six aircraft in the circuit, including two Cessna 172 aircraft, registered VH-EOE (EOE) and VH-LWX (LWX). Both aircraft were engaged in flying training, EOE with an instructor and student on-board and LWX with a solo student.

When LWX was on early downwind, the pilot advised Moorabbin air traffic control (ATC) of his intentions for the next approach and he was instructed to follow⁵ the preceding aircraft mid-downwind (EOE).
