In-flight breakup involving PZL Mielec M18A Dromader, VH-TZJ

37 km west of Ulladulla, New South Wales, 24 October 2013

ATSB Transport Safety Report
Aviation Occurrence Investigation
AO-2013-187
Interim – 23 December 2013

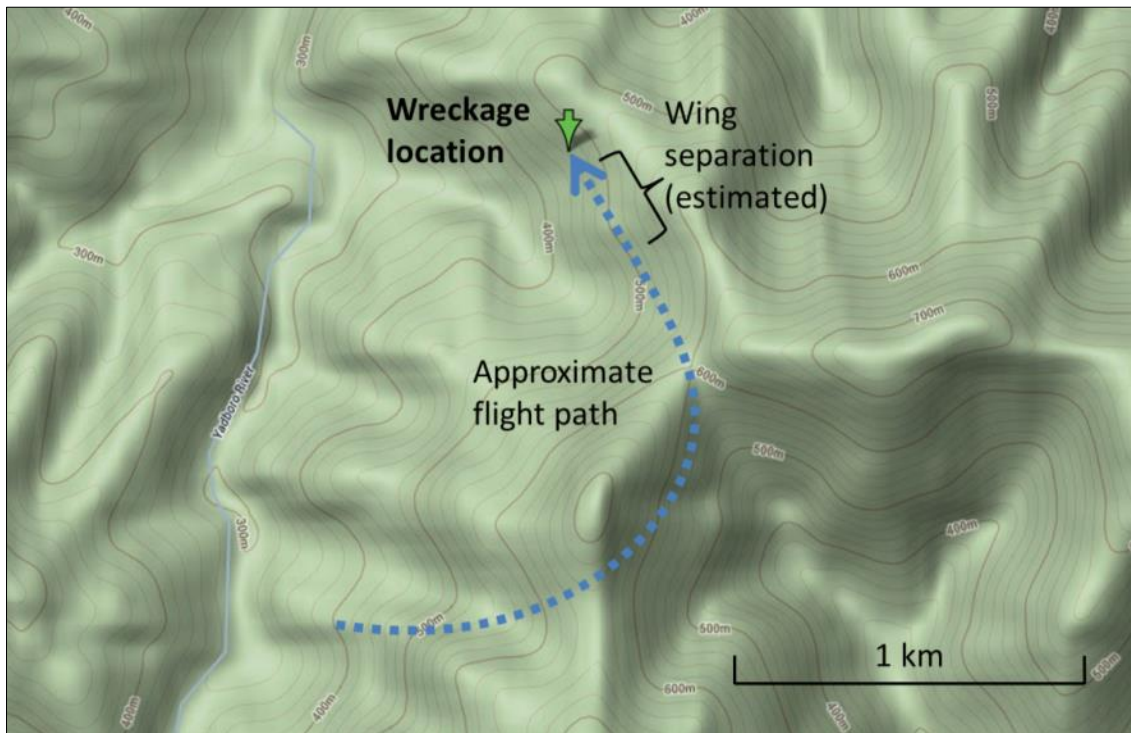
Figure 2: Approximate aircraft flight path

The helicopter crew later reported that TZJ made a broad, descending left turn onto an approximate north-north-westerly heading, flying along the ridgeline at about 100 ft above the trees and directly towards the target (Figure 2). At about the same time as or immediately after the aircraft's wings were rolled level, the left wing separated. The aircraft immediately rolled left and descended, impacting terrain. The accident occurred at about 1004. The aircraft was destroyed by impact forces and some parts of the wreckage were additionally damaged by small post-impact fires (Figure 3). The pilot was fatally injured.

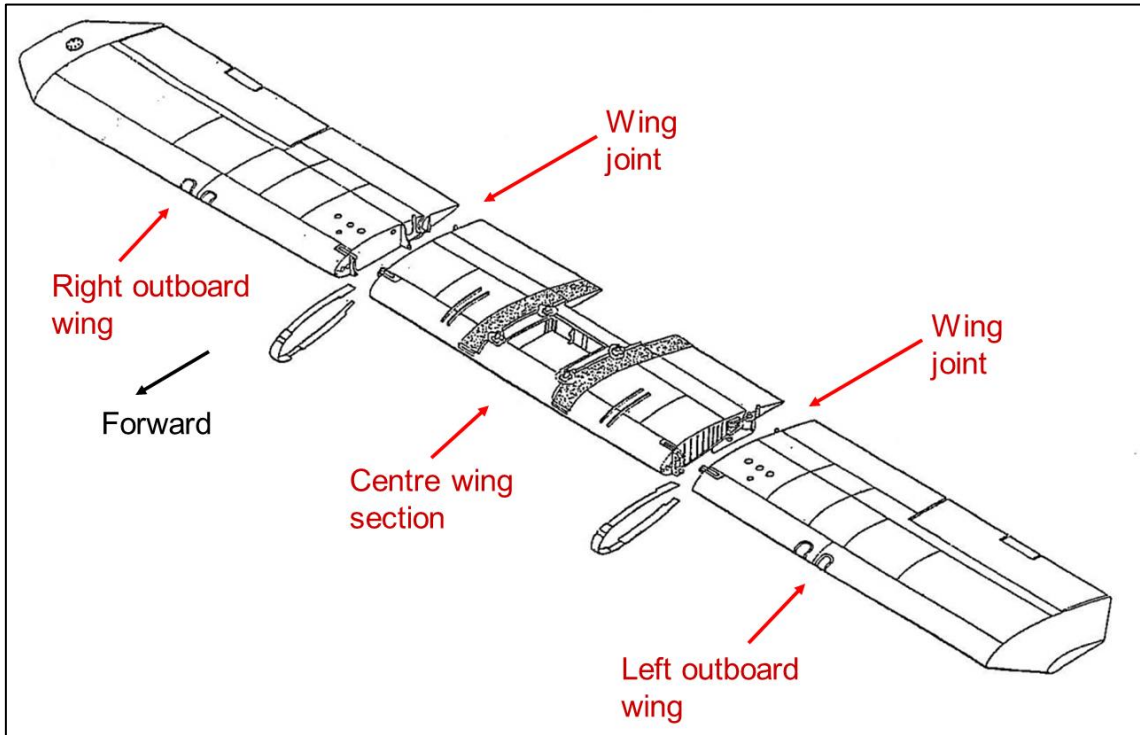
Figure 4: Overview of wing structure

M18 aircraft have a cantilever wing; that is, it is anchored at one end with no mid-span supports. The wing consists of three sections: the central wing section, and the left and right outboard wing sections (Figure 4). Between each outboard wing section and the centre section there are three attachment points (Figure 5). At each of the main spar attachment points, a single lug on the outboard wing is secured between two lugs on the centre wing by a through bolt, expansion mandrel and bush (Figure 5).

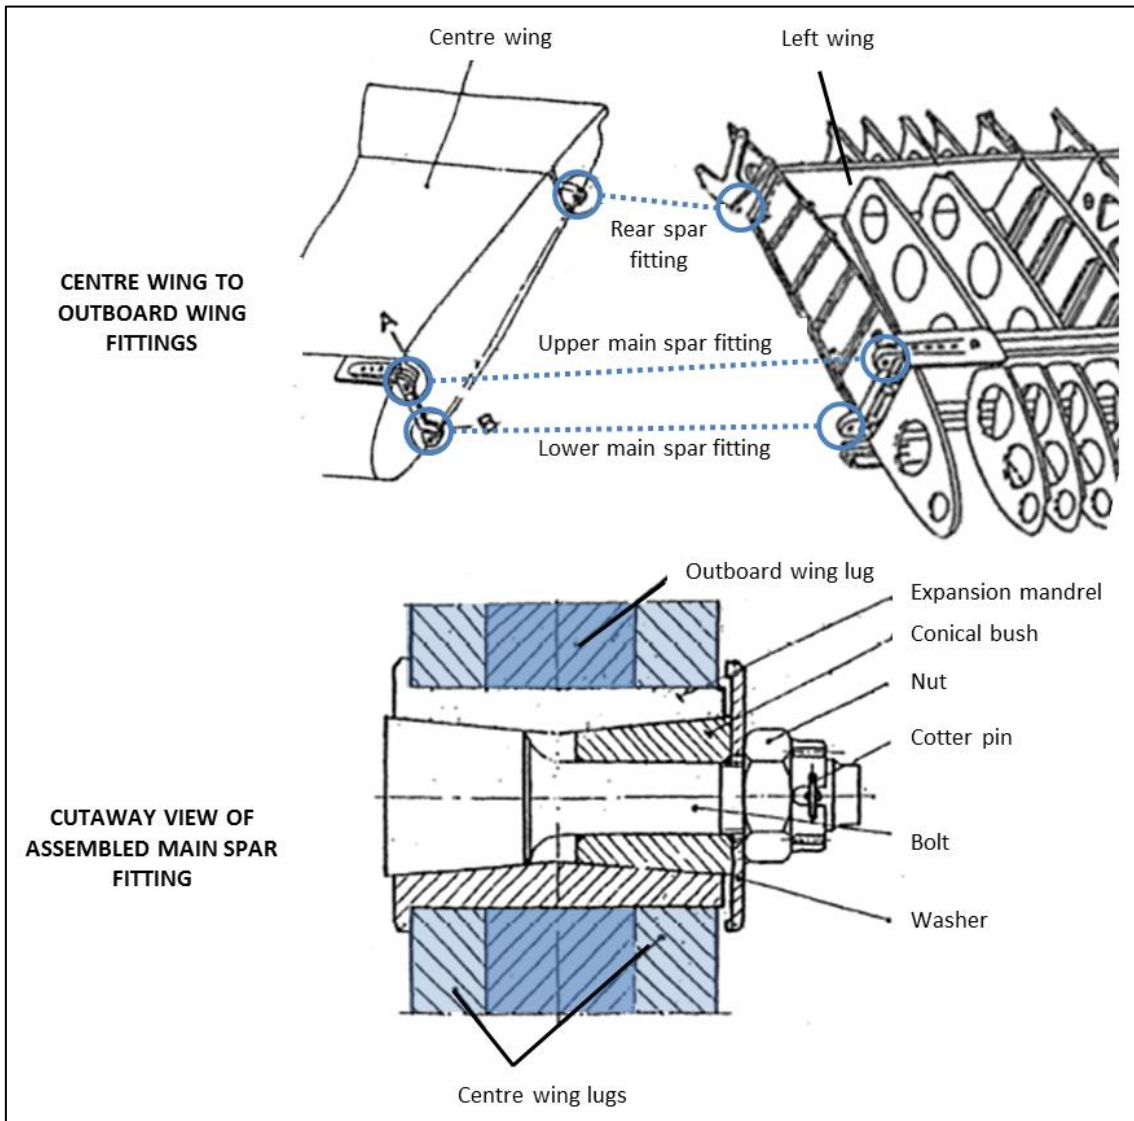
Figure 5: Centre wing to left wing attach fittings

Preliminary examination indicated that the left outboard wing lower attachment lug had fractured through an area of pre-existing fatigue cracking in the lug lower ligament.
