In-flight breakup involving PZL Mielec M18A Dromader VH-TZJ

37 km west of Ulladulla, NSW | 24 October 2013

ATSB Transport Safety Report
Aviation Occurrence Investigation
AO-2013-187
Preliminary – 2 December 2013

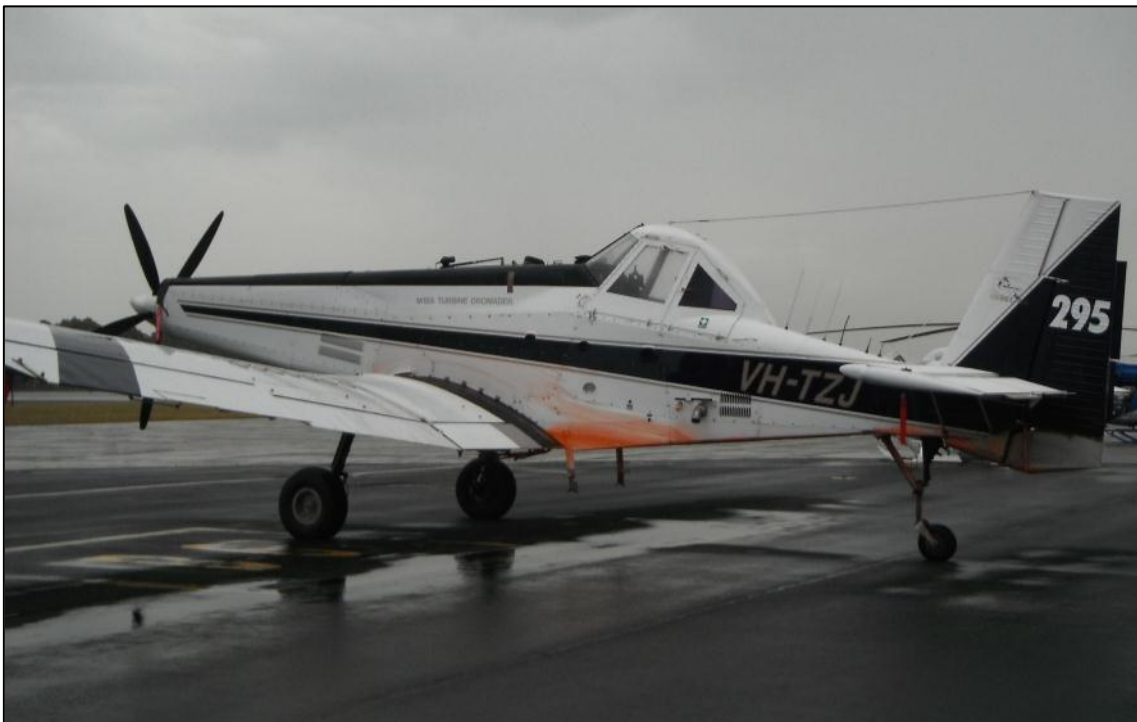
Figure 1: VH-TZJ on 22 October 2013

On 24 October 2013, at about 0940 Eastern Daylight-saving Time,¹ the pilot of a PZL Mielec M18A Dromader, registered VH-TZJ (TZJ) (Figure 1) took off from Nowra Airport, New South Wales to conduct a firebombing mission in the Budawang National Park about 37 km west of Ulladulla, New South Wales. Another firebombing aircraft with one pilot and a support helicopter with two crew and one observer were also involved in the mission. The other firebombing pilot described the weather at the time as 'okay' with moderate wind and little turbulence.

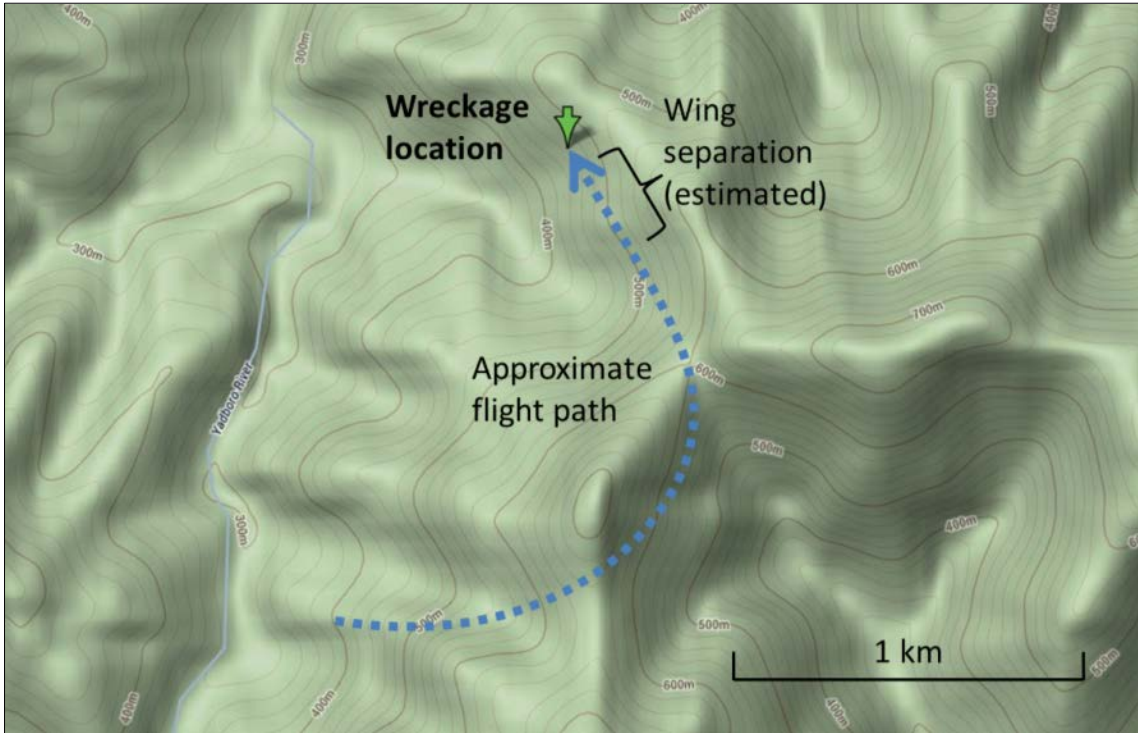
Figure 2: Approximate aircraft flight path

The helicopter crew later reported that TZJ made a broad, descending left turn onto an approximate north-north-westerly heading, flying along the ridgeline at about 100 ft above the trees and directly towards the target (Figure 2). At about the same time as or immediately after the aircraft's wings were rolled level, the left wing separated. The aircraft immediately rolled left and descended, impacting terrain. The accident occurred at about 1004. The aircraft was destroyed by impact forces and some parts of the wreckage were additionally damaged by small post-impact fires (Figure 3). The pilot was fatally injured.

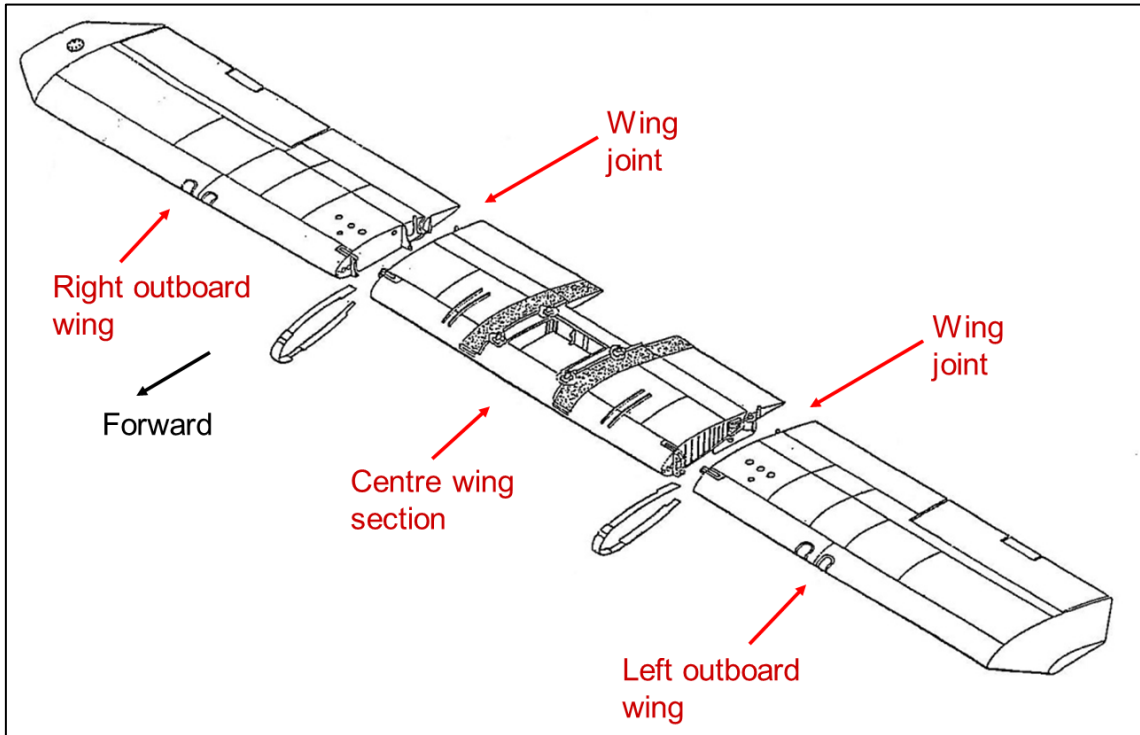
Figure 4: Overview of wing structure

M18 aircraft have a cantilever wing; that is, it is anchored at one end with no mid-span supports. The wing consists of three sections: the central wing section, and the left and right outboard wing sections (Figure 4). Between each outboard wing section and the centre section there are three attachment points (Figure 5). At each of the main spar attachment points, a single lug on the outboard wing is secured between two lugs on the centre wing by a through bolt, expansion mandrel and bush (Figure 5).

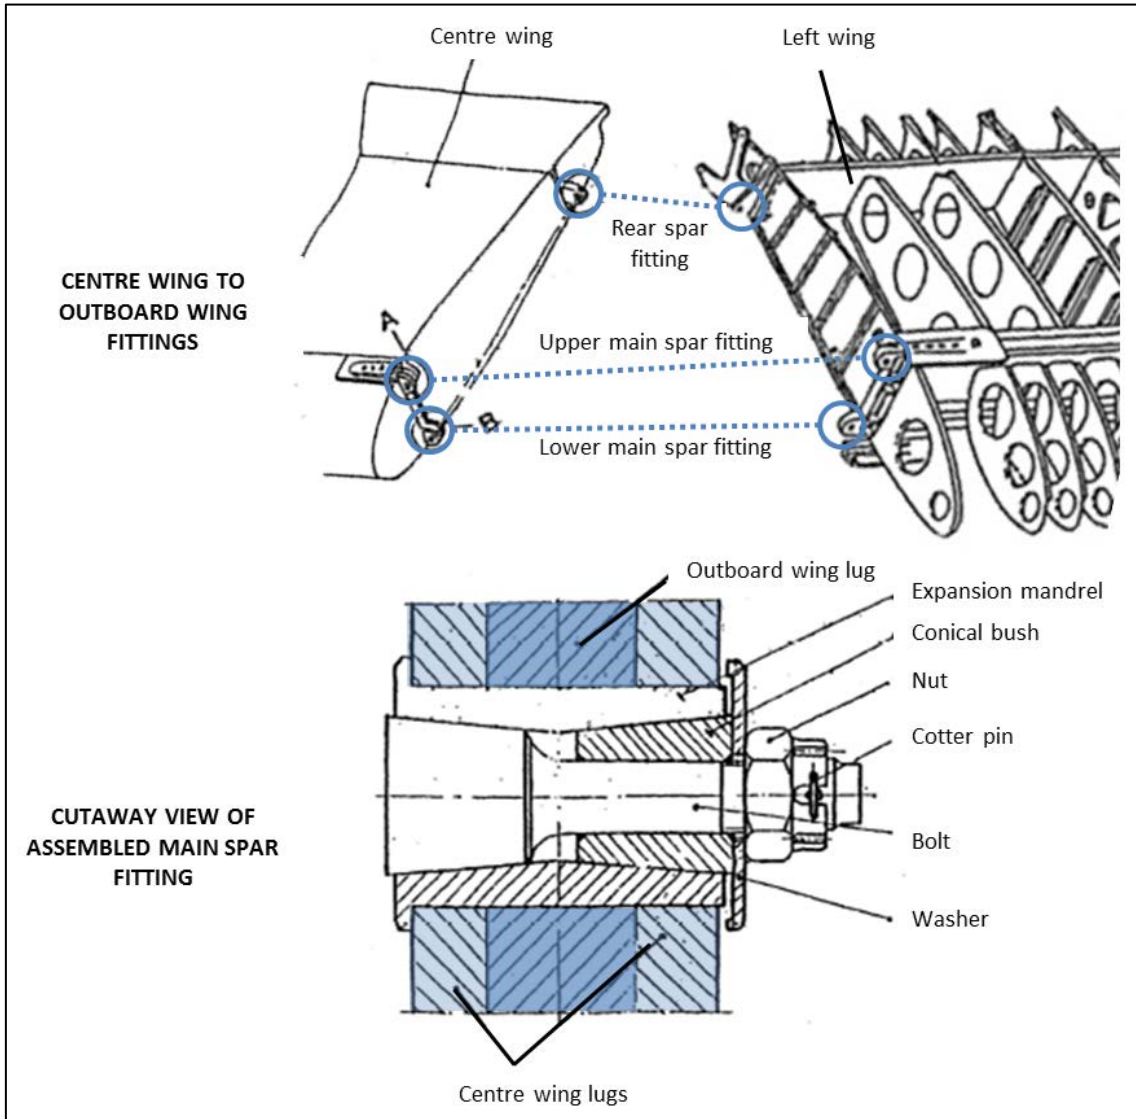
Figure 5: Centre wing to left wing attach fittings

In 2000, investigations by the US National Transportation Safety Board into a number of US M18 accidents in which the wings separated in-flight discovered severe corrosion and cracking in the wing lower attach fittings, which led to fatigue cracking and failure of the fitting.³
