Collision with terrain involving Van's RV-6A, VH-JON

8 km south of Moorabbin Airport, Victoria | 14 October 2014

ATSB Transport Safety Report
Aviation Occurrence Investigation
AO-2014-164
Final – 25 November 2016

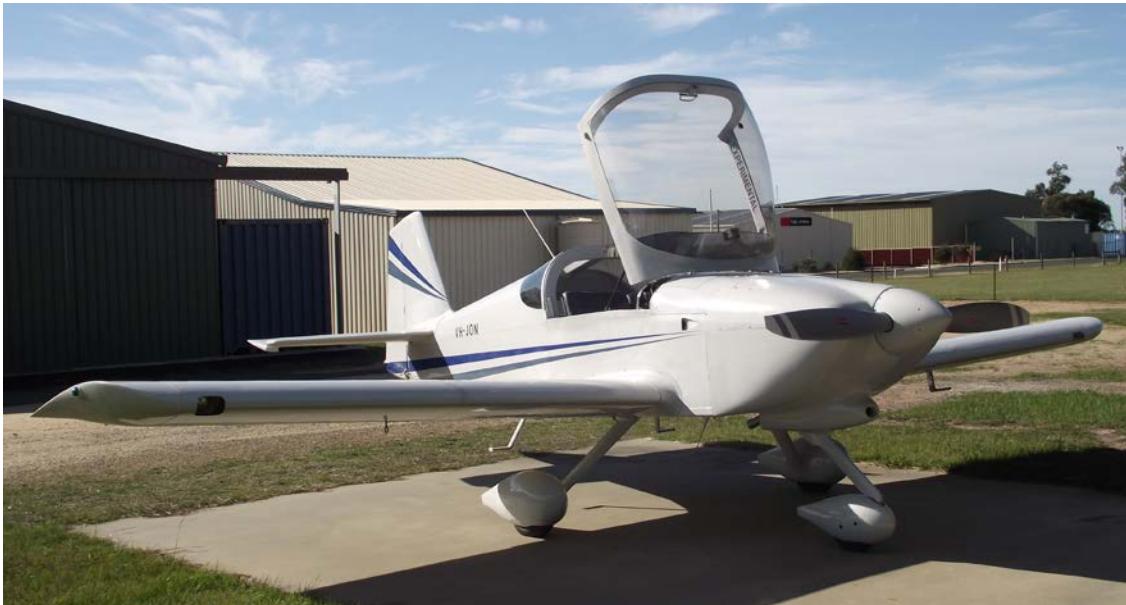
Figure 2: JON showing the tip-up canopy in the open position

Although the Van's RV-6 could be installed with aft- and forward-hinged canopies, JON was fitted with a forward-hinged 'tip-up' canopy (Figure 2), which had two locking mechanisms. The primary locking mechanism was operated by a locking lever located on the left side of the fuselage, adjacent to the pilot's seat. When placed into the locked position, a connecting rod from the lever latched two hooks into corresponding receptacles in the two rear corners of the canopy. The lever was then locked by a spring-loaded locking catch (Figure 3 and Figure 4).
