# Birdstrike involving a SAAB 340B, VH-OLM

Moruya Airport, New South Wales | 9 January 2015

**ATSB Transport Safety Report**  
Aviation Occurrence Investigation  
AO-2015-007  
Final – 14 December 2017

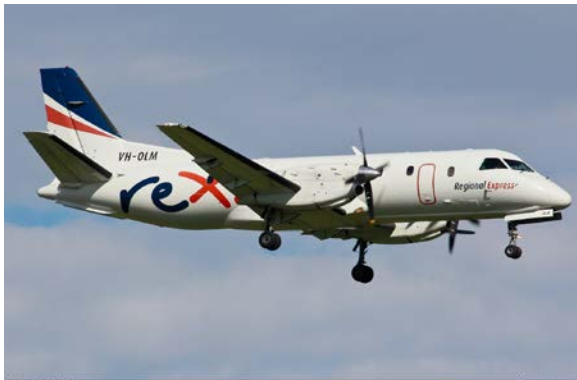
SAAB 340B, VH-OLM

On the morning of 9 January 2015, a Regional Express operated SAAB 340B aircraft, registered VH-OLM struck a flock of birds during its landing roll at Moruya, New South Wales. Inspection of the aircraft by the flight crew found bird impact marks but no visually identifiable damage. The crew continued their schedule to Merimbula, New South Wales. At Merimbula, the first officer noticed the tip of one propeller blade was missing, and the aircraft was subsequently grounded.

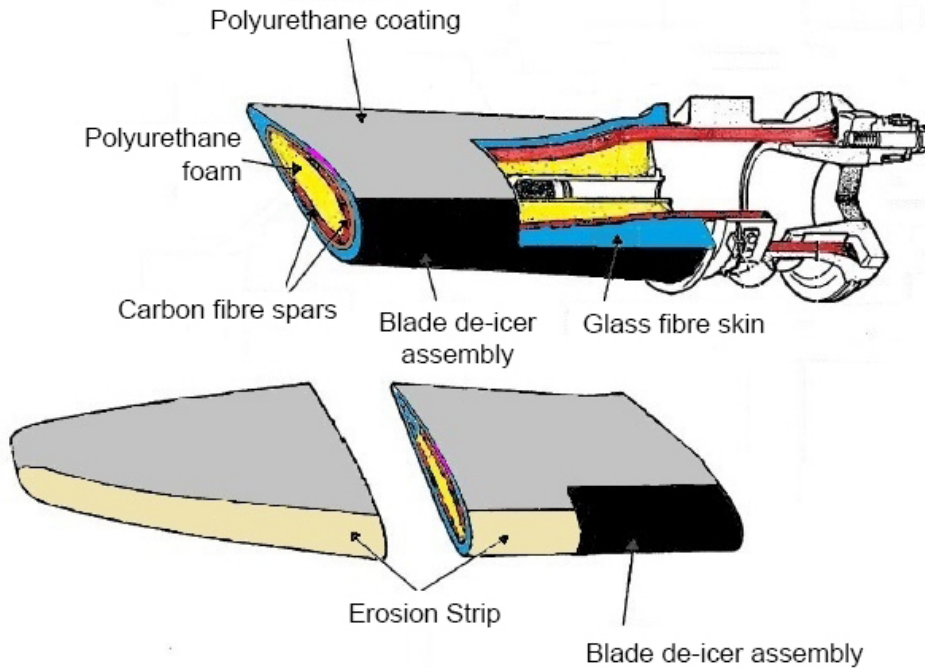
**Figure 3: Propeller blade construction**

The propeller blades were manufactured by Dowty Propellers. They were made of composite construction with a polyurethane foam core, carbon fibre spars, glass fibre skin, and a polyurethane coating. A braided metal strip between the glass fibre and polyurethane coating ran from the tip of the blade to its root, providing lightning protection (Figure 3).
