Aviation Occurrence Investigation – AO-2006-007

**In-flight engine failure
93km N of Perth Airport, WA
27 November 2006
Beechcraft King Air 200, VH-XDB**

In-flight engine failure – 93km N of Perth Airport, Western Australia – 27 November 2006 – Beechcraft King Air 200 – VH-XDB

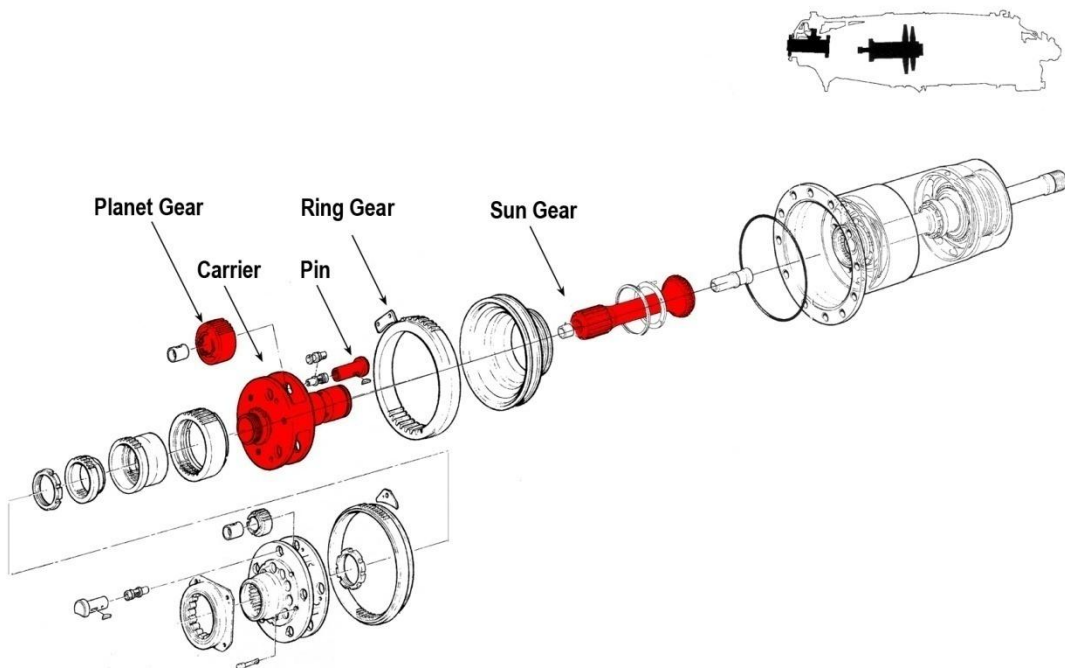
In order to suitably reduce the power turbine speed for propeller operation (33,000 RPM down to ~ 2,000 RPM), the PT6A-41 engine used a two-stage planetary gear system (Figure 7). Torque from the power turbine section was transmitted through the power turbine shaft and turbine coupling to the first-stage sun gear.

The first-stage sun gear consisted of a short hollow steel shaft with an integral spur gear at the front, which coupled to an intermeshing three-piece planetary gear set. The second-stage within the RGB was similar to the first but used five planet gears and was splined⁴ onto the propeller shaft.

Figure 7: Exploded diagram showing the arrangement between the sun gear and first-stage reduction gear set from the PT6A-series engine
