ATSB TRANSPORT SAFETY REPORT
Occurrence Investigation Report AO-2007-036
Final

**Fuel-related event – 50 km NW of
Swan Hill, Vic.
11 August 2007
VH-TJE
Boeing Company 737-476**

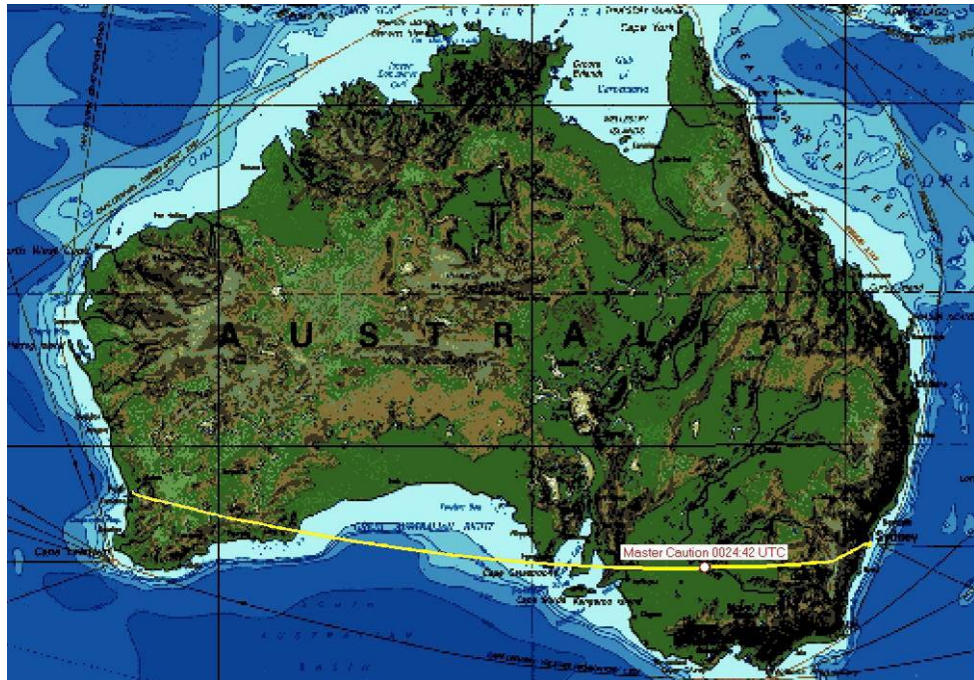
About 2 hours 40 minutes after takeoff, at 0824.42² (Figure 1), the master caution light illuminated, associated with low output pressure of the main tank fuel pumps. The main fuel tanks in the Boeing 737 series aircraft were located in each wing. A centre fuel tank, located in the wing centre section, was used for carrying additional fuel on longer flights, such as from Perth to Sydney.

Figure 1: Route flown with illumination of the master caution light indicated

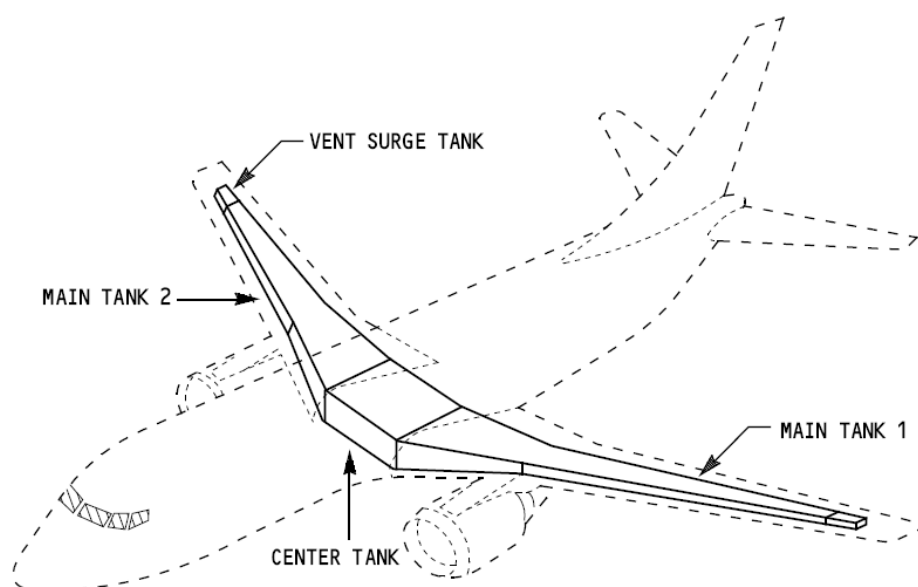
The aircraft's fuel system included three integral fuel tanks; the main fuel tanks in each wing and a centre fuel tank in the wing centre section for carrying additional fuel for long range flights (Figure 4). The aircraft had also been originally fitted with an auxiliary fuel tank located in the rear cargo compartment, but that tank had been deactivated.

Check valves regulate the output pressure from the fuel pumps. The centre tank check valves open at a lower pressure than the main tank check valves. Because of this, under normal operations with all pumps on, the engines would receive centre tank fuel first. When only residual fuel remains in the centre tank, the pumps in the main tanks then supply fuel to the engines. Thus, the aircraft would normally be operated and landed with fuel in the main tanks, with little or no fuel remaining in the centre tank.

Figure 4: Position of fuel tanks in B737-400 aircraft
