Aviation Occurrence Investigation – AO-2007-066

Final

Controlled flight into water
Lake Liddell, NSW – 7 December 2007
VH-LIS
Air Tractor Inc. AT-802

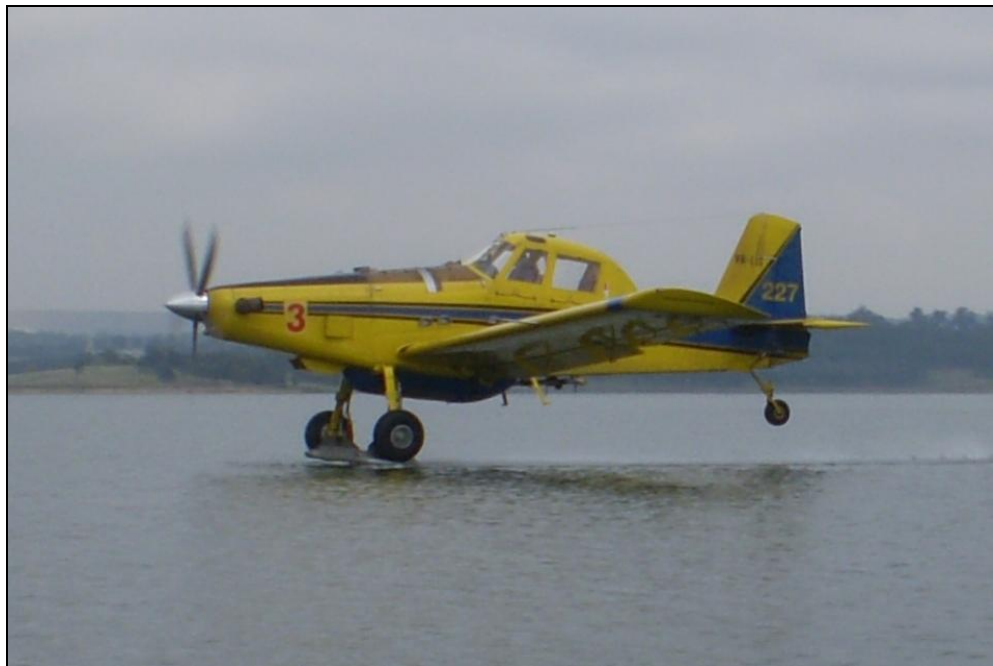
The purpose of the flight was to test an experimental in-flight water collection system using skis attached to the aircraft's main landing gear (Figure 1). The testing involved the pilot descending the aircraft until the skis contacted the surface of the lake and then maintaining that contact while skimming across the water's surface. While skimming across the surface, water would be forced through a hole in the base of each ski and into the aircraft's hopper via attached pipes and hoses. When sufficient water was collected, the pilot would climb the aircraft, dump that load, and return for another test run.

Figure 1: A previous water collection test flight on 6 December 2007

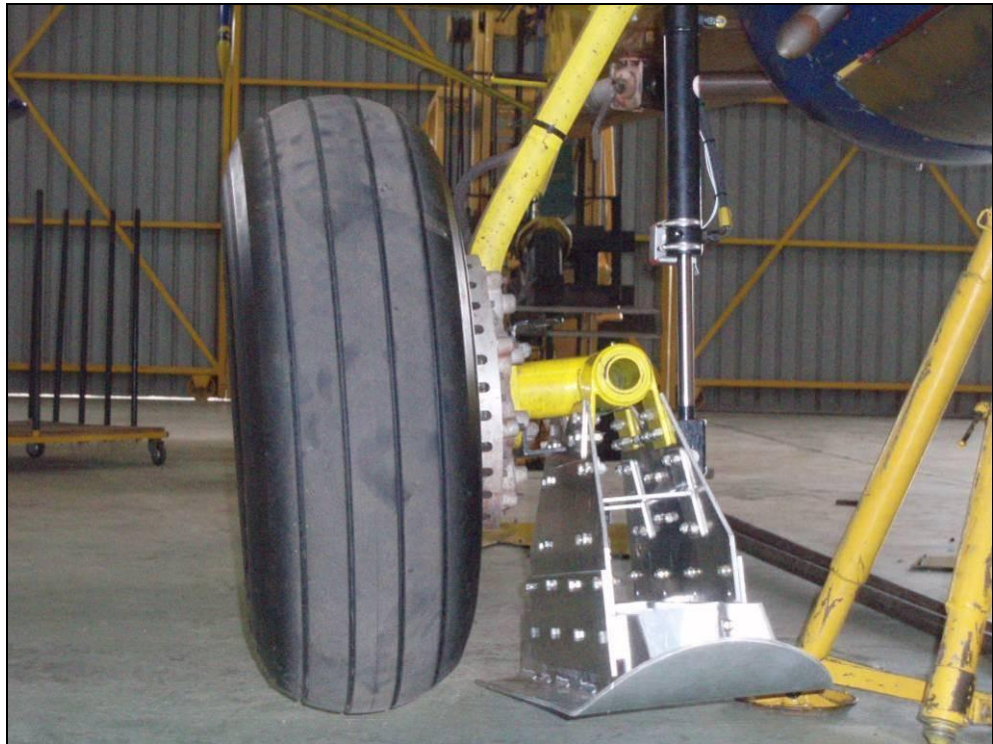
Before the skis were fitted to VH-LIS, they had been fitted to another company Air Tractor AT-802 aircraft, registered VH-LII (Figure 2). That aircraft was utilised to ground test the installation and the operation of the hydraulically-activated extension and retraction, of the skis.

Figure 2: Ski fitted to VH-LII in the extended position

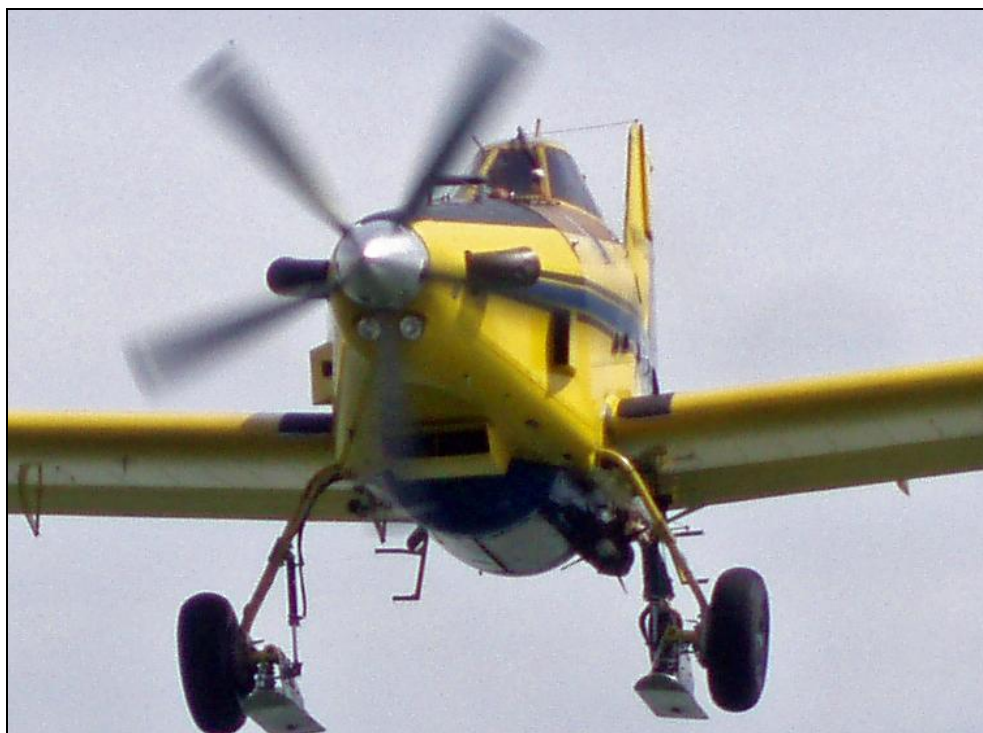
A company employee reported that VH-LII was also used to flight test the skis to ensure that the aircraft could be safely operated and landed with the skis attached (Figure 3). The pilot was reported to have advised a company employee that he considered that there was no change in the aircraft's performance or handling with the skis fitted, including no evidence of increased drag³ or vibration.

Figure 3: Initial flight testing in VH-LII

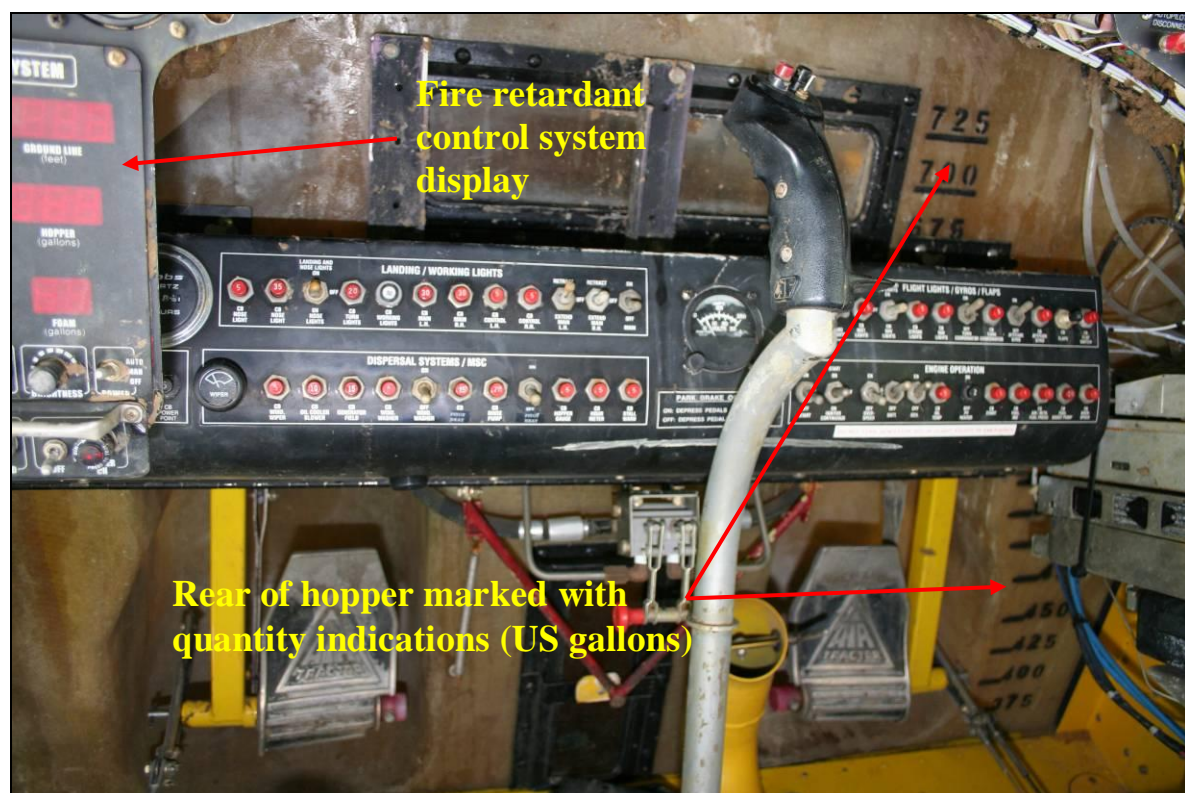
Other separate discussions by the pilot, with both company staff and the aeronautical engineer, also considered the need to monitor the amount of water collected during a run. In the absence of any other indications, the pilot was required to look inside the cockpit at the fire retardant control system panel, or the markings on the rear of the translucent aircraft hopper, to see the amount of water collected in the hopper (Figure 4). Discussions relating to the possible fitment of an aural indication of the hopper content levels took place, but nothing had been installed or implemented at the time of the flight tests.

Figure 4: Cockpit of VH-LIS
