ATSB TRANSPORT SAFETY REPORT
Aviation Occurrence Investigation
AO-2008-026
Final

Loss of control
19 km SE Sydney Airport, New South Wales
9 April 2008
VH-OZA
Fairchild Industries Inc. SA227-AC Metro III

Released in accordance with section 25 of the *Transport Safety Investigation Act 2003*

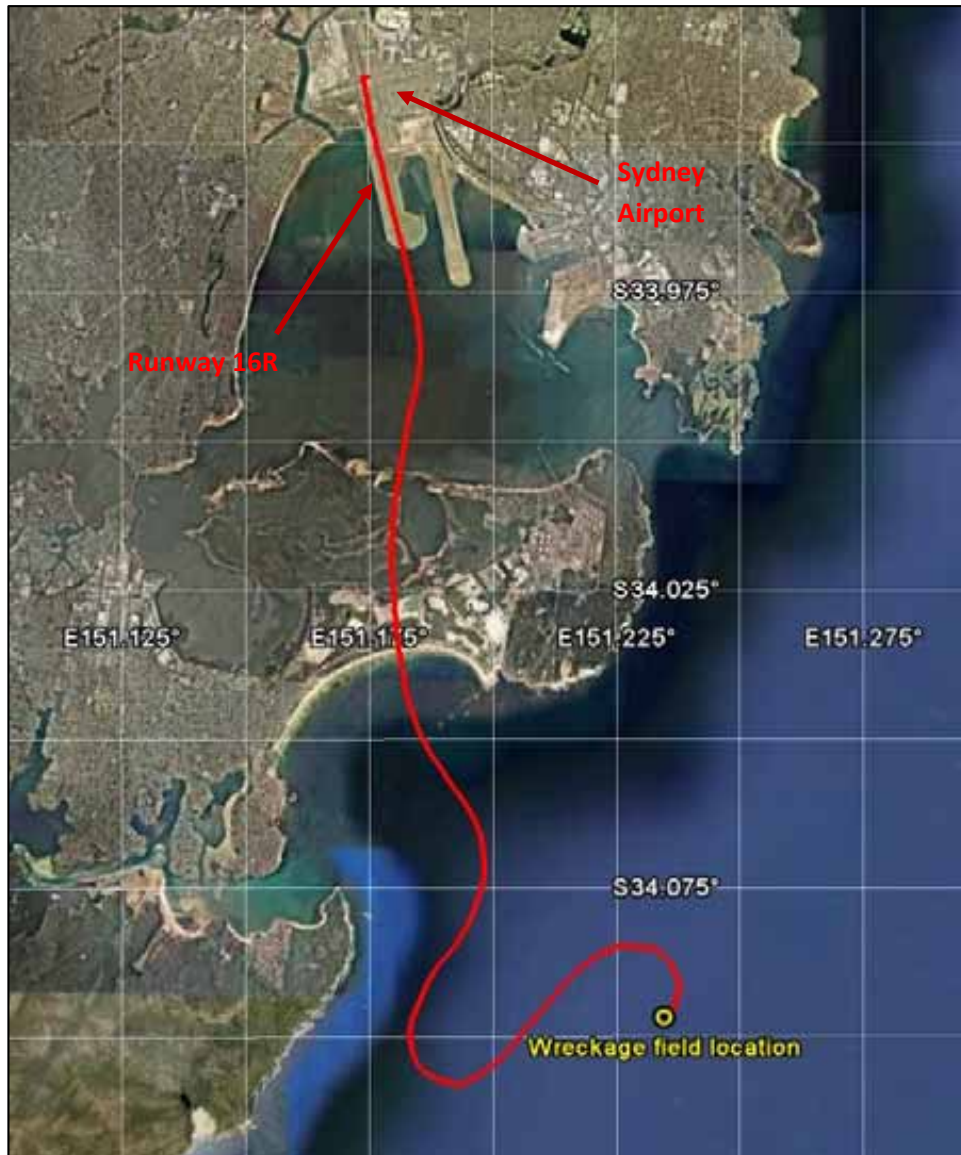
Figure 2: Radar track of OZA

Airservices radar data for the last portion of the flight showed that the aircraft commenced a right turn, then a left turn, followed by a descent, a climb, a right turn and a second descent before the radar returns from the aircraft ceased. The last recorded radar return indicated an altitude of 3,740 ft. The recorded radar data was overlaid onto a chart showing the aircraft's track from takeoff (Figure 2).

- the aircraft deviated left and right from track
- the aircraft was levelled at around 3,000 ft for 30 seconds, although cleared by ATC to climb to flight level (FL) 170⁴
- the aircraft then reached an altitude of 3,140 ft and, soon after, descended rapidly at an average rate of 8,400 ft/min to 1,540 ft
- the descent was arrested and a climb initiated at an average rate of 8,400 ft/min

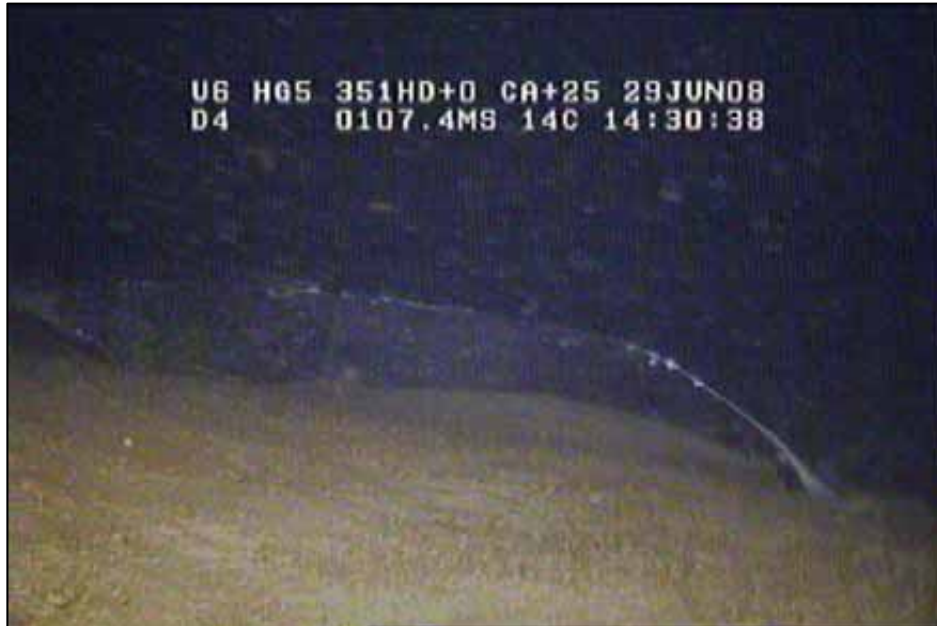
Figure 5: Propeller blade on the ocean floor as displayed on the ROV monitor

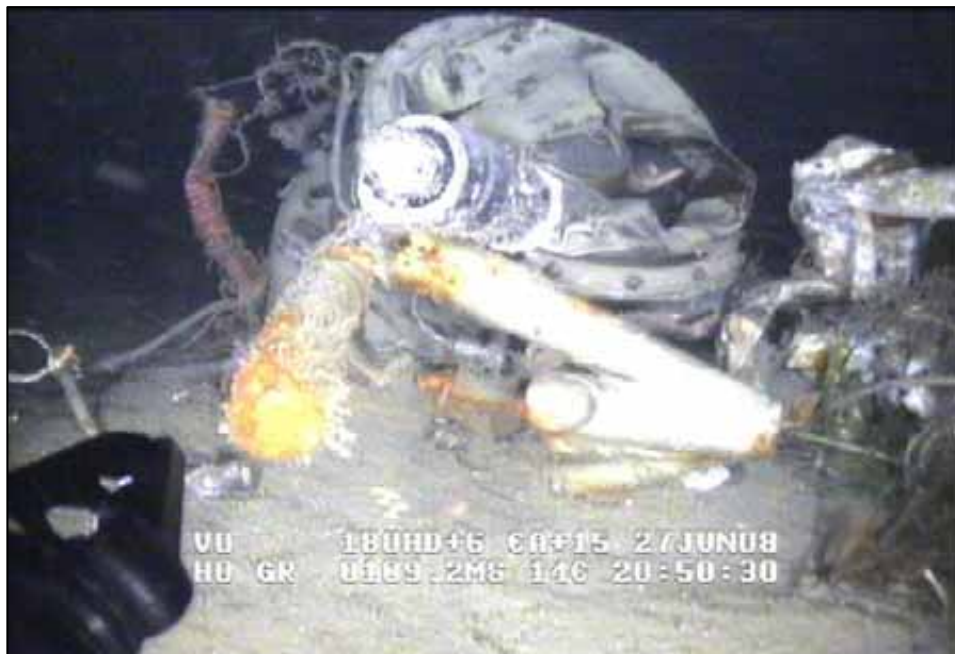
Figure 6: Engine on the ocean floor displayed on the ROV monitor

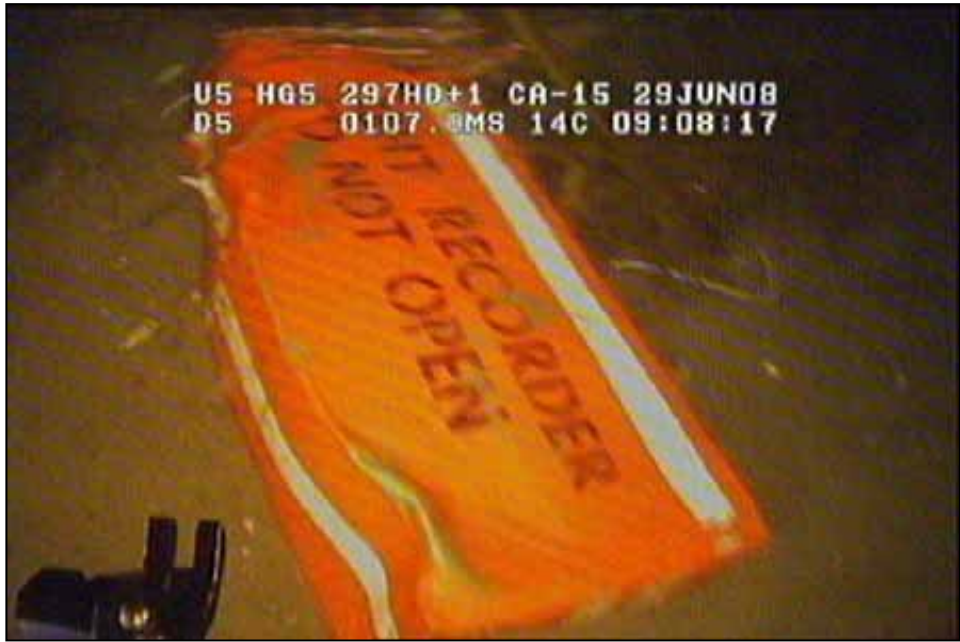
No data from the flight was able to be recovered from either of the aircraft's FDR or CVR (Appendix B).

Figure 7: FDR on the ocean floor as displayed on the ROV monitor

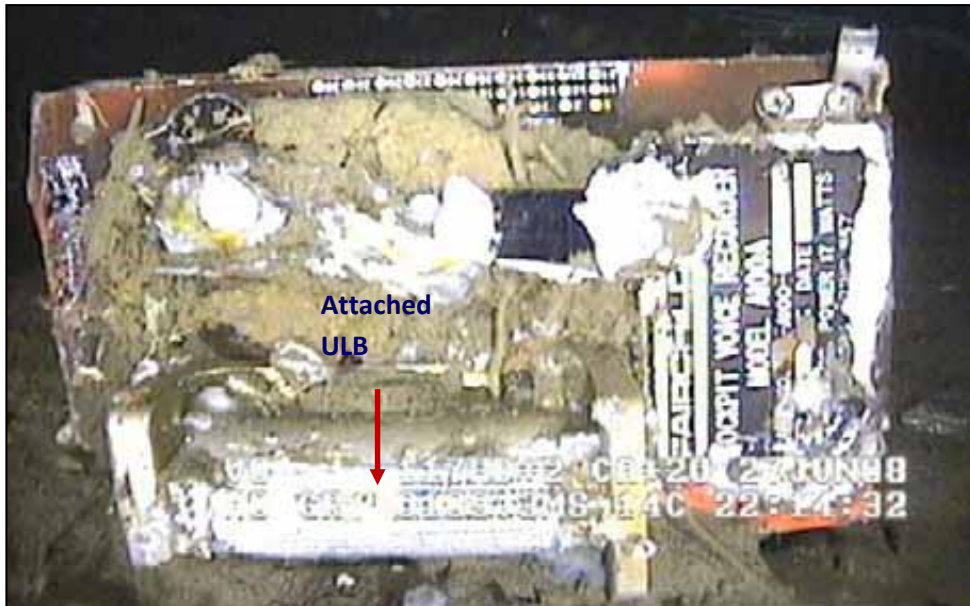
Figure 8: CVR on the ocean floor as displayed on the ROV monitor

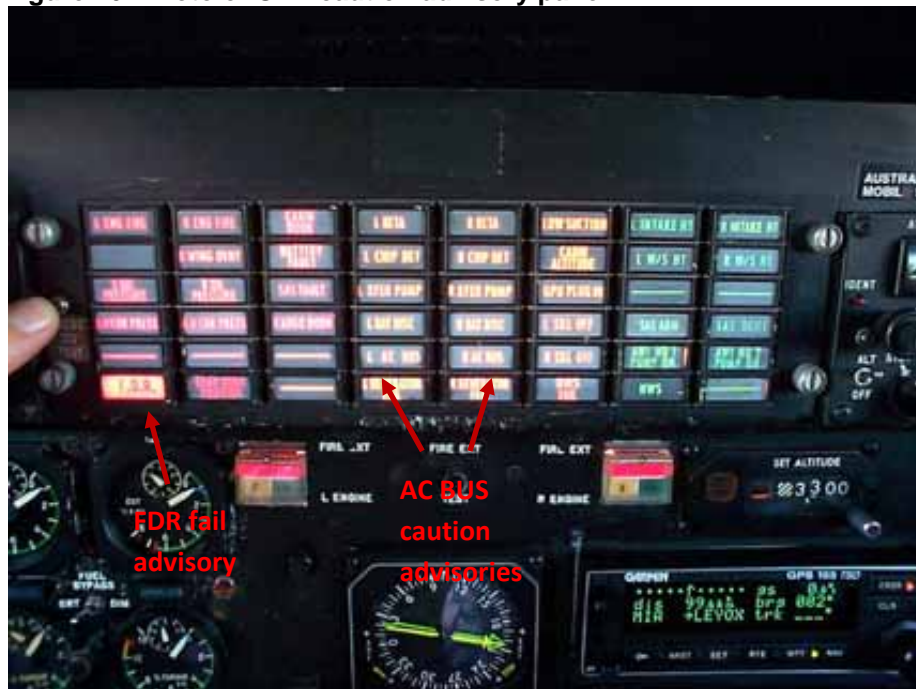
Each 115 VAC bus also powered a bus failure relay. If electrical power was lost to the respective bus, the bus failure relay relaxed and the caution advisory light illuminated. Illumination of one AC fail (L or R AC BUS) light was usually an indication of an AC bus tie circuit breaker failure.²¹ Illumination of both the L AC BUS and R AC BUS lights was usually an indication of an AC power source failure, typically an inverter failure. The L AC BUS and R AC BUS light capsules each included two light globes for redundancy (Figure 16).

Figure 16: Photo of OZA caution advisory panel

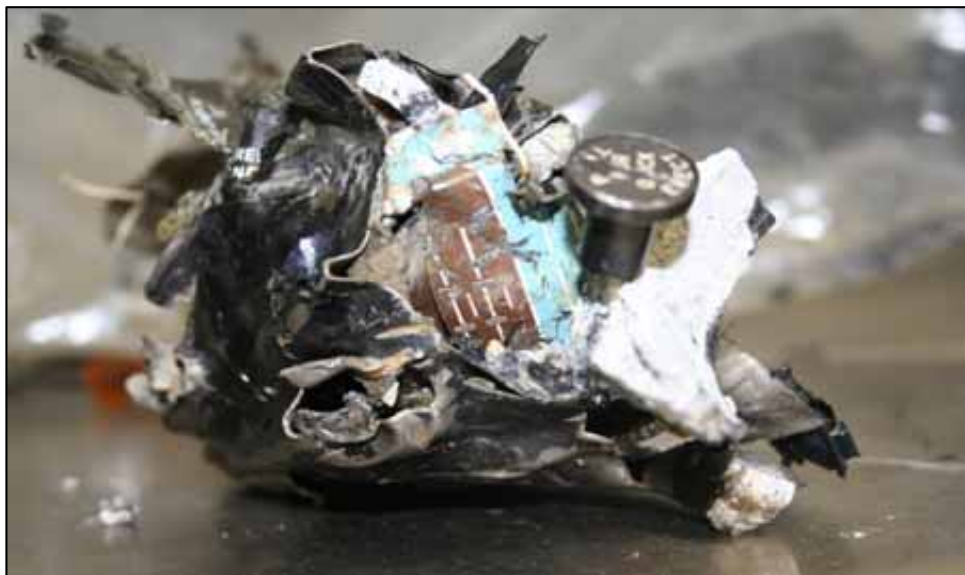
Figure 18: Recovered artificial horizon

The gyroscope rotor was removed from the AH and examined for indications of rotation at the time of the impact with the water (Figure 18).

Examination of the inside of the gyroscope casing end cap found rotor fan blade impact marks. Those impact marks displayed no evidence of rotational scoring from

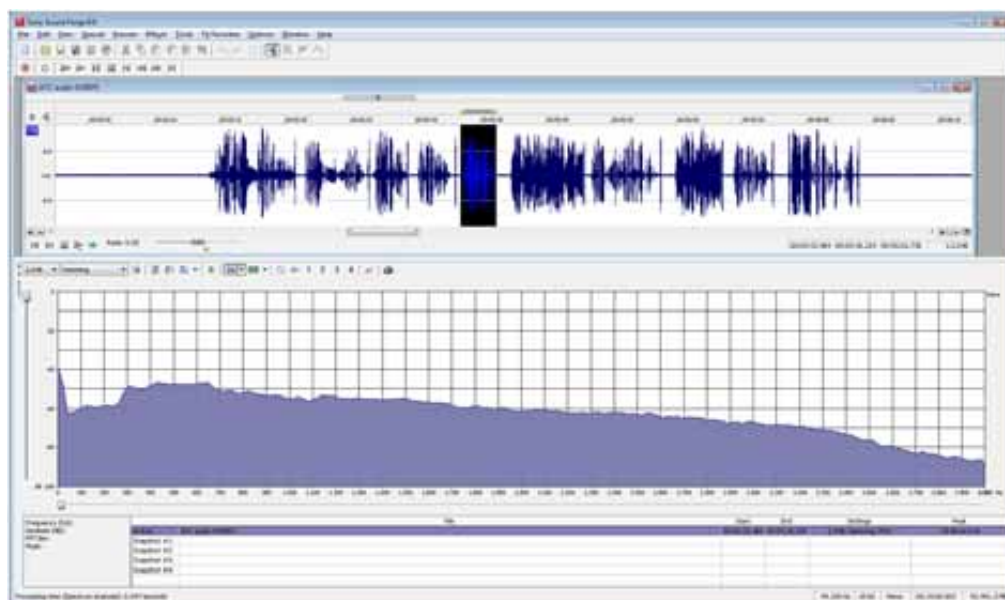
Figure 21: VHF radio transmissions - OZA

There were no corresponding interference frequencies in any of the recorded transmissions from the pilot of OZA (Figure 21).

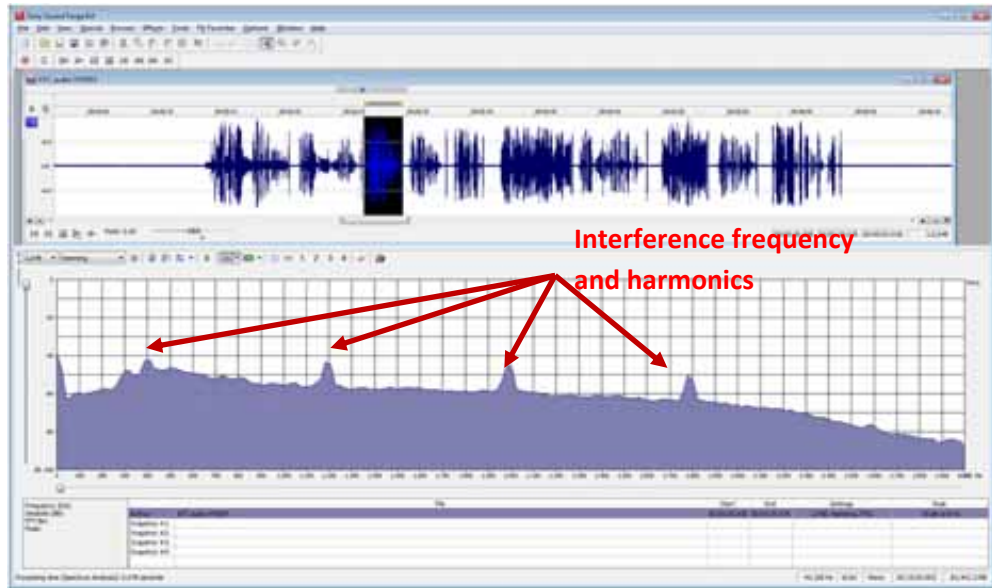
Figure 22: VHF radio transmissions - VEU

An examination of the radio transmissions from VEU at Canberra showed that the interference at frequencies 397, 1,193, 1,992 and 2,788 Hz was only present when the aircraft's AC power supply was selected ON (Figure 22).

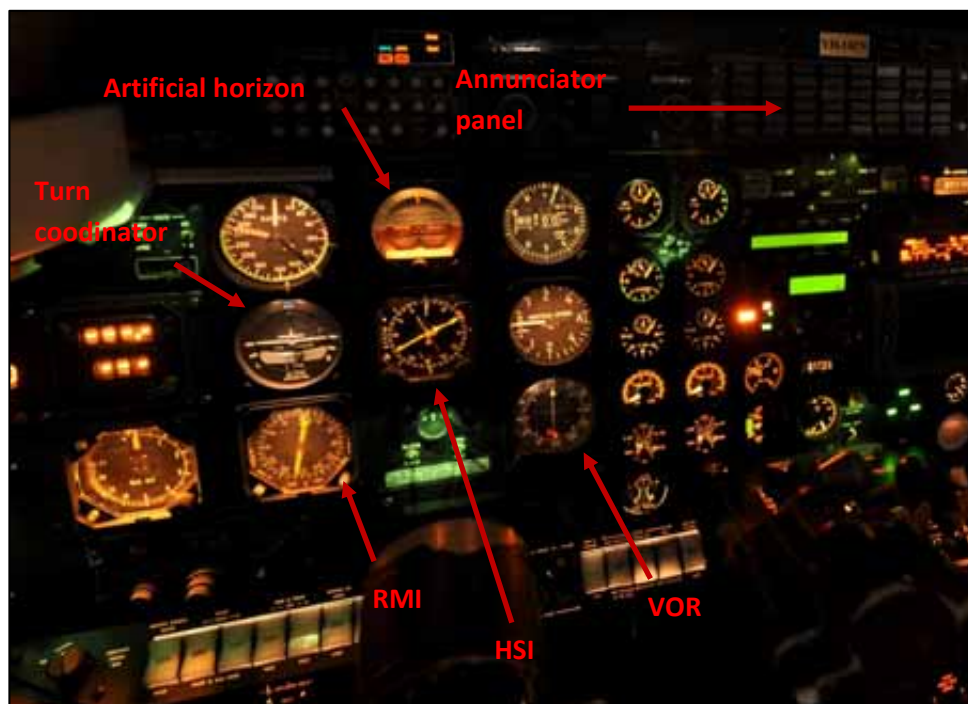
During normal night operations, the flight instruments available to a single pilot for primary attitude reference included the pilot's and copilot's AHs, one turn coordinator and one turn and bank indicator (Figure 24).

Figure 24: VH-OZN instrument panel during simulated normal night operations (pilot side) with no warning/caution lights or flags visible

A loss of AC power meant that the pilot's and copilot's AHs would have been inoperative, with the effect that the pilot would have been deprived of any primary attitude information from his instrumentation (Figure 25). The autopilot would also not have been available for use.

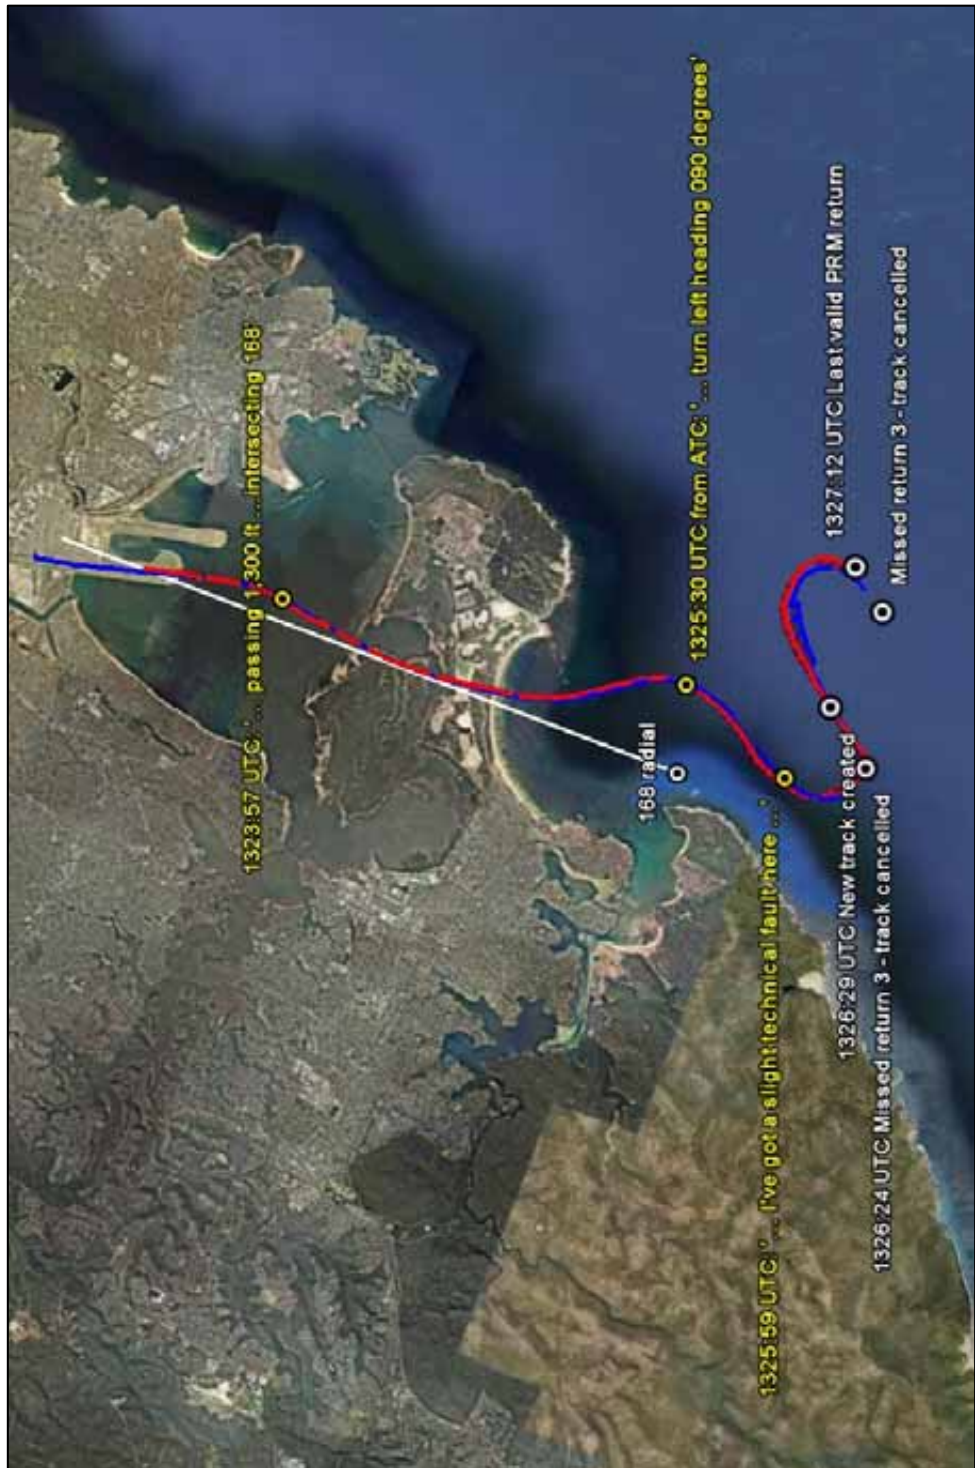
Figure A-6: Radar tracks (Sydney TAR – blue, PRM – red)

UTC: (hhmm:ss)	Event:	Comment:
1321:59	Initial TAR secondary return	Aircraft was stationary on taxiway golf adjacent to runway 16R.
1323:11	Aircraft airborne	First increase in Mode C altitude.
1323:18	Initial PRM return	
1324:29	Aircraft intercepted the 168° radial	In accordance with the Standard Instrument Departure (Sydney Curfew Two Departure).
1325:28	End of continuous climb after takeoff	Aircraft reached an altitude of 3,140 ft (Mode C of 2,900 ft).
1326:18 to 1326:29	Loss of PRM secondary returns	PRM track cancelled (no. 80).
1326:20 to 1326:27	Loss of TAR secondary returns	Primary returns continued to be received.
1326:27 to 1326:29	Radar returns regained	Aircraft track changed from south-south-west to north-east. Aircraft reached a minimum altitude of 1,540 ft (Mode C of 1,300 ft). New track created for PRM (no. 143).
1326:53	Maximum recorded Mode C value	Aircraft reached a maximum altitude of 4,340 ft (Mode C of 4,100 ft)

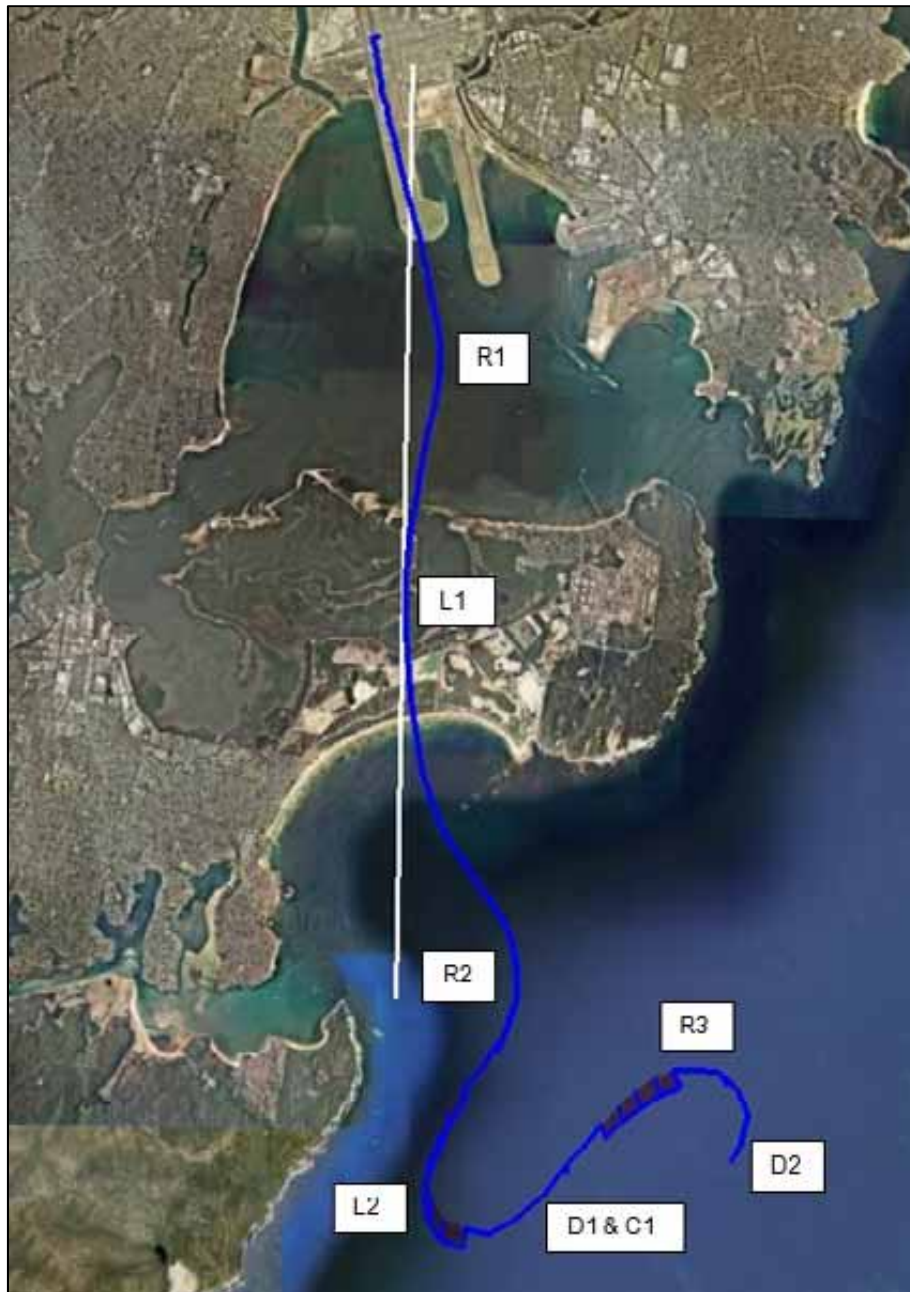
Figure A-8: Aircraft manoeuvres annotated on a track plot

with the water is considered to have occurred shortly after this time. This indicated an average rate of descent of approximately 10,400 fpm.

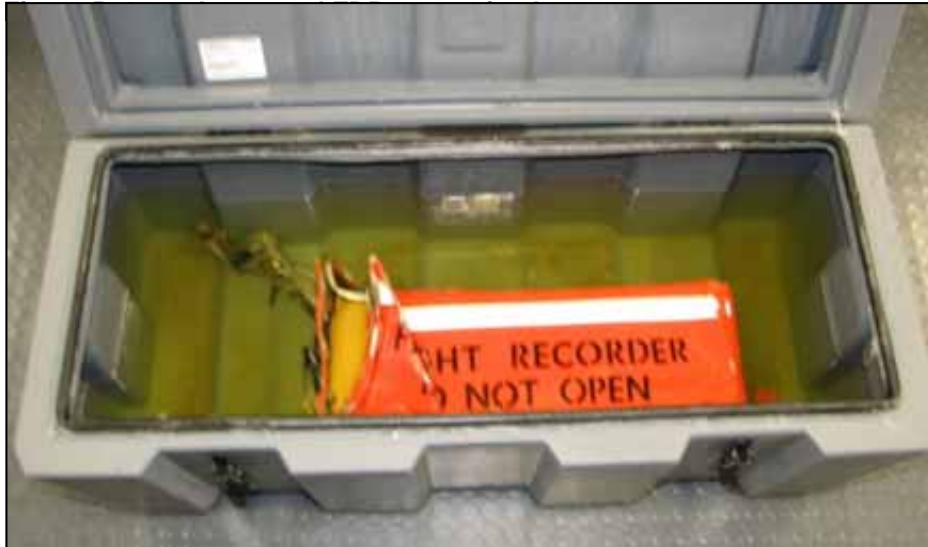
Upon opening of the container, the FDR was found to be immersed in water, as-packed (Figure B-4).

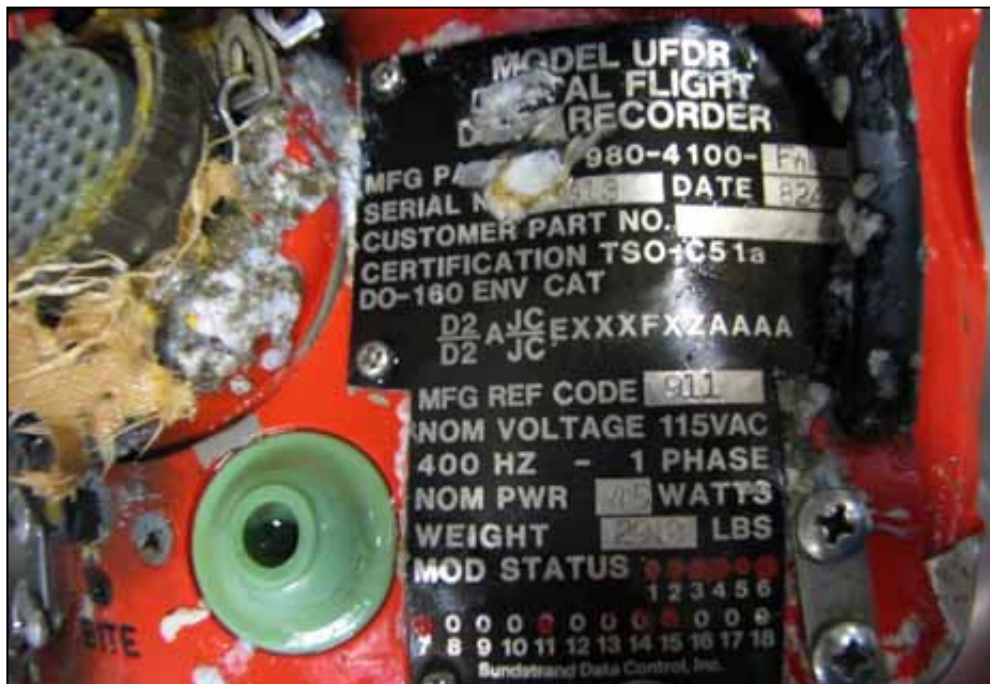
Figure B-5: FDR data plate

On 2 July 2008, the FDR was removed from the shipping container and examined. The recovered FDR was identified from the manufacturer's data plate as a Sundstrand Data Control (now Honeywell Aerospace) model Universal Flight Data Recorder (UFDR), part number 980-4100-FWUS, serial number 1313 (Figure B-5). The maintenance records for VH-OZA confirmed that this FDR was fitted to VH-OZA at the time of the accident.

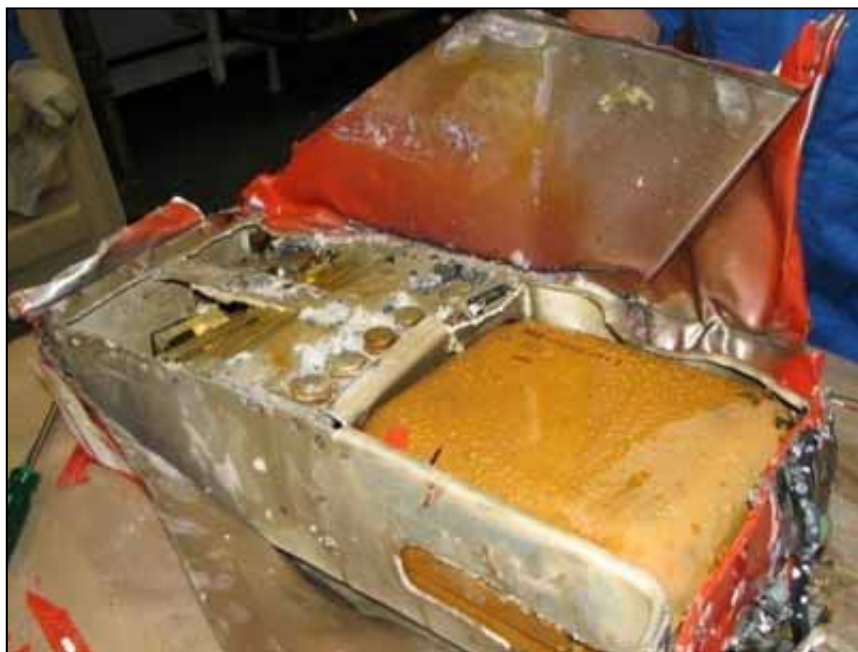
The FDR had been subjected to substantial impact forces and saltwater immersion, which had resulted in extensive damage to the recorder, including a fracture of the crash-protected enclosure and wiring damage. Some discolouration of the external paint was observed. Analysis of the paint discolouration was the subject of a separate materials examination (see Appendix C). The recorder was dismantled (Figures B-6 to B-12) and the recording tape was extracted from the crash protected enclosure for replay.

Figure B-6: VH-OZA's FDR during disassembly showing the crash protected enclosure and associated electronics

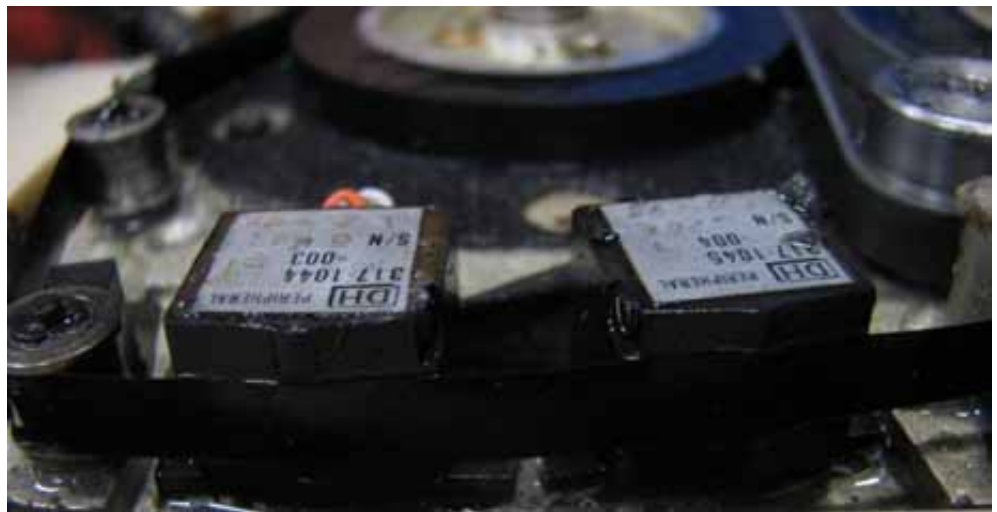
Figure B-11: Tape adhesion to tape transport heads

At the location where the tape had stopped and the tape had adhered to the heads (at about 3,900 secs from one end of the tape and 7,400 secs from the other) the tape signal strength was reduced across all tracks (Figure B-14). During the analogue to digital conversion, the recovery stalled and had to be restarted. The recovery was restarted after the reduced signal strength location, resulting in approximately 33 seconds of data⁵² per track not being recovered at this point. The damage to the tape at this location was considered to be a consequence of magnetic tape and head corrosion damage due to water immersion for over 2 months.

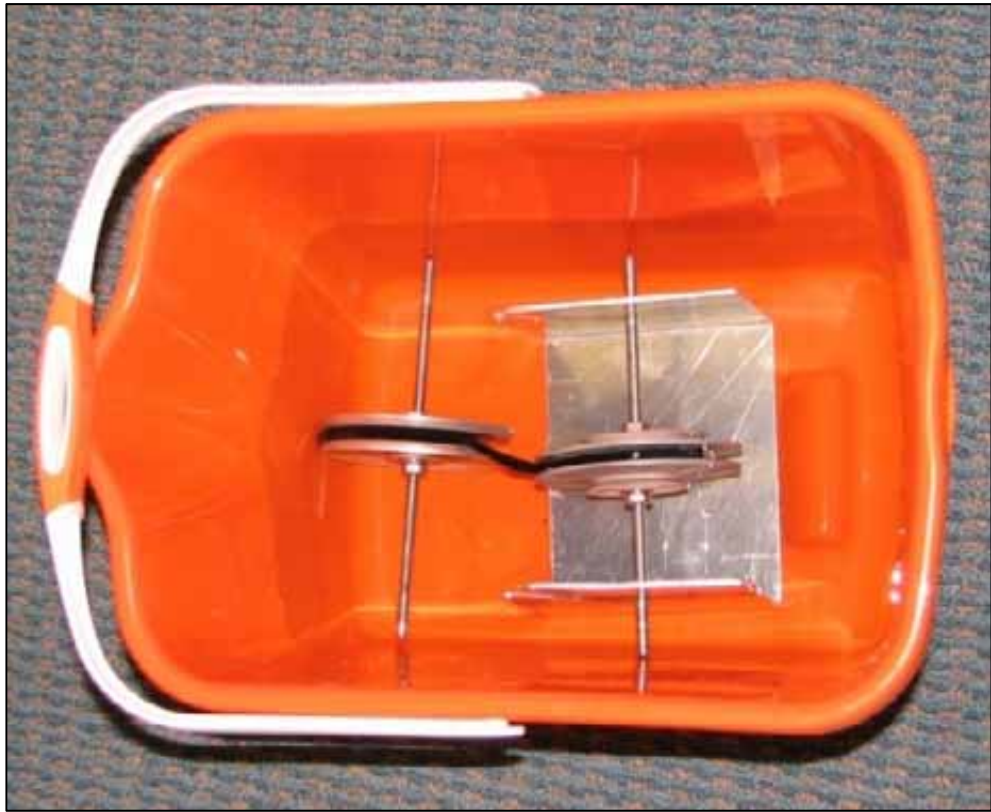
Figure B-12: Tape removed from FDR rinsed and cleaned and on spools

The tape was in reasonable condition and, after cleaning, was replayed using the ATSB's FDR analysis workstation. No evidence of heat or fire damage was found during disassembly of the crash protected module.

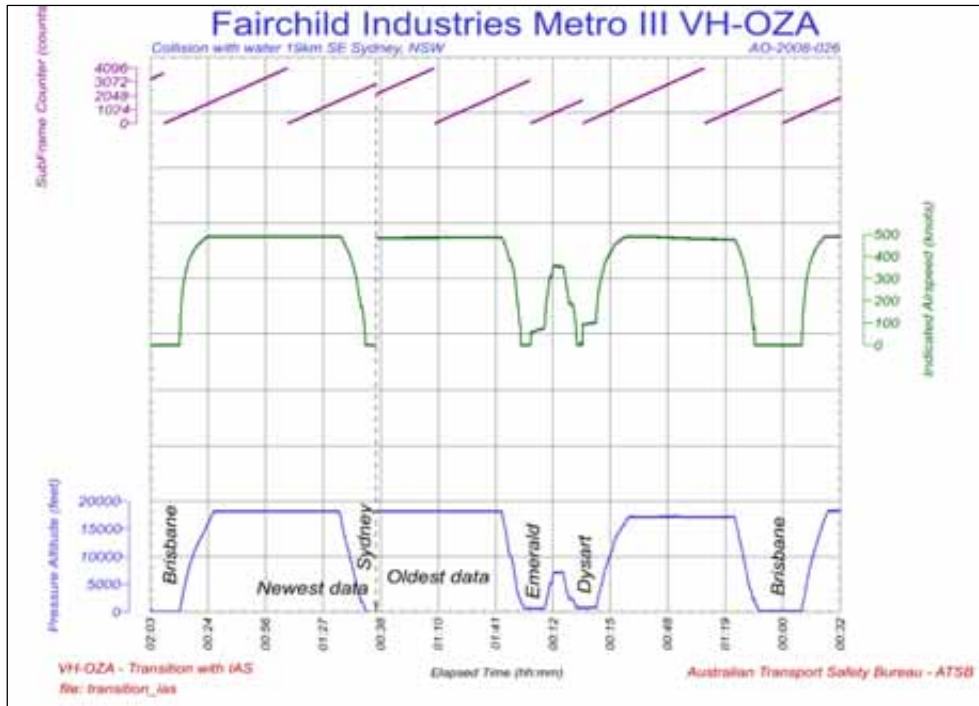
All parameters recorded on the FDR were serviceable, with the exception of indicated airspeed (IAS). The IAS was recorded at an unreasonably high value, and increased as the aircraft climbed until the top of climb, where it remained steady during the cruise. The IAS reduced during descent. The IAS therefore changed in conjunction with altitude or static air pressure only. This characteristic was evident across the entire FDR recording.

Figure B-15: Plot of airspeed and IAS over a number of flights

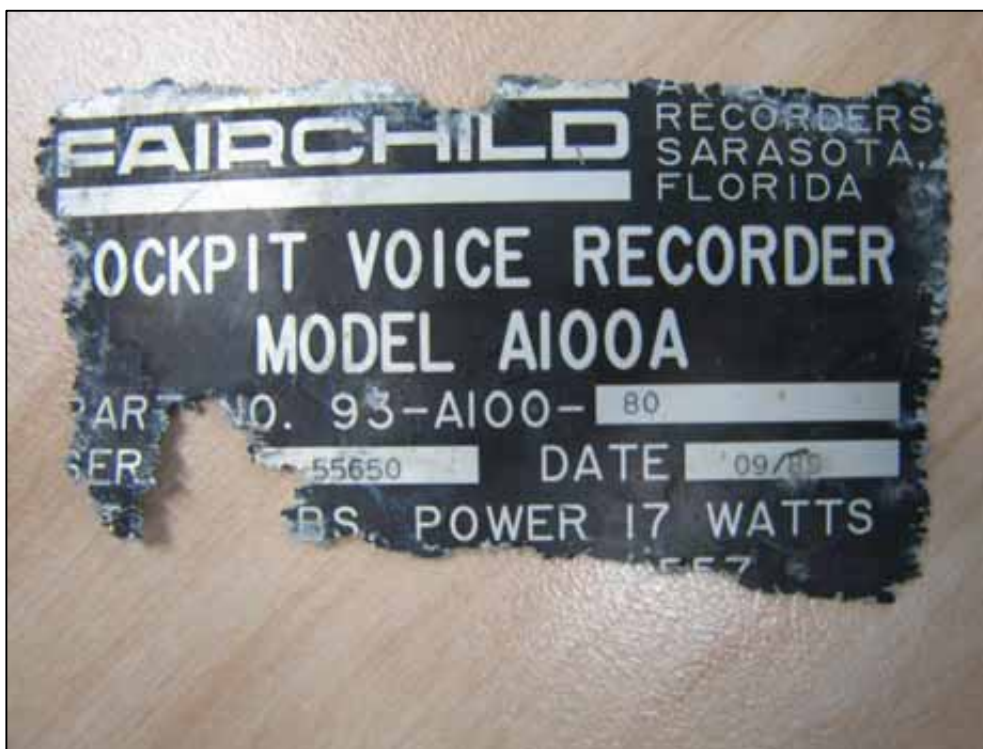
Figure B-2: CVR data plate

The CVR had been subjected to substantial impact forces and saltwater immersion, which had resulted in extensive damage to the recorder. The recovered CVR was identified from the manufacturer's data plate as a Fairchild model A100A CVR, part number 93-A100-80, serial number 55650 (Figure B-22). The maintenance records for VH-OZA confirmed that this CVR was fitted to VH-OZA at the time of the accident.

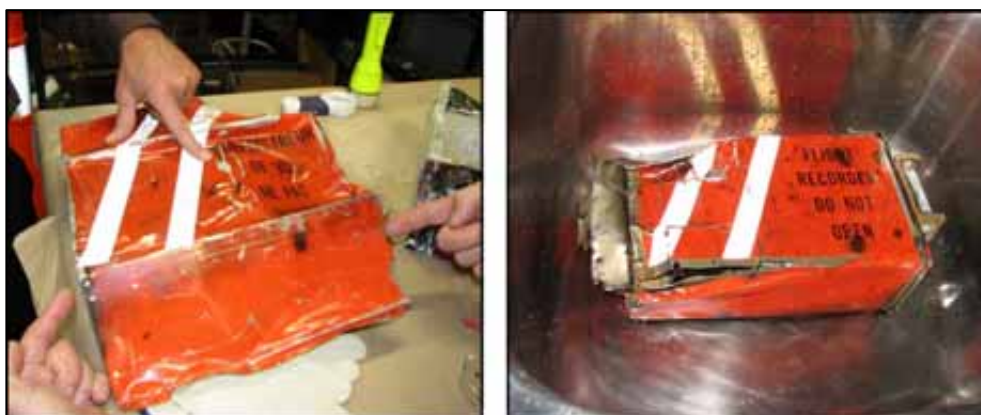
Figure C-1: FDR (left) and CVR (right) as received by the ATSB

While the unit displayed obvious damage resulting from the accident impact, it was noted that isolated and localised areas over the external surfaces of the CVR outer case were also discoloured; the regions ranging from dark brown to black in discrete patches (Figure C-2). The FDR casing displayed similar effects. Manufacturing data for the CVR indicated the unit to have been painted with an enamel based compound, formulated to the *International Orange* paint code #12197.

On the basis of the ATSB's knowledge and understanding of the accident scenario, it was considered most likely that the discolouration of the FDR and CVR cases resulted from the short-term exposure of the units to the effects of a flash-fire or explosion that ignited upon impact of the aircraft with the water. The physical violence of the impact would have produced ideal conditions for such an event, with any spray of atomised fuel from ruptured fuel tanks being ignited from exposure to damaged electrical systems or hot engine components.

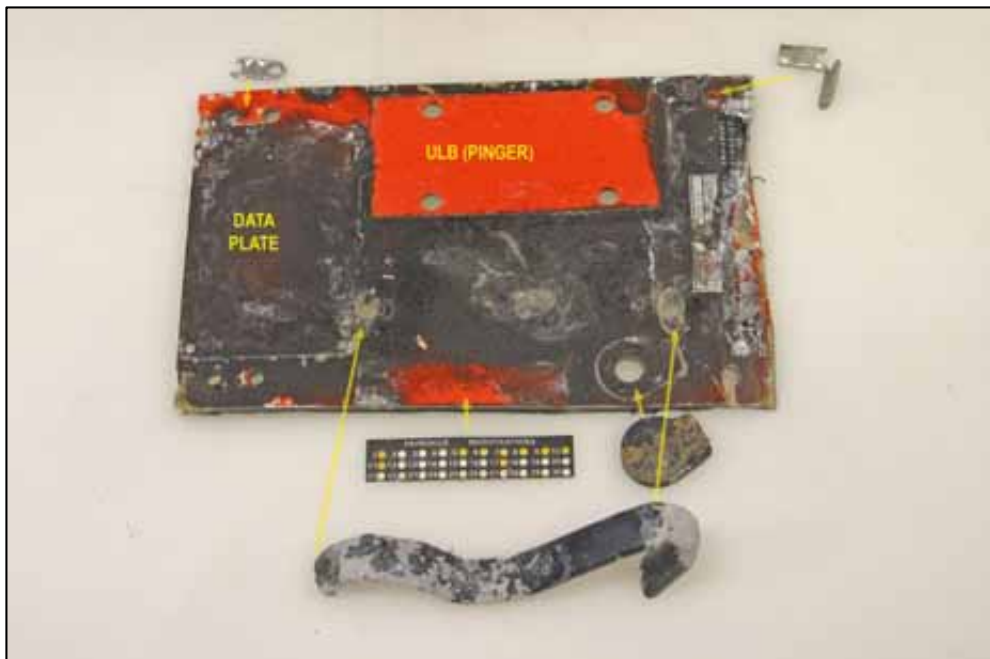
Figure C-3: CVR face plate showing the location of various front attachments

Fittings that had been attached to the front panel of the CVR (including the modification status plate, audio cap and the grab handle) were removed for the examination. The front panel of the unit was of particular interest because the majority of the surface displayed significant discolouration; having changed from orange to dark grey or black. In some areas, the painted surface underneath the fittings had also discoloured. However, in other regions, notably below the underwater locator beacon (ULB), the surfaces remained essentially unaffected (Figure C-3).

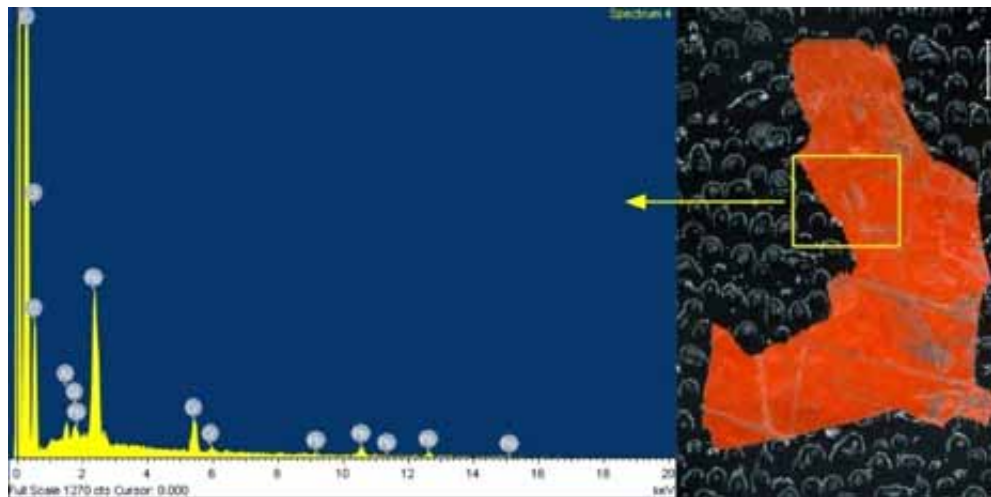
Figure C-7: Undamaged paint sample from CVR and its chemistry

using Energy Dispersive Spectroscopy (EDS) techniques under the scanning electron microscope (SEM). Semi-quantitative chemical analysis of the paint samples revealed its primary constituents to be lead (Pb), chromium (Cr) and silicon (Si). No differences were noted in the chemistry between the discoloured and undamaged regions as shown in Figure C-6 and C-7.

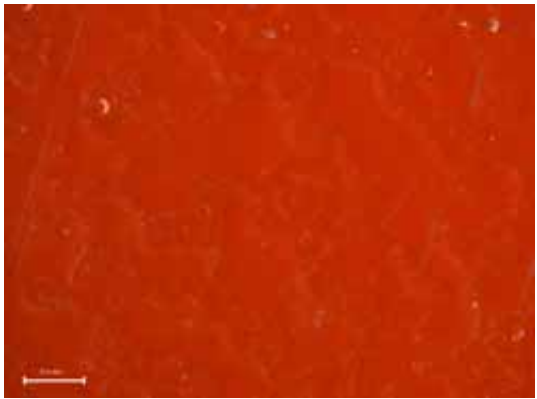
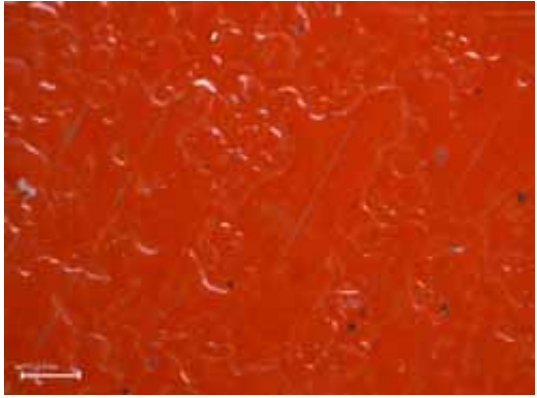
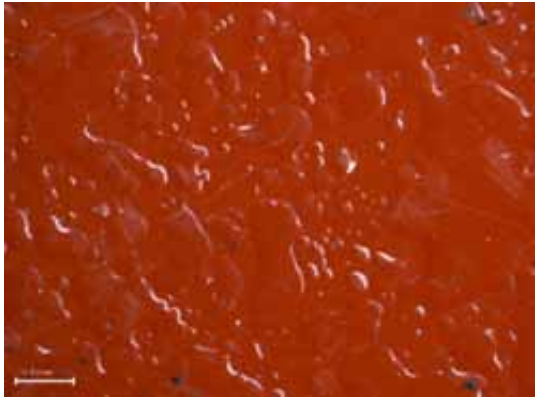
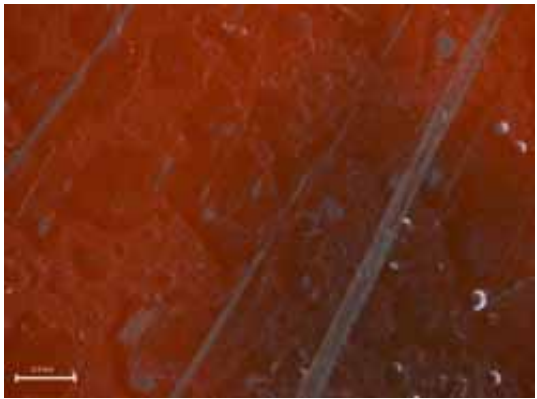
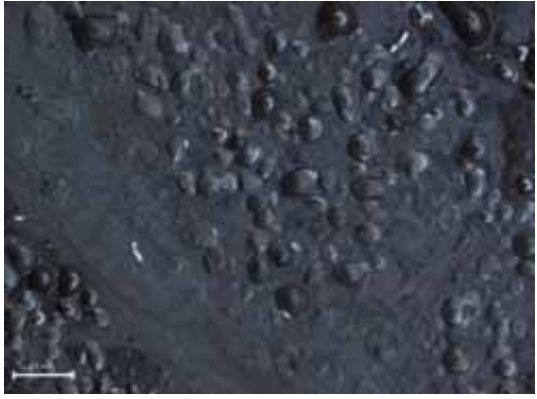
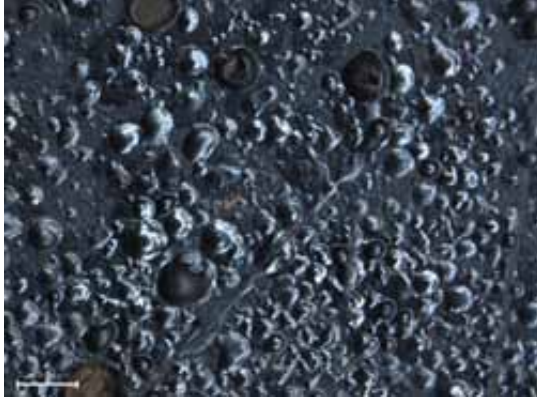
Table C-2: Test program (A) for CVR panel coupon testing

Results from the testing under program (A) showed that the paint readily changed colour and darkened from the original *International Orange*, to a brown/black shade after exposure to elevated temperatures. At temperatures around 350 to 375°C, a marked change in the paint colour was observed; by 400°C the paint had blistered and turned completely black.

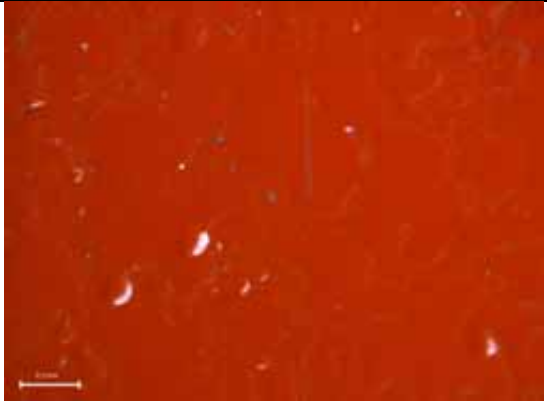
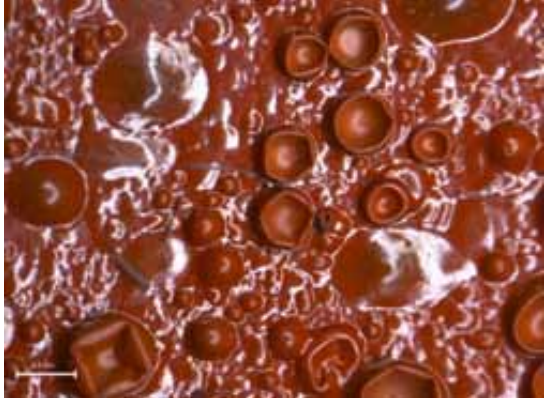
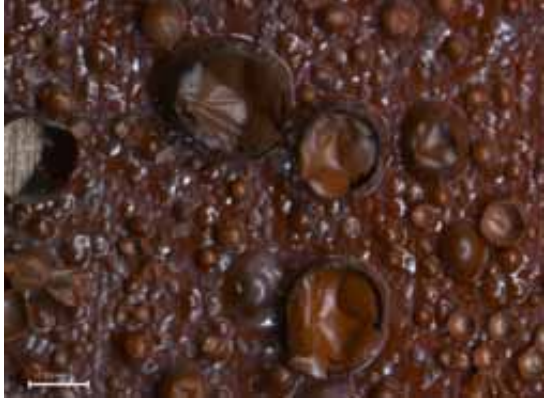
Table C-3: Test program (B) for CVR panel coupon testing

Results from the testing at 1,000°C under program (B) found that the paint changed in appearance after 7 seconds of exposure. Obvious blistering and lifting of the paint followed rapidly.
