Flight Control System Event

19 km west of Camden, NSW – 8 May 2008

INFRA-08549

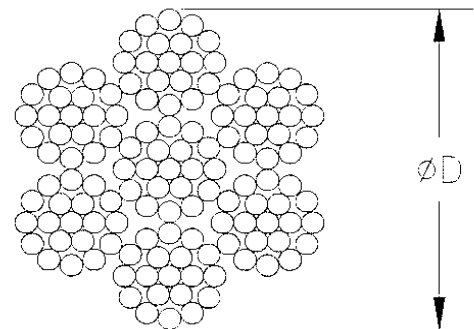
Figure 2: 7x19 cable construction

All of the cable samples had been produced as conventional spiral-wound regular lay² wire rope, with seven strands of 19 wires each and a nominal 1/8" (3.175 mm) cable diameter (ØD, Figure 2).
