Aviation Occurrence Investigation AO-2008-033

Final

Operational non-compliance
Perth Airport, WA
9 May 2008
PK-GEF
Boeing Company 737-8CX

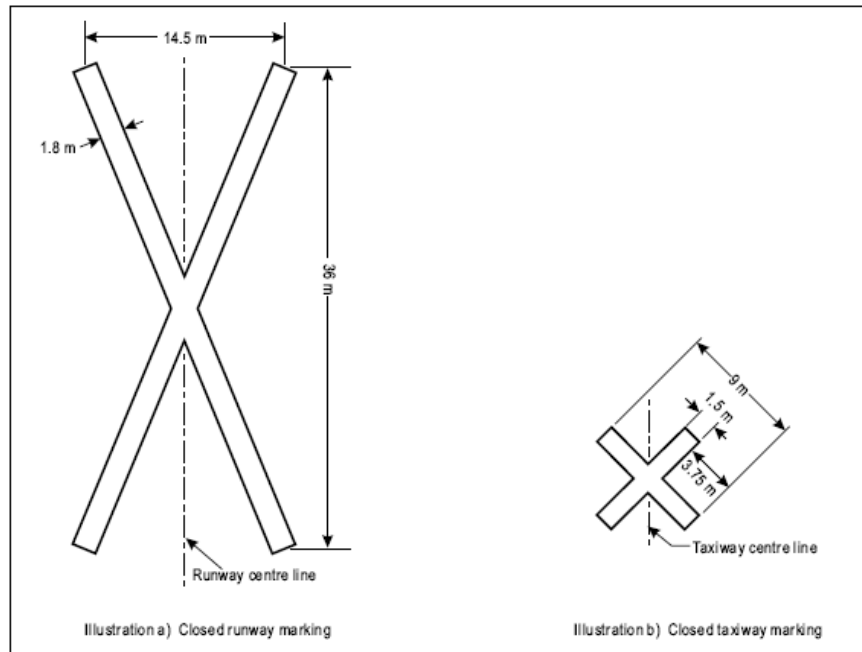
Figure 4: ICAO-recommended closed runway or taxiway markings

7.1.4 The closed marking shall be of the form and proportions as described in Figure 3, illustration a), when displayed on a runway, and shall be of the form and proportions as detailed in Figure 3, illustration b), when displayed on a taxiway. The marking shall be white when displayed on a runway and shall be yellow when displayed on a taxiway [Figure 4 below].

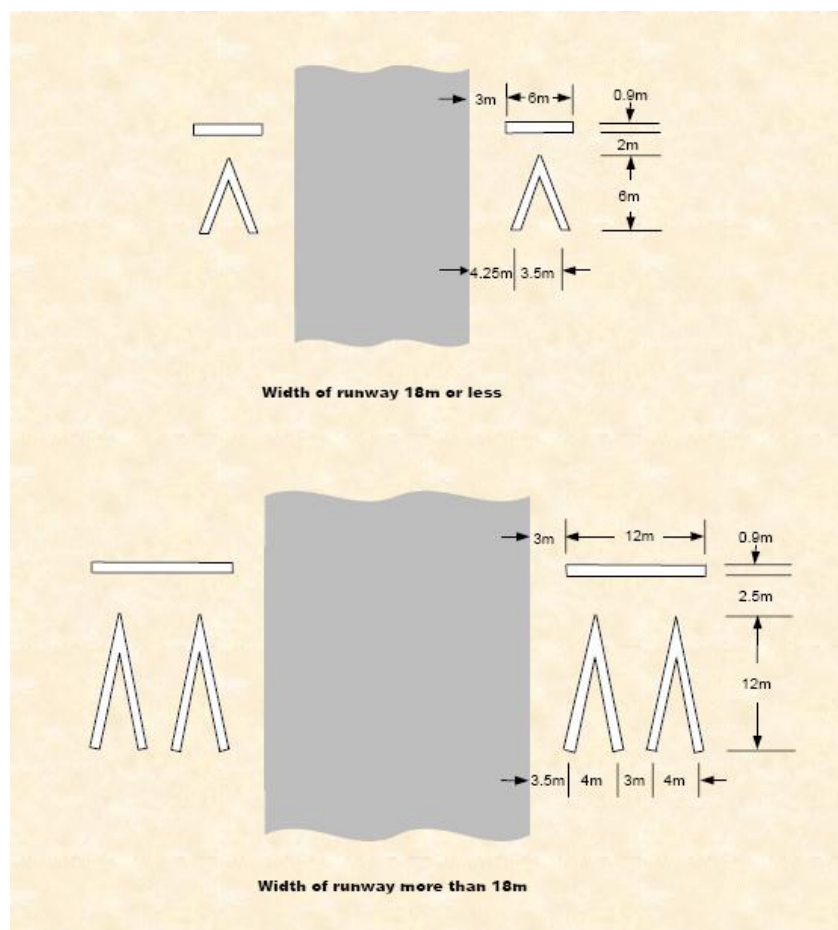
Figure 5: Australian temporarily displaced threshold markings (less than 5 days)

8.3.9.8 When a threshold at an air traffic controlled aerodrome is to be temporarily displaced for 5 days or less, and the displacement is more than 450 m, the new threshold location is to be indicated by the above markings [Figure 5 below] but the permanent threshold markings may be retained.

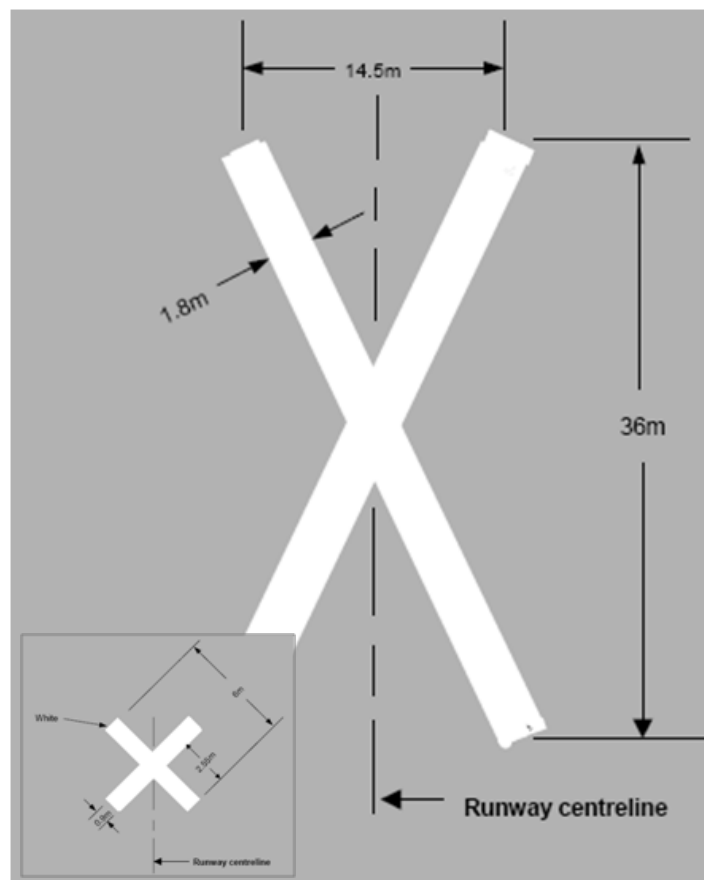
Figure 6: Unserviceability markings - large (smaller-sized marking included in the inset for comparison)

8.9.2.5 The larger markings must be used on Code 4 runways [Perth runway 21 was classified as a code 4 runway] when the whole or part of the runway is permanently closed to aircraft operations, for more than 30 days [Figure 6 below]. Markings must be displayed at each end of the unserviceable runway, and also in the intermediate area, at intervals of not more than 300m.

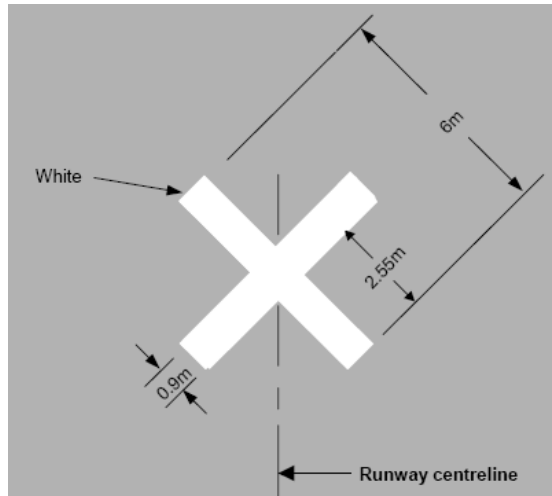
Figure 7: Unserviceability markings (small)

8.9.2.7 In other cases of runway unserviceability, if markings in accordance with the larger configuration are not used, then the smaller markings [Figure 7, see next page] must be used. The smaller markings must be displayed at each end of the unserviceability and in the intermediate area at intervals of not more than 200m.
