Aviation Occurrence Investigation – AO-2008-035

Collision with terrain

83 km NE Georgetown, Qld

VH-IDM

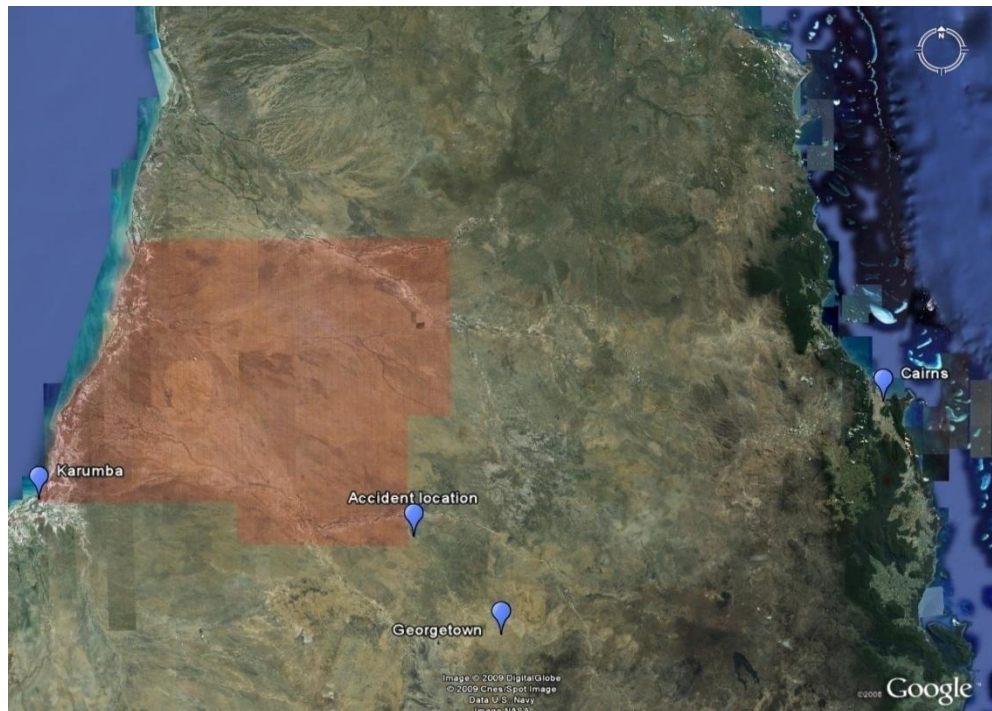
Figure 1: Survey area and accident location

At about 1000, Australian Search and Rescue (AusSAR) detected an Emergency Locator Transmitter (ELT) transmission and initiated a search. At approximately 1300, the wreckage of the aircraft was located about 83 km north-east of Georgetown (Figure 1) and the pilot was found to be fatally injured.

Satellite photograph courtesy of Google Earth Note: The red area depicts the survey region
