**ATSB TRANSPORT SAFETY REPORT**  
Occurrence Investigation Report AO-2008-043  
Final

**Collision with terrain  
10 km east of Cairns Aerodrome, Old  
Robinson Helicopter Company  
R44 Clipper II, VH-RYW**

**18 June 2008**

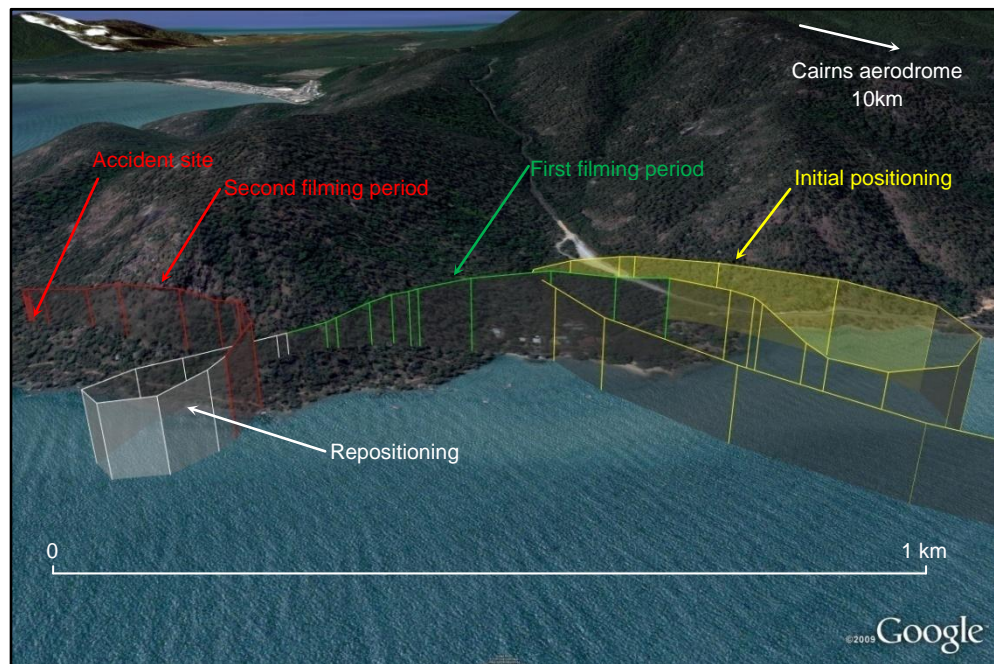
**Figure 2: GPS flight profile looking south-east**

In response to a request by one of the passengers, the pilot initially positioned the helicopter to the south-west of the development site, in order to commence the filming in a north-easterly direction, along the development site (Figure 2).

Following the repositioning of the helicopter, a second period of filming commenced at 1034 (Figure 2). During that filming, the pilot manoeuvred the helicopter in a similar orientation and airspeed to that of the first period of filming. The altitude during the second period of filming commenced at about 500 ft and reduced to about 370 ft. Those altitudes corresponded to heights above the ground of between about 200 and 470 ft.

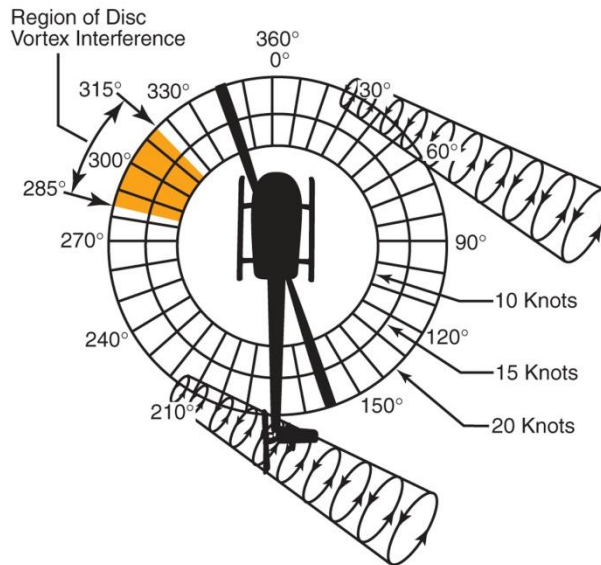
**Figure 6: Main rotor vortex interference**

A wind from the left front of the helicopter at between 285° and 315° caused vortices generated by the main rotor to affect the airflow over the tail rotor (Figure 6). The result was a variation in the thrust produced by the tail rotor, and associated deviations in yaw.

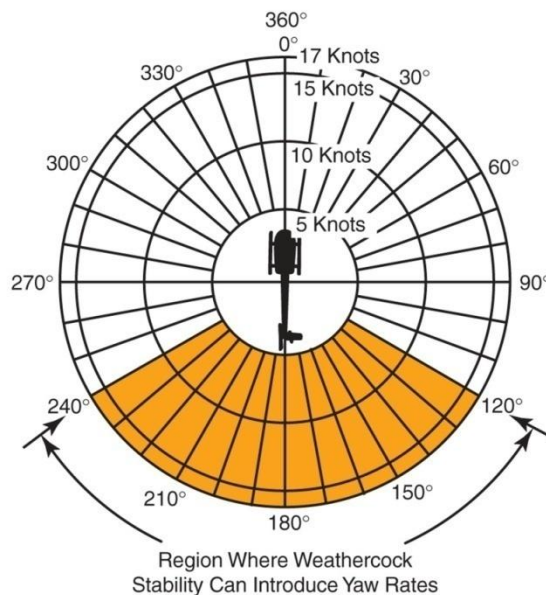
**Figure 7: Weathercock stability**

Relative tailwinds from 120° to 240° can accelerate existing yaw rates by the relative wind acting on the vertical fin and fuselage (Figure 7). In this case, the relative wind acts to weathercock the nose of the helicopter into the relative wind.

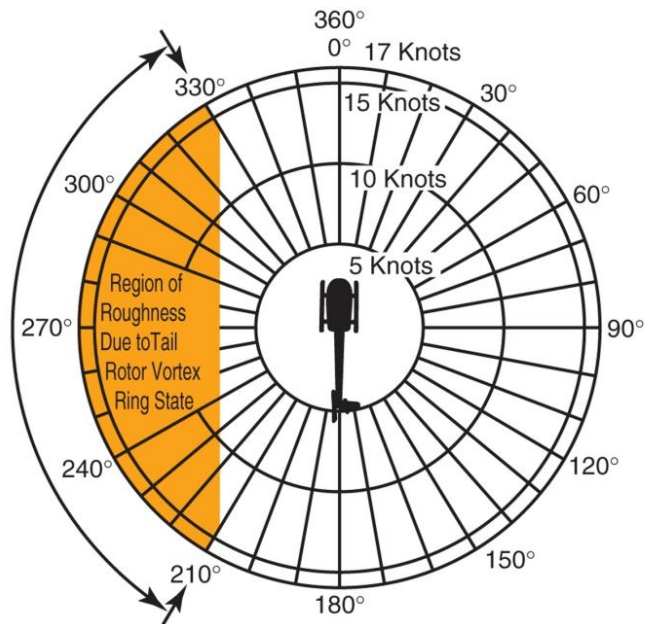
**Figure 8: Tail rotor vortex ring state**

A left crosswind from between 210° and 330° can result in tail rotor vortex ring state<sup>17</sup> (Figure 8). A variation in tail rotor thrust results, with associated deviations in yaw.
