ATSB TRANSPORT SAFETY REPORT
Occurrence Investigation Report AO-2008-062
Final

Collision with terrain
6 km NE Purnululu ALA, Western Australia
14 September 2008
VH-RIO
Robinson Helicopter Company R44 Raven

Aviation Occurrence Investigation
AO-2008-062
Final

**Collision with terrain
6 km NE of Purnululu ALA, Western
Australia
14 September 2008
VH-RIO
Robinson Helicopter Company R44 Raven**

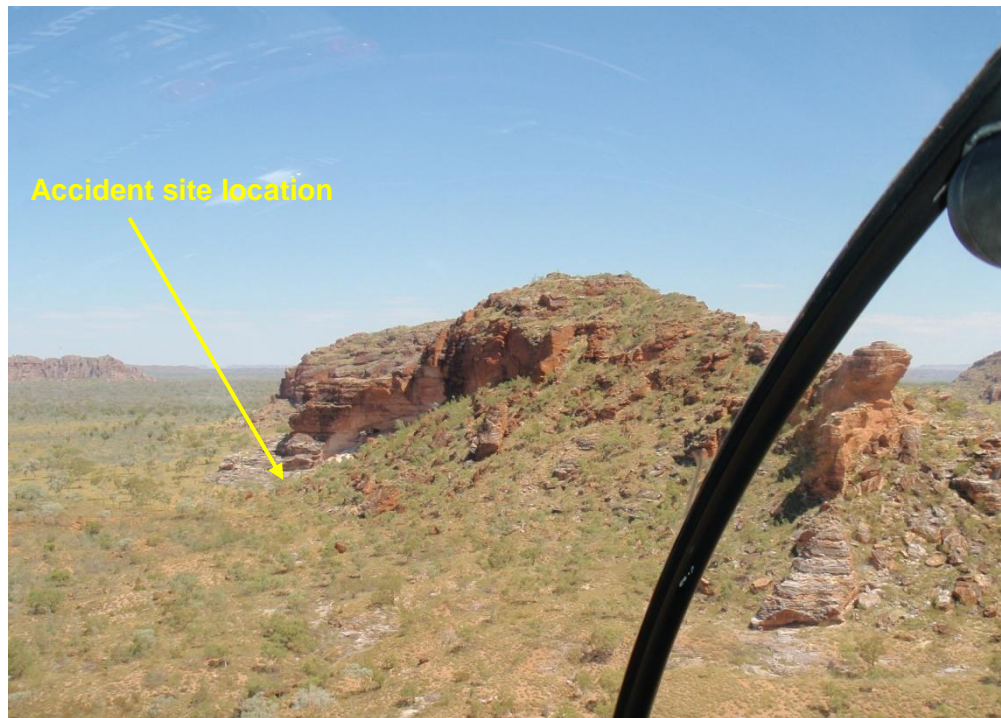
Figure 3: Approaching the distinctive rock formations (looking south)

A series of images taken between 1244 and 1245 showed the helicopter diverging from the regular scenic route and tracking to the south towards an area that contained distinctive rock formations (Figures 3, 4 and 5). The helicopter's speed and height, as derived from this sequence of images, was not consistent with the standard scenic flight parameters.
