ATSB TRANSPORT SAFETY REPORT
Aviation Occurrence Investigation
AO-2008-065
Final

Collision with terrain
Luddenham, New South Wales
24 September 2008
VH-CZX
Liberty Aerospace Incorporated XL2

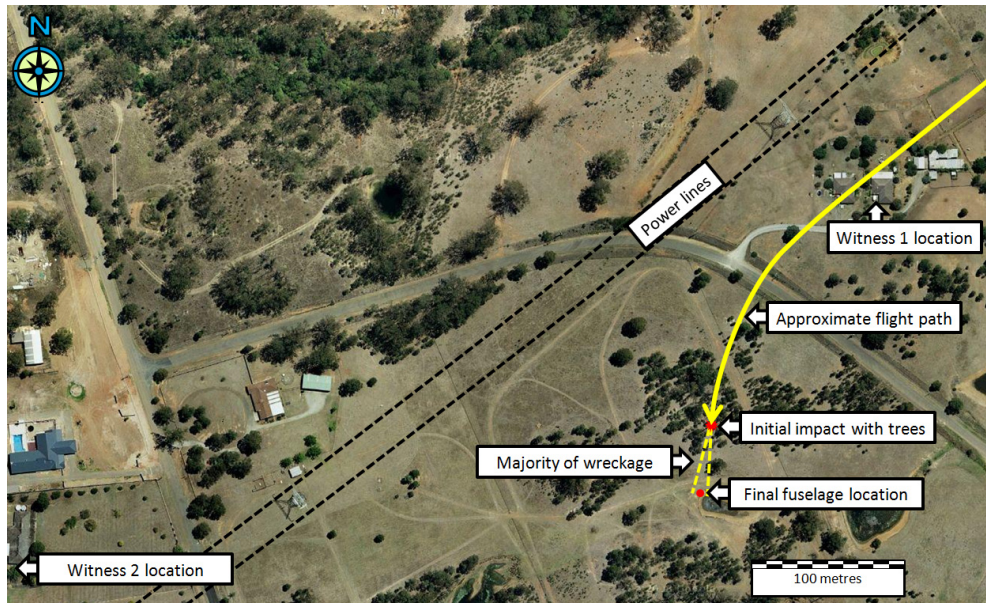
Figure 1: Witness locations and approximate aircraft flight path

Two witnesses reported observing the aircraft immediately prior to the ground impact. The location of those witnesses is shown at Figure 1. Witness 1 reported seeing the aircraft fly slowly at very low level before descending rapidly into trees. Another witness (Witness 2) saw the aircraft 'nose diving towards the ground' with the wings rocking as it descended. From Witness 1's description and the geometry of the accident site, the investigation estimated the aircraft's height in the vicinity of Witness 1 as below 250 ft AGL. A telephone call to the national emergency telephone service to report the accident was recorded around 90 seconds after the time of the last radar return.⁴
