ATSB TRANSPORT SAFETY REPORT
Aviation Occurrence Investigation AO-2008-067
Final

Total power loss
Talbot Bay, Western Australia
25 September 2008
VH-NSH
Bell Helicopter Co 407

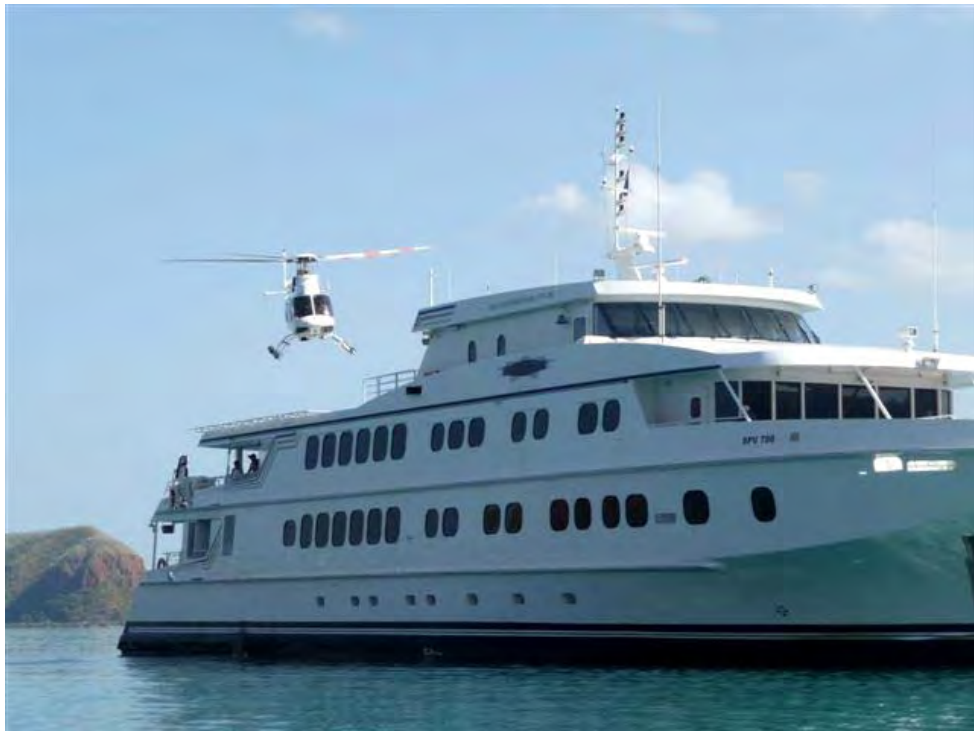
Figure 1: Departure from the cruise ship immediately prior to the power loss

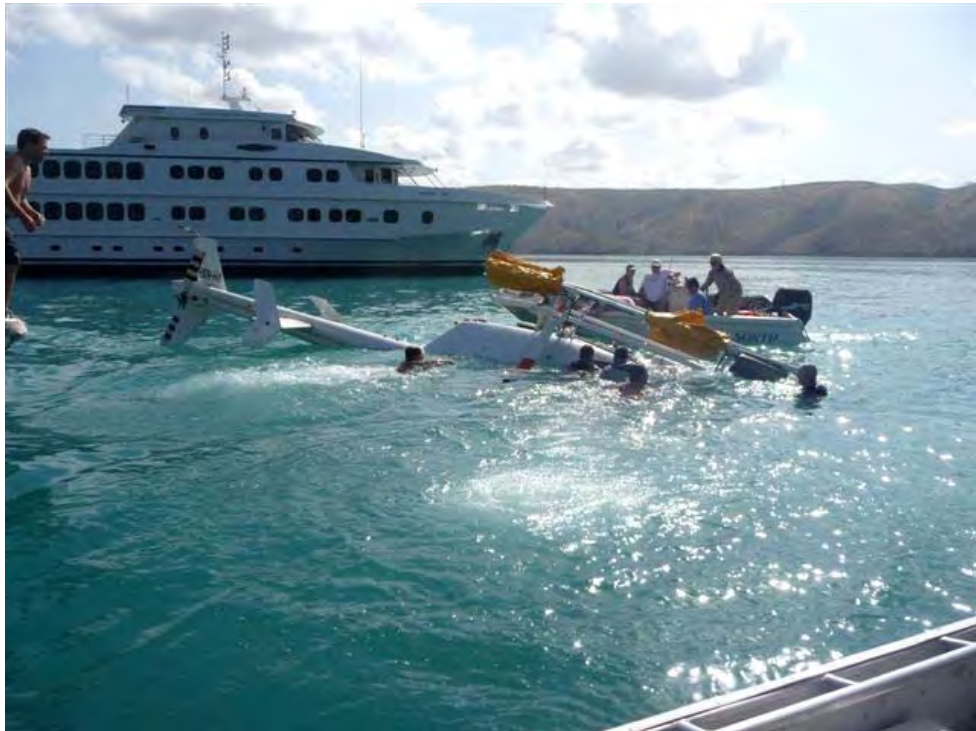
A number of the ship's personnel entered the water and assisted the occupants of the helicopter to exit the aircraft (Figure 2). Of the occupants, two had been unable to free themselves from the cabin area, with one losing consciousness before being rescued.

Figure 2: Rescue of the occupants of the helicopter

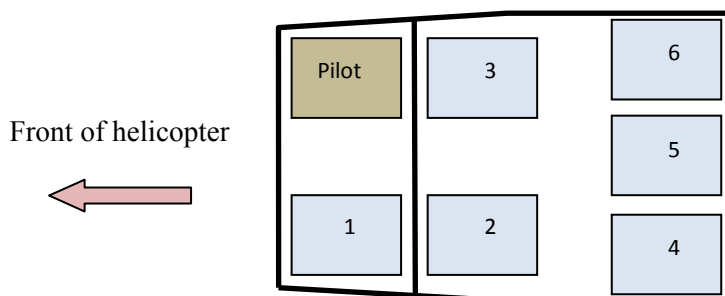
The pilot reported that he was unable to open the right cockpit door¹⁵ due to the opposing water pressure. In response, he exited the helicopter through the left cockpit door, which had been opened by the passenger in the left-front seat (seat 1 in Figure 7) in order to exit the helicopter.

Figure 7: Plan view of the helicopter's seating layout

The second last passenger to be rescued from the helicopter reported that she had 'given up' after becoming disoriented and commenced ingesting water. The remaining passenger, who was still strapped into the left rear seat when rescued (seat 4 in Figure 7), had stopped breathing. Quick action by one of the tender boats' crew assisted the passenger to resume breathing.
