**ATSB TRANSPORT SAFETY REPORT**  
Occurrence Investigation Report AO-2008-068  
Final

**Tail rotor pitch link failure  
near Hoxton Park Aerodrome, NSW  
19 September 2008  
VH-BUK  
Eurocopter AS350 BA**

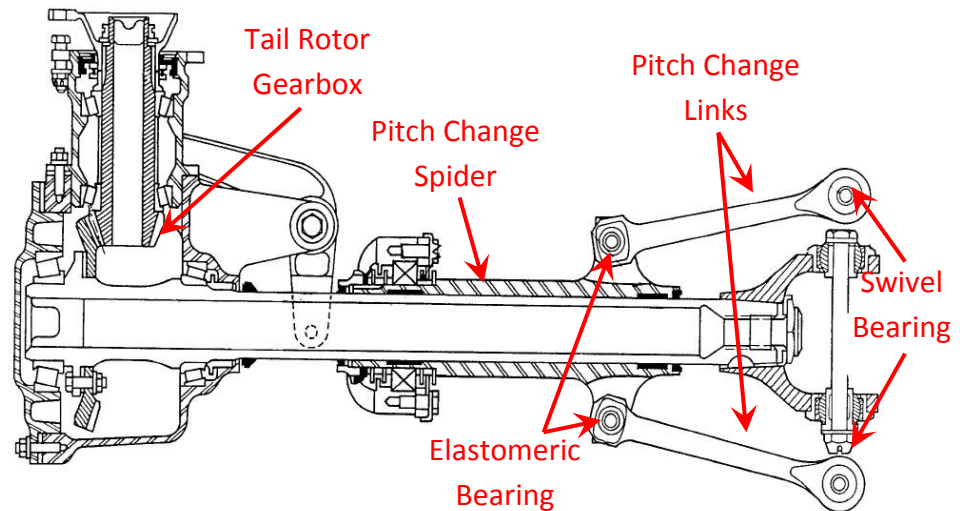
**Figure 1: Tail rotor drive assembly**

The pitch links were aluminium in construction and consisted of a swaged-in, self-lubricating spherical bearing at one end and an elastomer-damped, sleeve-type bearing at the opposite end (Figure 1). The pitch links were not service life limited components and they were not recorded on the original aircraft build documentation. Manufacturing records for the links could not be located. However, the manufacturer indicated that the links were probably made prior to 1993.

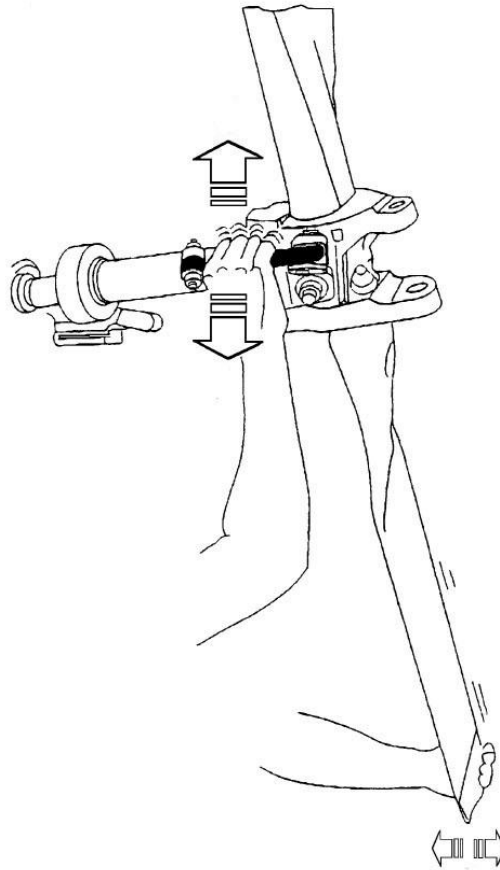
**Figure 2: Tactile check for bearing play**

The ALF checks, per section 05.21.00.603 of the maintenance manual, consisted of a visual inspection similar to the 500-hour service check, as well as a tactile check to confirm there was no play in the spherical bearing. The tactile check was best illustrated by Figure 2 and involved imparting an oscillating axial load on the bearing, while applying a low-amplitude, see-saw motion to the blades.

The ALF inspection was to be carried out by qualified maintenance personnel or by a suitably trained pilot. Records showed the most recent 30-hour inspection was completed by the pilot at 3,606.4 aircraft hours on 15 September 2008, approximately 13 hours prior to the failure of the pitch link. Around this time, the tail rotor was closely inspected by the pilot of VH-BUK as well as the pilot of a second AS350 that was present at the same location. The tactile check of the links was directly compared between the two aircraft. A small amount of play was identified in the links belonging to the second aircraft; however, no play in the links on VH-BUK was detected.
