**ATSB TRANSPORT SAFETY REPORT**  
Aviation Occurrence Investigation AO-2008-076  
Final

**Collision with terrain**  
**VH-OPC**  
**Piper Aircraft Corp PA-31-350**  
**3 km N Bathurst Airport, NSW**  
**7 November 2008**

**Collision with terrain**  
**3 km N Bathurst Airport, NSW**  
**7 November 2008**  
**VH-OPC**  
**Piper Aircraft Corp. PA-31-350 Chieftain**

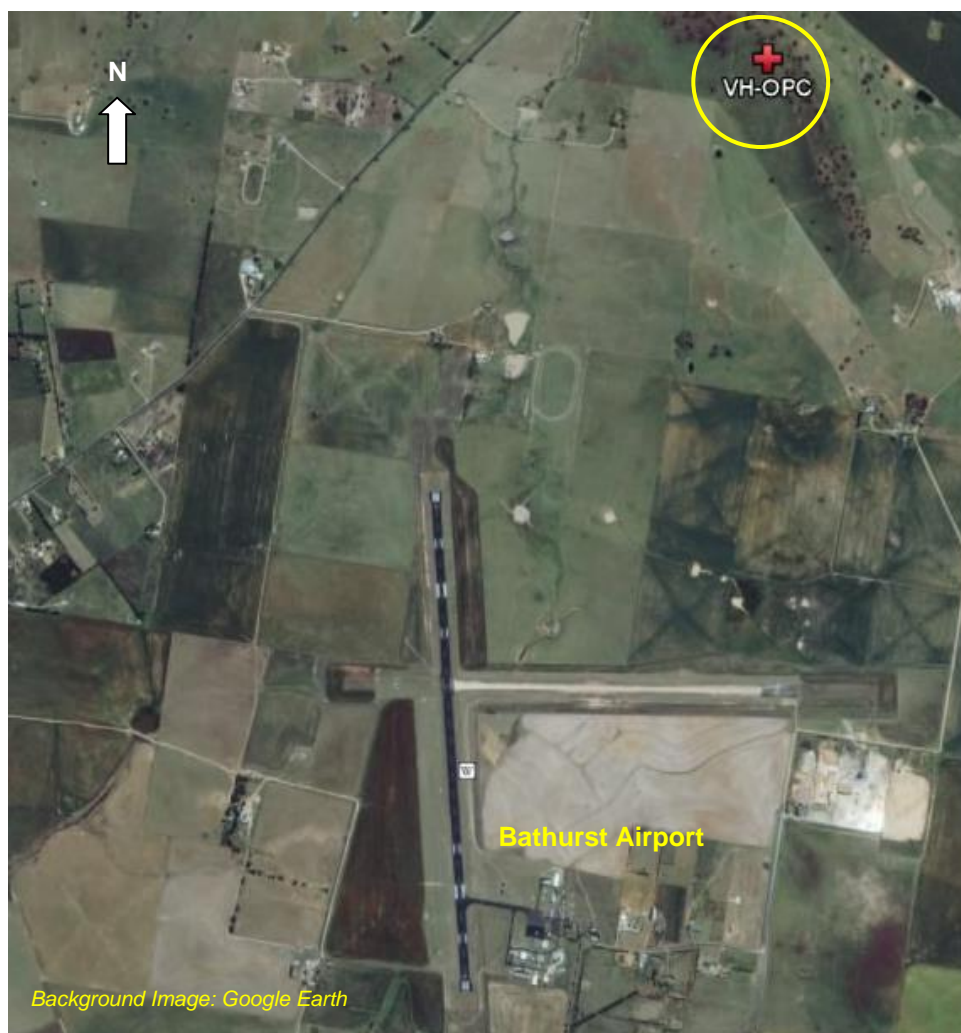
**Figure 2: Accident site location (circled)**

At about 2024, a number of residents of Forest Grove, a settlement to the north of Bathurst Airport, heard a sudden loud noise from an aircraft at a relatively low height overhead, followed shortly after by the sound of an explosion and the glow of a fire. A witness located about 550 m to the south-west of the accident site, (Figure 2) reported seeing two bright lights that were shining in a constant direction and ‘wobbling’. There was engine noise that was described by one witness<sup>2</sup> as getting very loud and ‘rattling’ or ‘grinding’ abnormally before the aircraft crashed. At 2024:51, the first 000 telephone call was received from witnesses and shortly after, emergency services were notified.

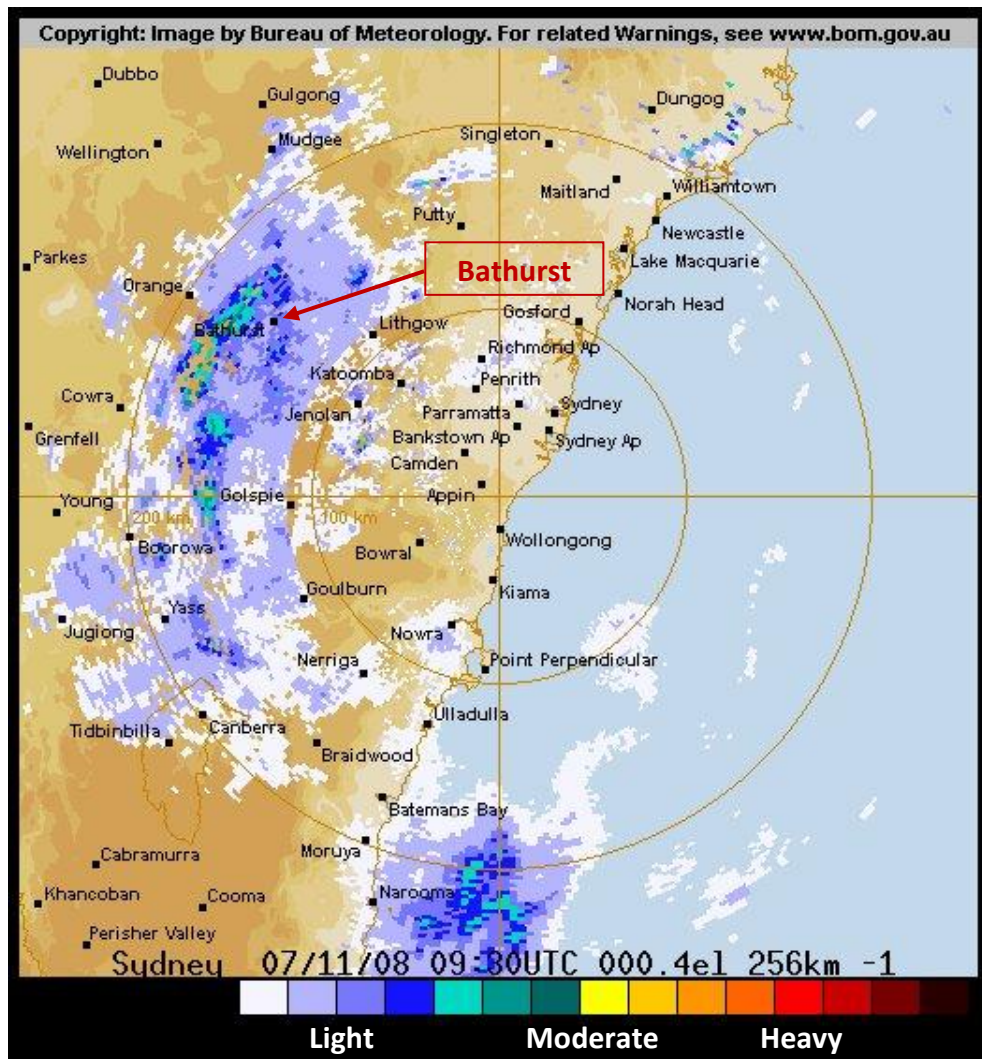
**Figure 5: Weather radar image representing the conditions at 2030<sup>8</sup>**

show that, prior to and at about the time of the accident, a band of precipitation was passing through the Bathurst region (Figure 5).

The Bathurst aerodrome forecast that was valid for the time of the accident indicated deteriorating conditions from 1900 with rain and broken<sup>9</sup> cloud at 7,000 ft above aerodrome elevation, and moderate turbulence below 5,000 ft. Intermittent periods of visibility reduced to 4,000 m and broken cloud at 1,000 ft were also expected after 1900.

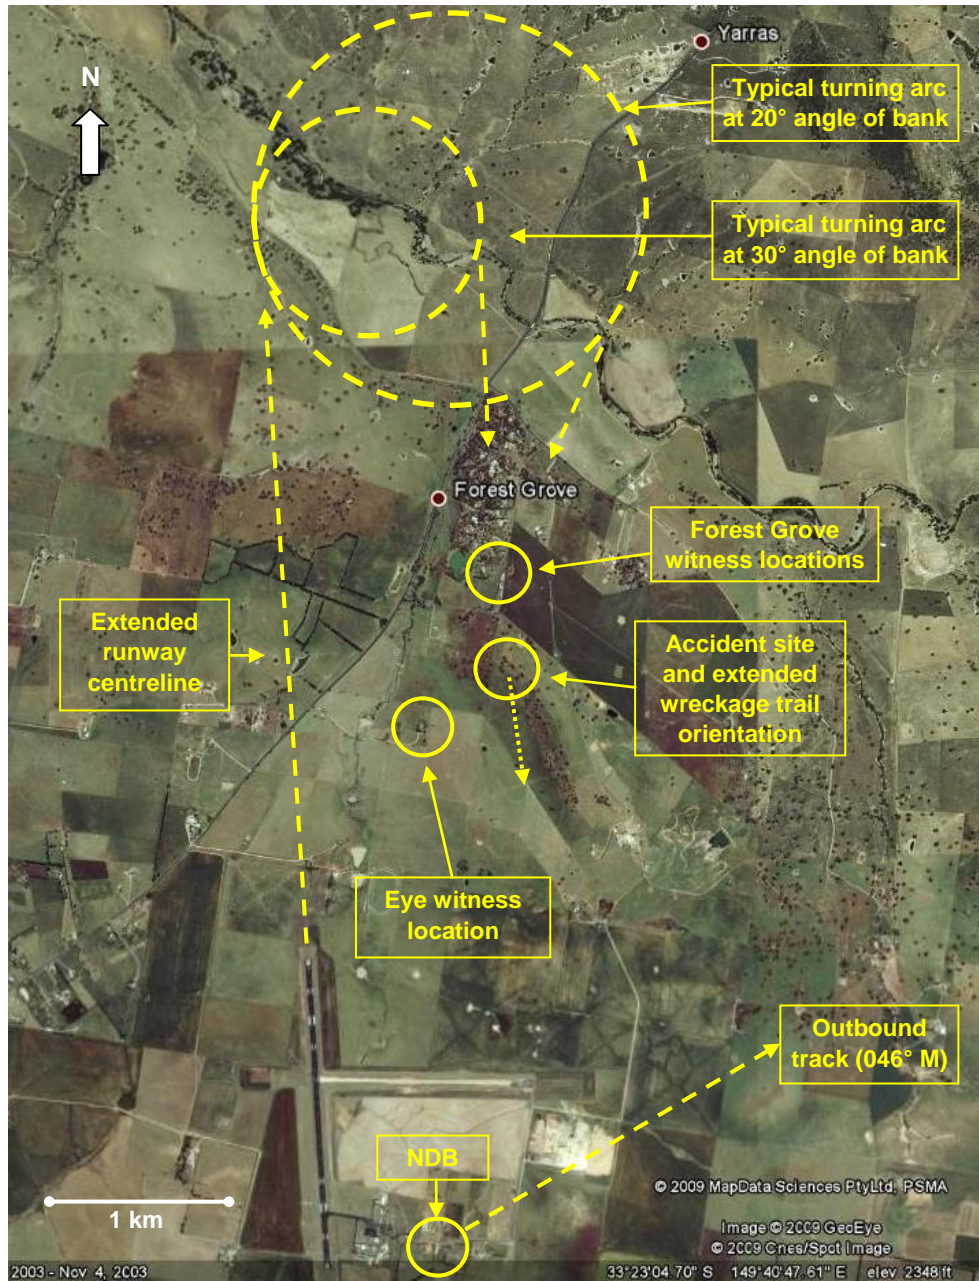
Figure 13: Representation of derived track parameter information

The investigation did not have any direct evidence of the aircraft's actual flight path immediately preceding the accident. However, the investigation was able to derive some possible aircraft flight path parameters from the timing and content of the pilot's radio transmissions, the wreckage trail orientation and the investigation's understanding of the pilot's standard departure procedures (Figure 13). For simplicity, wind was not factored into the calculations and aircraft speed was taken to be 120 kts.

The only information regarding the descent profile was the minimum descent angle of  $20^\circ$  over the trees. If a descent angle of  $20^\circ$  was applied to the likely track of the aircraft, the aircraft would have been about 600 ft above the witnesses at the southern end of Forest Grove, 450 m from the accident site. The suddenness of the noise heard by those witnesses supports a steep descent profile.
