ATSB TRANSPORT SAFETY REPORT
Aviation Occurrence Investigation
AO-2008-081
Final

Midair collision
Cessna 152, VH-FMG and
Liberty Aerospace Inc. XL-2, VH-XLY
Casula, NSW,
18 December 2008

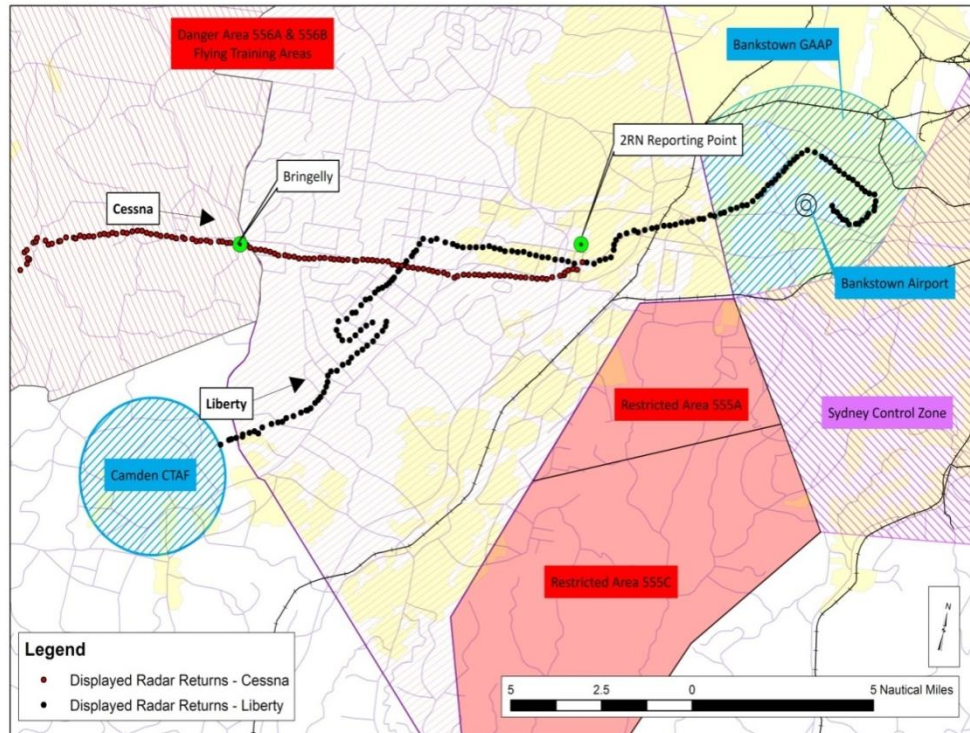
Figure 1: Displayed radar tracks of the Cessna and Liberty

The recorded radar data showed that, as the Cessna was returning to Bankstown from the training area, the Liberty departed Camden and maintained the runway heading of 060° into the training area, before tracking towards the 2RN radio transmission tower, which was the southern inbound reporting point to Bankstown. The radar data indicated that, about midway between the Camden CTAF area and 2RN, the Liberty conducted a left turn through 180°, followed by a turn to the right through 180°. The Liberty then flew in a northerly direction and flew above and behind the Cessna, which was about 600 ft below and tracking towards the 2RN reporting point. The Liberty continued to track north for a short time, then turned to the right, descended and tracked towards 2RN (Figure 1).

Following the merging of the radar returns in the vicinity of 2RN, one radar return faded and the other return continued to the vicinity of Bankstown Aerodrome. The fading radar return corresponded to the Cessna’s initial track towards Bankstown.

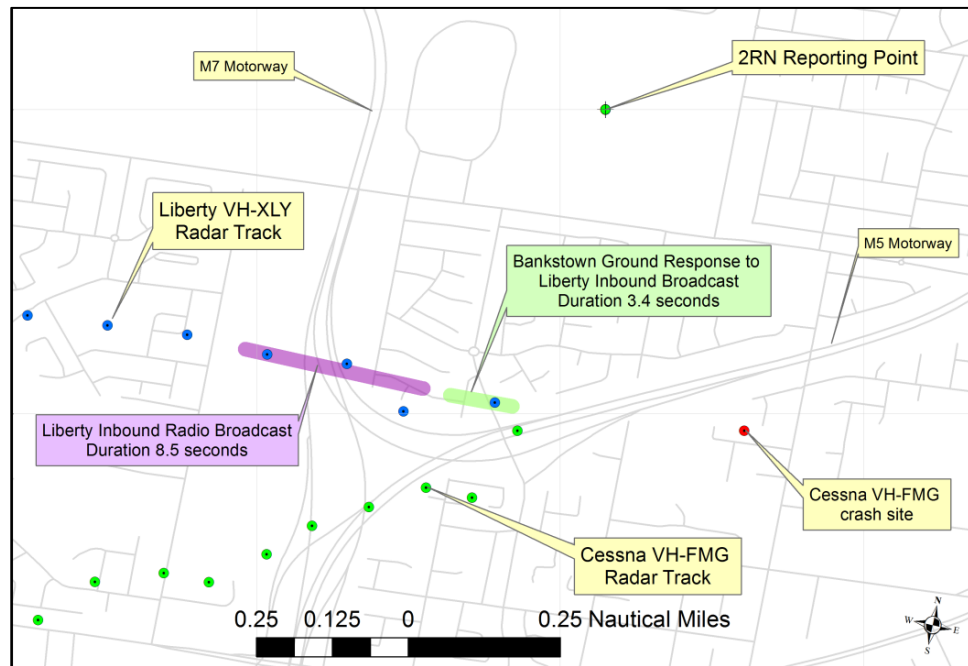
Figure 2: Location of the Liberty during the student pilot under test and SMC radio transmissions

that the broadcast was on the Bankstown ground¹⁴ frequency and to contact the tower¹⁵ on frequency 132.80 MHz. That radio broadcast from the SMC lasted 3.4 seconds. The location of the radio broadcasts by the student pilot under test and SMC in relation to the collision is displayed in Figure 2. The location of the Liberty during those transmissions was to the south-west of 2RN and not in accordance with the instructions contained in documentation published for operations at Bankstown.¹⁶

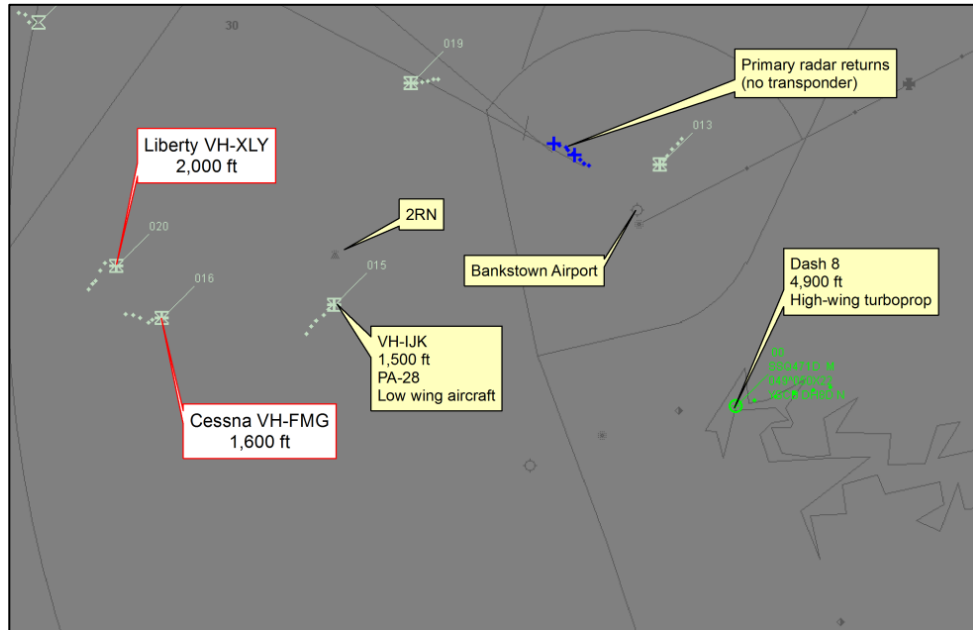
Figure 3: Air situation display at the reported time of the Liberty sighting the Cessna

A depiction of the air situation display (ASD)²³ at the time that the Liberty pilots reported first sighting a Cessna in the training area is at Figure 3.

The ASD also displayed other aircraft at that time, including primary and secondary radar returns. The radar return immediately ahead of the Liberty was identified as Cessna VH-FMG (FMG) and another radar return to the east was identified as a Piper PA-28 low-wing aircraft, registered VH-IJK. The only other radar return in the area ahead of the Liberty's flight path was an instrument flight rules Bombardier DHC-8 (DHC8) high-wing turboprop aircraft, which was 2,900 ft above the Liberty and about 13 NM (24 km) distant. The DHC8 was likely to have been obscured by cloud at the time given the reported meteorological conditions.

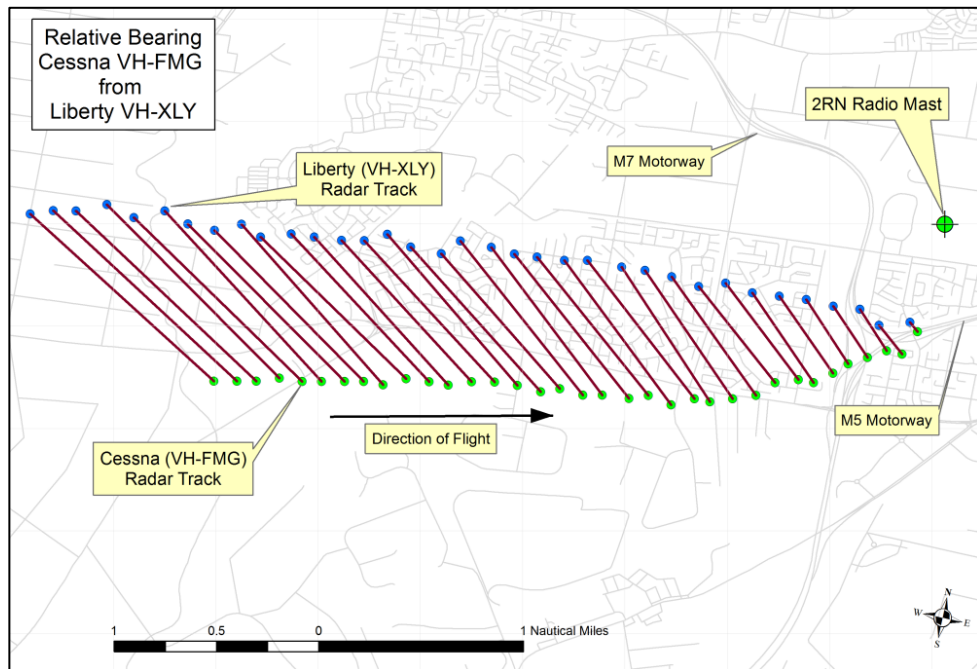
Figure 15: Relative bearing of the Cessna from the Liberty in the 2 minutes prior to the collision

The radar data for the period from when the pilots in the Liberty reported sighting the Cessna until the collision is displayed in Figure 15. The corresponding radar returns for each time group are paired with a line and show that when the Liberty assumed a track towards 2RN, the Cessna maintained an almost constant relative bearing to the right of the nose of the Liberty. There would have been some movement of the Cessna in the Liberty's windscreen as the Liberty descended to the same altitude as the Cessna; however, once at the same altitude, there would have been little apparent movement of the Cessna in the windscreen of the Liberty.

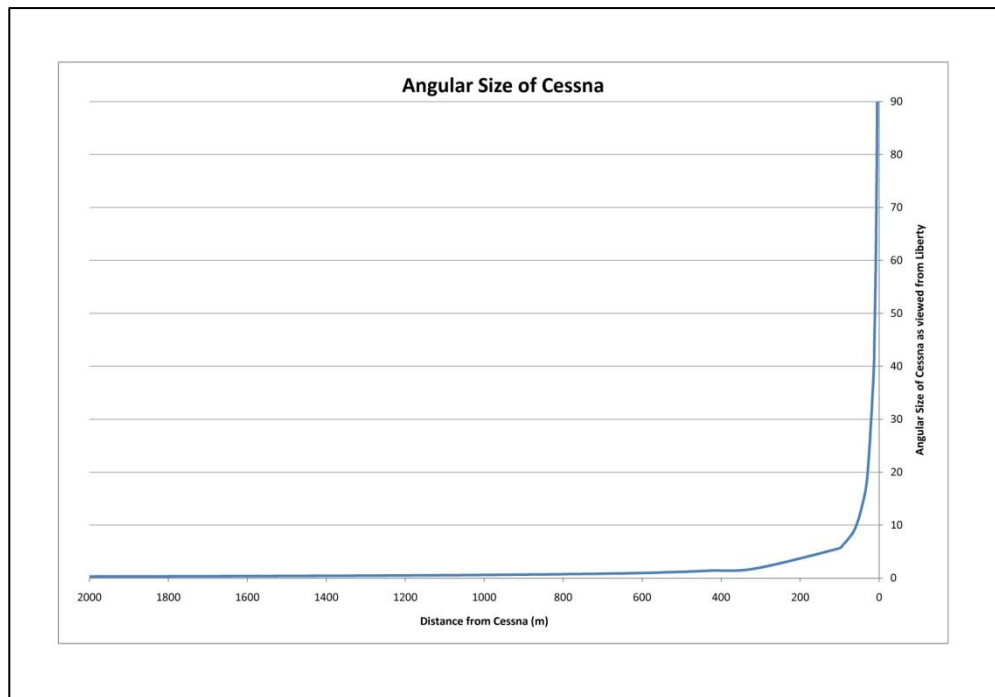
Figure 16: Angular size chart for the approximate Cessna wingspan of 10 m

The Cessna's wingspan was about 10 m. When an object of that size is viewed at the estimated 2,000 m distance that it was first reported as seen by the pilots of Liberty, it has an angular size of 0.28° . The angular sizes of a 10 m object at varying distances from a specified viewpoint were calculated and are presented at Figure 16.

As indicated on the chart by reading left to right on the horizontal distance scale, the angular size of the Cessna's 10 m wingspan remains relatively small as the distance to the viewer decreases until the distance between the aircraft is about 200 m or less. At that point, the increase in the size of the Cessna is essentially exponential, rapidly increasing in visual size.

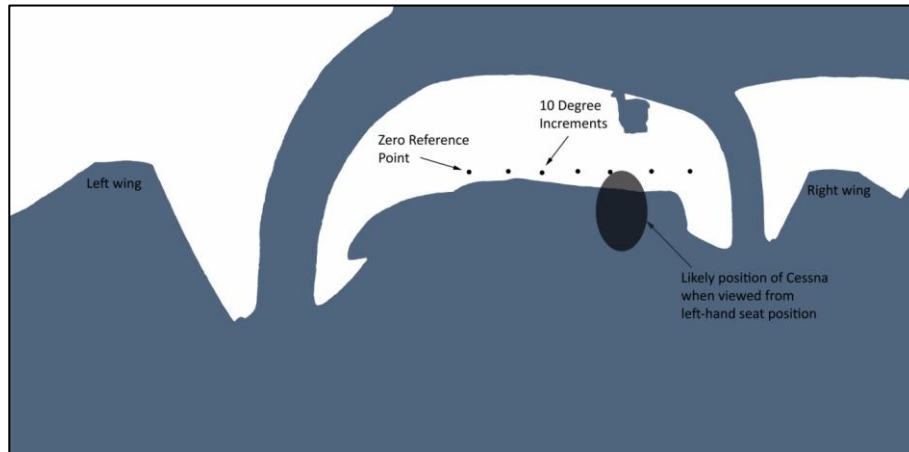
Figure 17: Liberty left pilot's seat monocular cockpit vision diagram³¹

The left seat cockpit vision diagram for the Liberty that was developed by the investigation is at Figure 17. The zero reference point³⁰ is located directly ahead of the pilot on the horizon. The light grey shaded areas indicate those areas of obstruction to monocular vision. The likely position of the Cessna when viewed from the left seat is indicated. As the Liberty was above the altitude of the Cessna for some period prior to the collision, the area extends below the horizontal reference level.

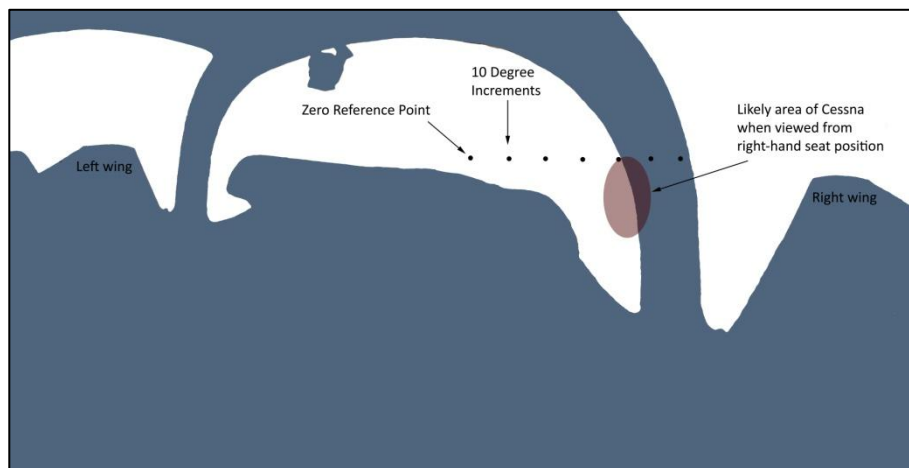
Figure 18: Liberty right pilot's seat monocular cockpit vision diagram

The right seat cockpit vision diagram for the Liberty that was developed by the investigation is at Figure 18. As previously, the light grey areas represent areas of obstructed monocular vision.

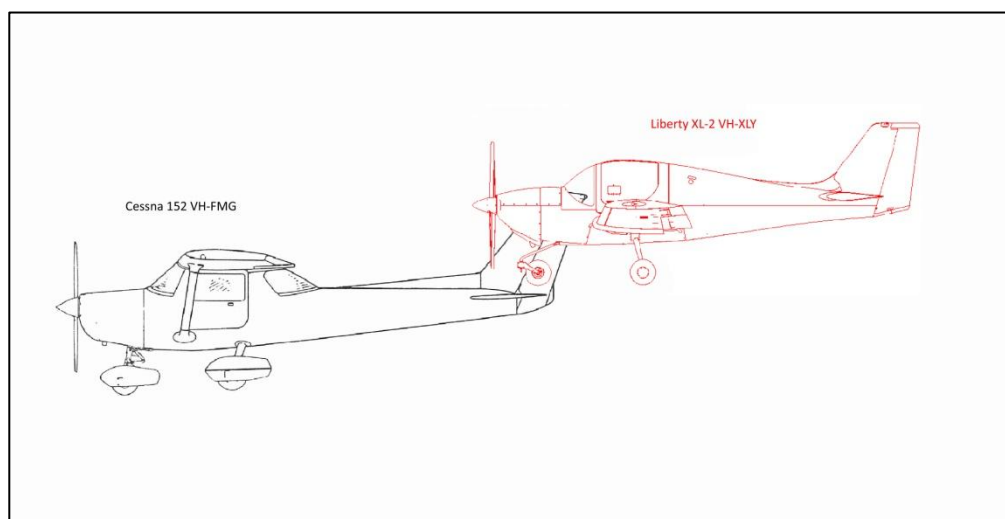
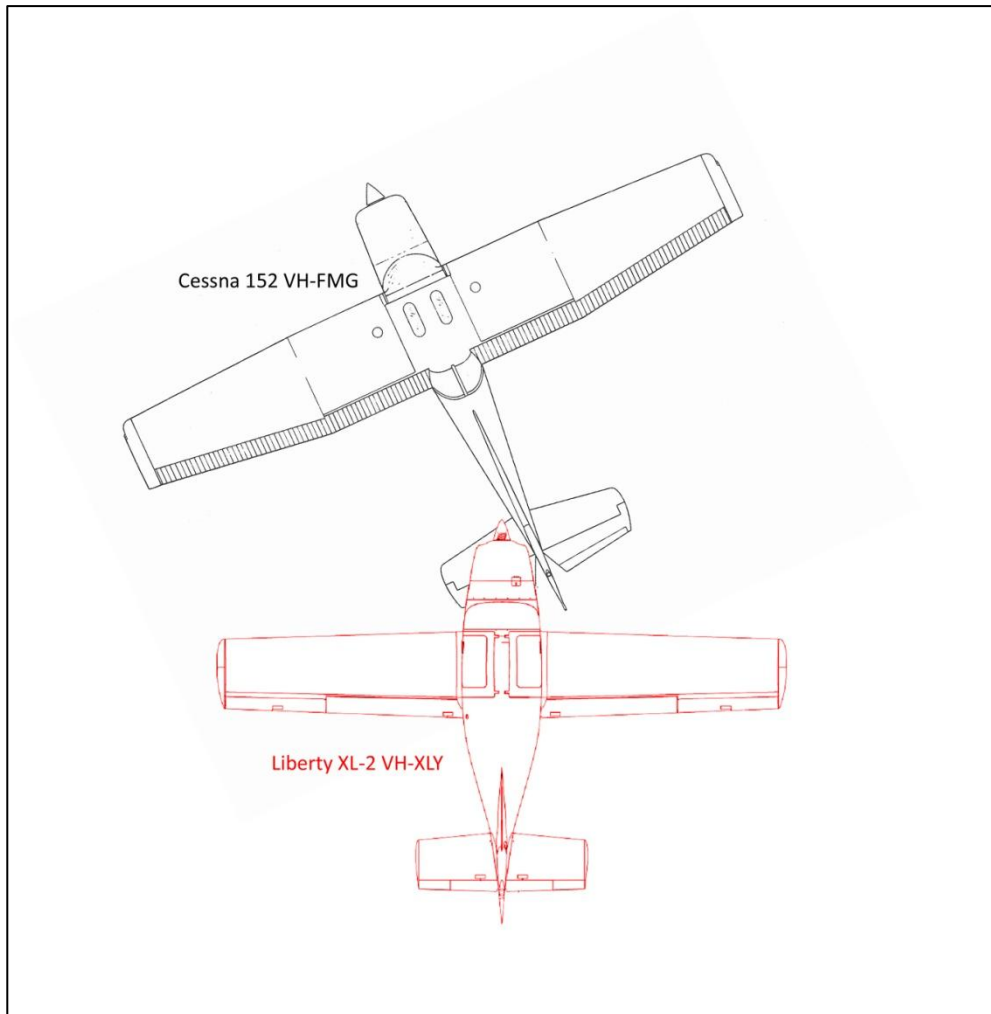
Figures 20 and 21 show the orientation of both aircraft at the point of impact from the side and plan views respectively.

The impact from the Liberty deflected the Cessna's vertical fin to the right and resulted in a twisting failure of the empennage of the Cessna towards the right, before its separation about midway between the cabin and tail. Once that structure failed and separated from the remainder of the aircraft, the flight control cables were the only connection between the tail and the remainder of the aircraft. The witness reports of the uncontrolled rotation of the separated tail section were explained by the vertical airflow over that aerofoil during the vertical descent.

The separation of the Cessna's tail to the right resulted in the tail commencing to rotate in that direction and possibly completing one revolution before the Cessna's tail-mounted white navigation light came into contact with the left underwing surface of the Liberty. That impact liberated the navigation light, which was the first item found along the wreckage trail. It is also possible that the student under test in the Liberty, as the handling pilot at the time of the collision, could have rolled the aircraft to the left as an instinctive reaction to the rapid bloom of the Cessna in the Liberty's right windscreen, placing the Liberty's left wing lower and closer to the Cessna's tail.

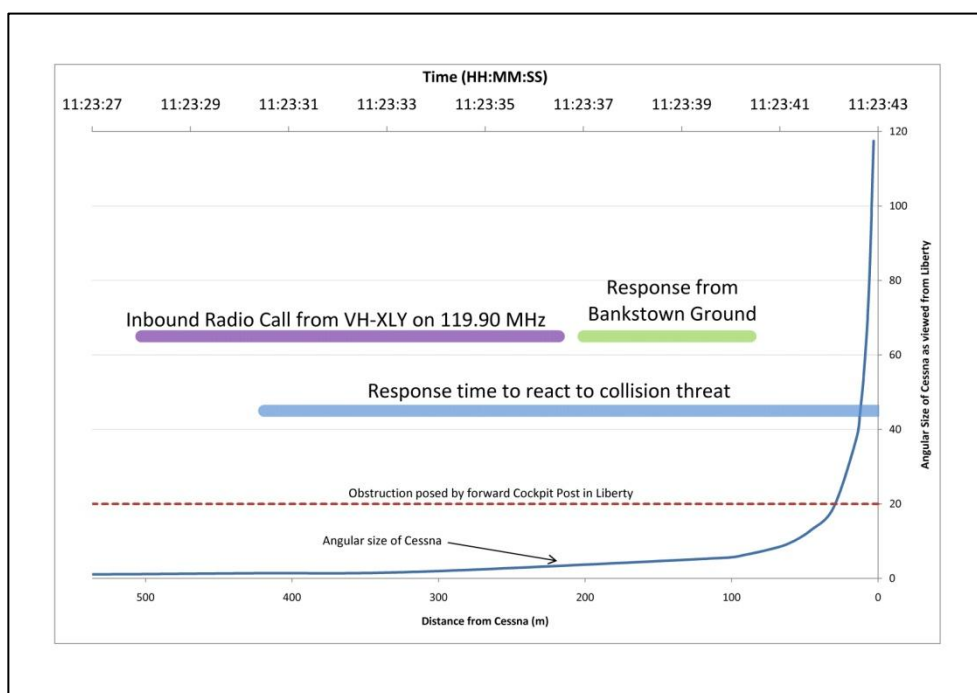
Figure 22: Radio broadcast, visual size of Cessna, obstruction to vision and time to react to the collision threat

The times and durations of the inbound radio broadcast made by the student pilot on the incorrect frequency in relation to the angular size of the Cessna are represented in Figure 22. Also indicated are the limitations imposed by cockpit vision obstructions from the right seat in the Liberty. The 12.5 second time to act and avoid a collision is also presented for reference.

The combination of the student pilot's inbound radio broadcast and response from the SMC would have impacted on his attention to other tasks during the more than 12 seconds taken by those calls. The little more than 2 seconds between the end of the SMC's transmission and the estimated time of the collision minimised any hope that the student might have avoided the collision. The student under test was most likely processing the unexpected response from the SMC and, having realised his error, was possibly in the process of switching the radio to the aerodrome control (ADC) frequency at that time. That would explain why the ATO did not have to change radios to broadcast the MAYDAY call, and the record of that call on the ADC frequency.
