**ATSB TRANSPORT SAFETY REPORT**  
Aviation Occurrence Investigation – AO-2009-017  
Final

**Wirestrike**  
**Langkoop, Victoria**  
**20 April 2009**  
**VH-EZT**  
**Robinson Helicopter**  
**R44 Raven II**

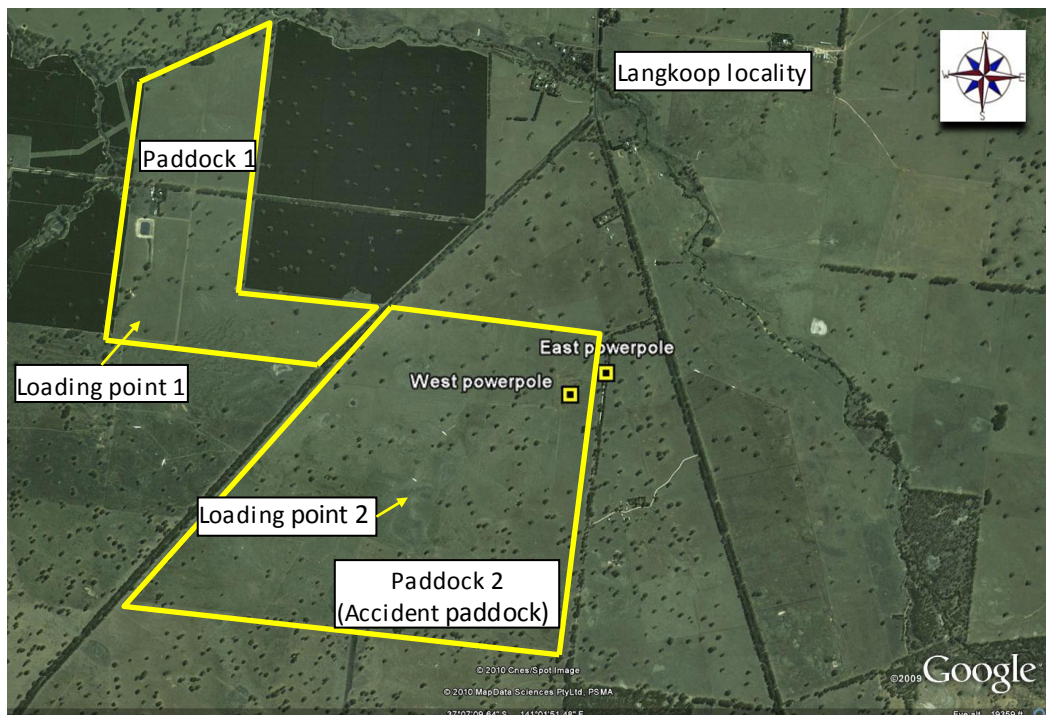
**Figure 1: Overview of spray paddocks 1 and 2**

Before commencing spraying, the forestry site manager, who was supervising spraying operations, briefed the helicopter operator's chief pilot about the spraying requirements, the layout of the two paddocks that were to be sprayed and the associated hazards (Figure 1). With the aid of a site topographic map, the chief pilot relayed that information to both pilots and discussed how the paddocks would be sprayed.

Both helicopters were loaded with chemical at loading point 1 (Figure 1) and spraying was commenced in paddock 1 at about 0800. Spraying continued for 1 hour and 30 minutes, when the helicopters repositioned to meet a load vehicle in paddock 2. At 0936 the helicopters were shut down for 30 minutes awaiting a

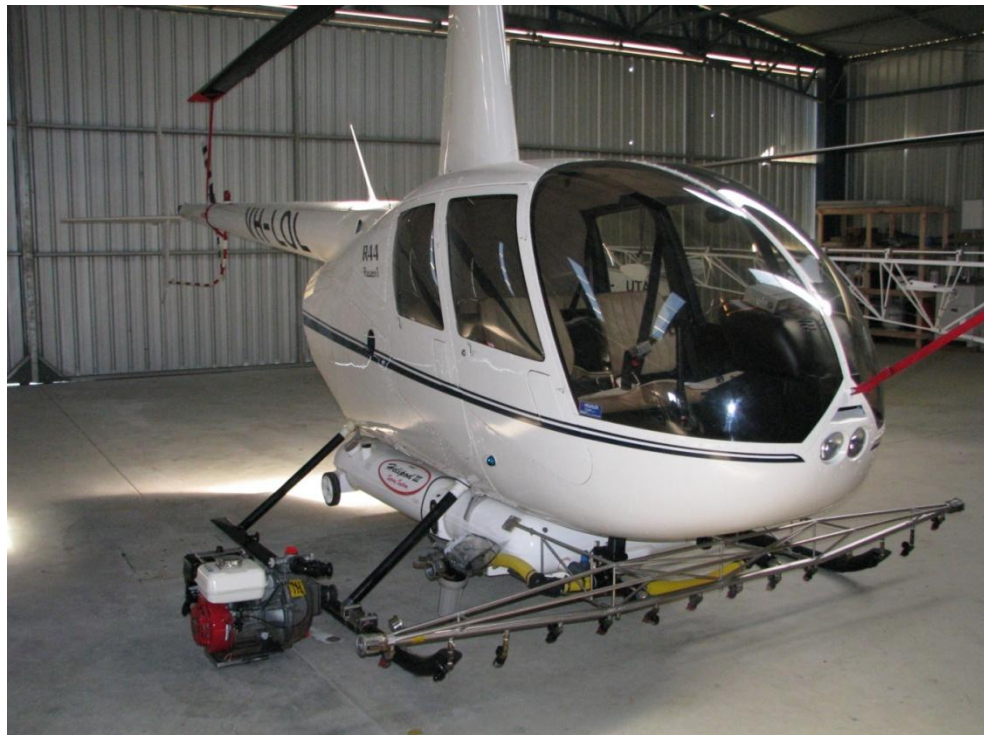
**Figure 3: Operator's Helipod III spray system configuration**

The Robinson R44 was a single-engine helicopter with a semi-rigid, two-bladed main rotor and seating for four people, including the pilot. The helicopter had skid-type landing gear and was fitted with a Helipod III spray system (Figure 3).
