ATSB TRANSPORT SAFETY REPORT
Aviation Occurrence Investigation AO-2009-021
Final

**Flight control system event
520km NW of Gold Coast Aerodrome
Queensland
18 May 2009
VH-VNC
Airbus Industrie A320-232**

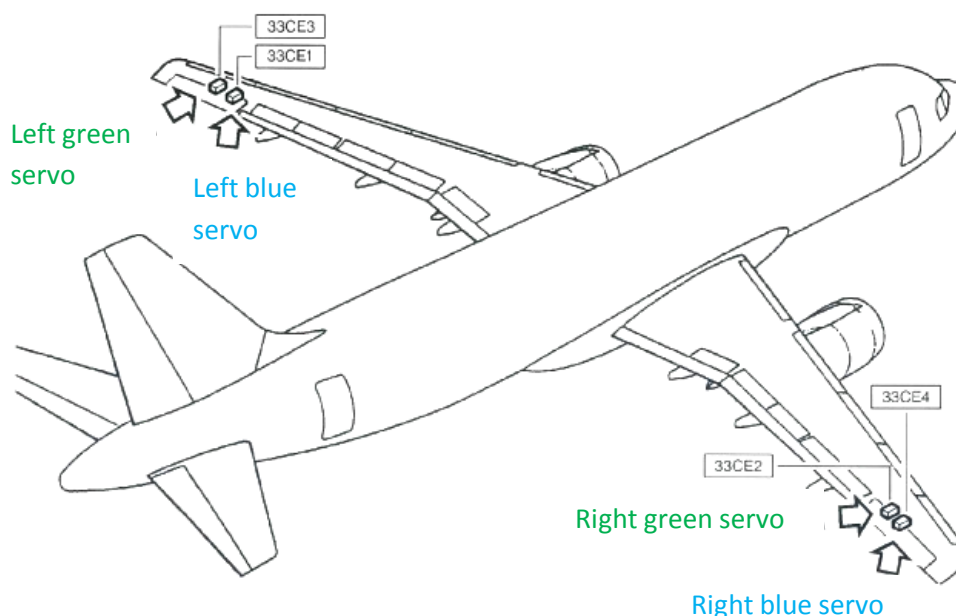
Figure 1: Aileron servo locations

The ailerons are controlled electrically by inputs from the PIC's and copilot's side stick controllers, or by the autopilot systems through either ELAC 1 or 2. The ELAC 1 or 2 electronic output signals control the hydraulically-actuated aileron servos, which deflect the ailerons up or down as required to control the aircraft about its roll axis.⁶ Each aileron has two servos (Figure 1), and only one servo on each side operates at any one time (active mode). The other two servos remain on standby (damping mode). For added redundancy the aileron servos are operated by two independent hydraulic systems, identified as blue and green.
