# In-flight engine failure – Christmas Island

## 19 October 2009

On 19 October 2009, a British Aerospace Avro-RJ70 aircraft sustained an in-flight engine failure shortly after taking off from Christmas Island.

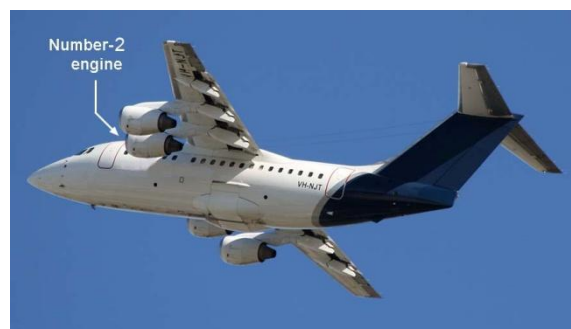
**Figure 1: Photograph<sup>4</sup> of VH-NJT showing the engine configuration**

The Avro-RJ70 aircraft, serial number E1228, was manufactured in 1993 by British Aerospace (BAe) of the United Kingdom (UK) (Figure 1). The RJ70 was originally developed from the BAe 146-100 aircraft platform. Both types shared a virtually identical configuration; however, the RJ70 was fitted with higher power engines and digital avionics.

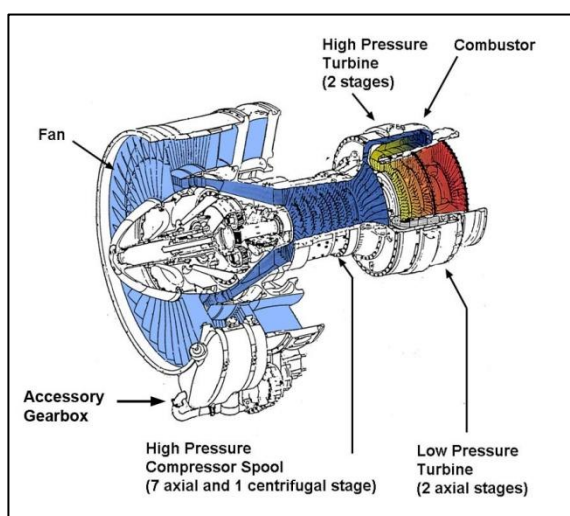
**Figure 2: Cutaway of the Honeywell LF507 engine**

The failed number-2 engine was a Honeywell model LF507-1F high bypass-ratio turbofan (SN 7266). The LF507 engine design was modelled on the ALF502 engines fitted to BAe 146 aircraft. However, the LF507 was uniquely equipped with a FADEC<sup>5</sup> fuel management system. The engine comprised four modules (Figure 2):

- front fan module driven by a two-stage low-pressure turbine (LPT)
- gas producer module containing a seven-stage high-pressure compressor (HPC) a single-stage centrifugal compressor, and a two-stage high-pressure turbine (HPT)
- combustor turbine module comprising an annular reverse-flow combustion chamber and a two-stage LPT
- accessory gearbox module.

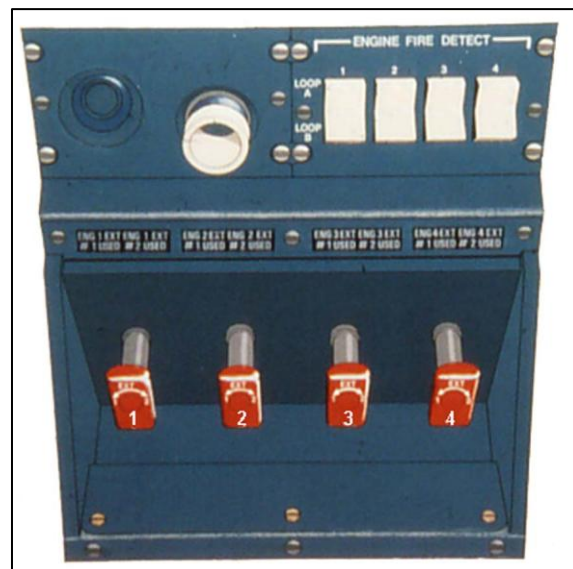
**Figure 11:** Illustration<sup>11</sup> of the overhead fire panel within the flight deck

The fire handle was located on the flight deck overhead panel. Its manipulation followed three distinct phases, as follows (see also Figures 11 and 12):

Instruction, familiarisation and experience using the engine fire protection system is provided to flight crews through flight simulator training, during which they are exposed to normal, abnormal and emergency situations and procedures. To maintain currency, company pilots complete recurrent training in the simulator every 6 months. That training included manipulation of the fire handle in response to simulated engine fire conditions. While the fire handle in the simulator is not connected to a cable or mechanical linkage, the handle was designed to be manipulated in the same manner as an actual RJ70 aircraft. The fire handle in the training simulator may become worn through constant use, and consequently over time require less force during operation in order to extend and rotate the fire handle beyond the initial detent.

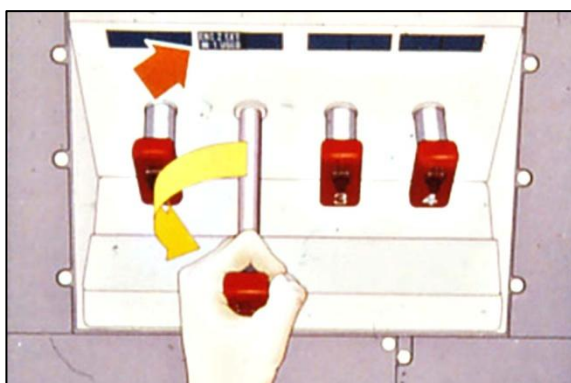
Figure 12: Illustration<sup>12</sup> showing actuation of a fire handle

Note: rotating the handle left or right will discharge either the number-1 or -2 fire extinguisher.
