ATSB TRANSPORT SAFETY REPORT
Aviation Occurrence Investigation AO-2009-075
Final

Midair collision
20 km south-east of Orange
New South Wales, 8 December 2009
VH-NFO, Aerospatiale AS.350B
VH-LXC, Kawasaki BK117

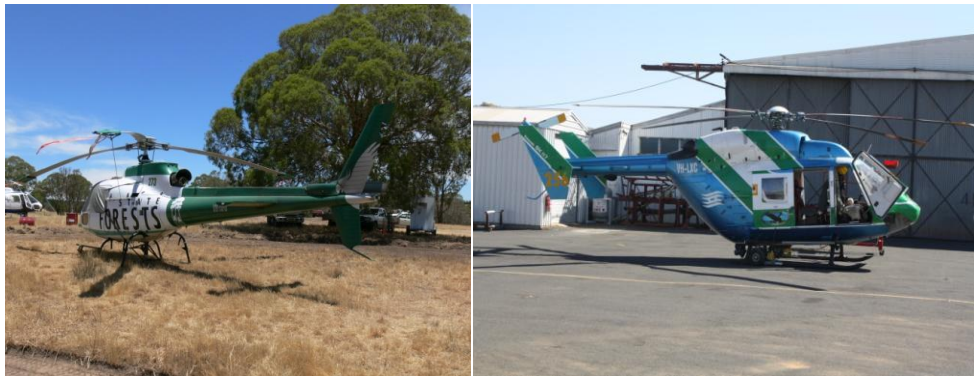
Figure 1: NFO (left) and LXC (right)

On 8 December 2009 at about 1840 Eastern Daylight-saving Time¹, an Aerospatiale AS.350B helicopter, registered VH-NFO (NFO), and a Kawasaki BK117 helicopter, registered VH LXC (LXC), were engaged in aerial firebombing operations about 20 km south-east of Orange Aerodrome, New South Wales (NSW) (Figure 1). One pilot was on board each helicopter. After the pilot of NFO had landed to refuel, he noticed damage to the trailing edge of the helicopter's vertical fin. In addition, the plastic anti-collision light cover on top of the vertical fin was broken. The pilot reported the damage to the pilot of LXC. Examination of LXC did not reveal any apparent damage. There were no injuries.

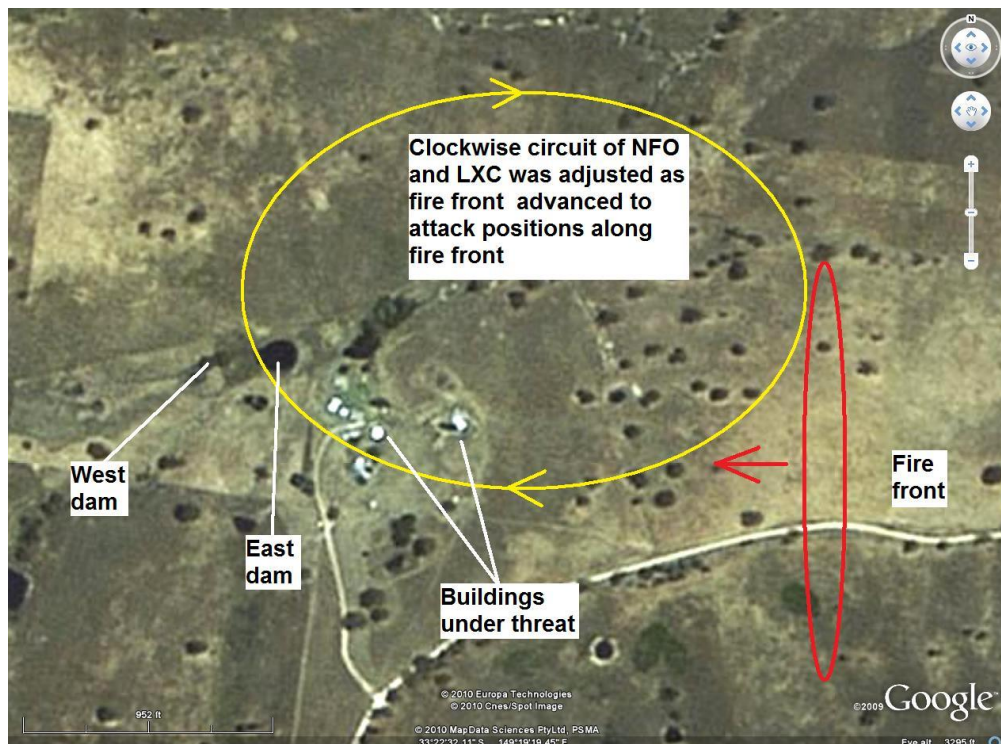
The pilots stated that the fire front was aligned approximately north-to-south and was moving west. The wind was generally from the south. The fire was advancing rapidly and had progressed to within 150 to 200 m of a house and other buildings (Figure 2). There were two small dams 80 m apart about 100 m north-west of the buildings. Both pilots were initially refilling the buckets from the larger, eastern-most dam, but subsequently took water from both dams. They were conducting firebombing runs from north-to-south.

Figure 2: Aerial view of the area showing the east and west dams and the buildings that were under threat relative to the fire and its direction of advance. As an indication of scale, the distance from fire front as marked to the east dam was approximately 600 m
