ATSB TRANSPORT SAFETY REPORT
Aviation Occurrence Investigation AO-2010-066
Preliminary

Uncontained engine failure and air turn-back Near San Francisco Airport, USA

30 August 2010

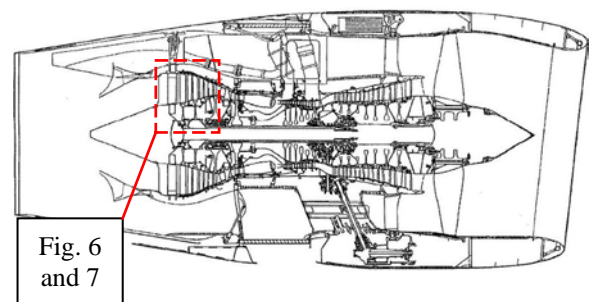
Figure 4: RB211-524 engine

Figure 4 shows the general layout of the RB211-524 engine and Figure 5 presents the subject engine with the fairings removed. During the early stages of the examination, it was evident that the internal turbo-machinery had been significantly disrupted, with extensive damage sustained by the intermediate pressure (IP) and low pressure (LP) turbine rotors (Figure 6 and 7).
