Loss of control Robinson Helicopter R44 Astro VH-HFH

Cessnock Airport, New South Wales | 4 February 2011

ATSB Transport Safety Report
Aviation Occurrence Investigation
AO-2011-016
Final – 30 April 2012

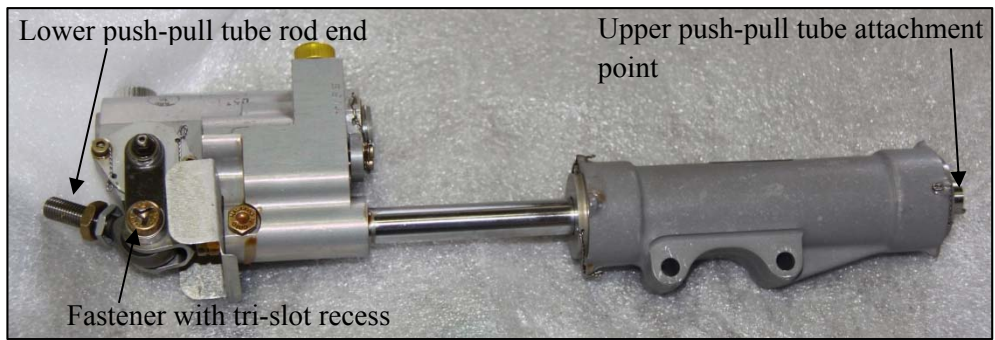
Figure 3: Hydraulic-boost servo

The approved method of replacing the hydraulic-boost servo was detailed in the manufacturer's R44 maintenance manual. The procedure involved the disassembly of a number of major components, including the fuel tanks, to gain access to the servos. In addition, the upper and lower flight control push-pull tubes needed to be disconnected from their servo attachment points (Figure 3).

The manual required the removal of the lower push-pull tube from the servo by unthreading it from its rod end (Figures 3 and 8) and stipulated that disconnection of the tube by disassembling the rod end securing fastener (Figure 8), was prohibited. The manufacturer advised that correct assembly of that fastener was critical to the proper operation of the servo and that the helicopter would be rendered uncontrollable if there was a disconnection of any of the upper or lower push-pull tubes.

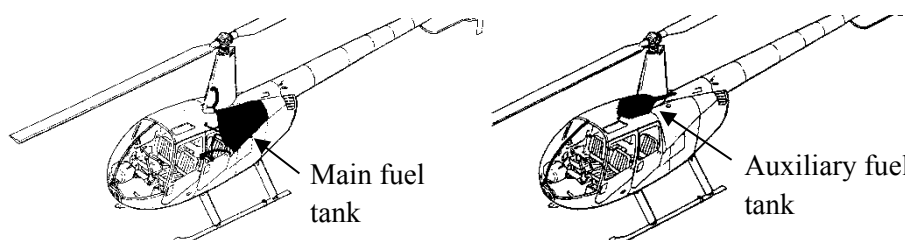
Figure 6: Fuel tanks

Finally, the ATSB identified that fatal injuries sustained by the instructor and passenger were due to the post-impact fire and that a large number of R44s had not been modified to include upgraded bladder-type fuel tanks that reduce the risk of post-impact fuel leak and subsequent fires.

The R44 was originally manufactured with two all-aluminium fuel tanks that were installed above the engine firewall, either side of the main transmission (Figure 6).

On 20 December 2010, the manufacturer issued R44 Service Bulletin 78 (SB-78) requiring that R44 helicopters with all-aluminium fuel tanks be retrofitted with bladder-type tanks as soon as practical, but no later than 31 December 2014. The background information to the service bulletin stated:

To improve the R44 fuel system's resistance to a post-accident fuel leak, this retrofit must be performed as soon as possible.

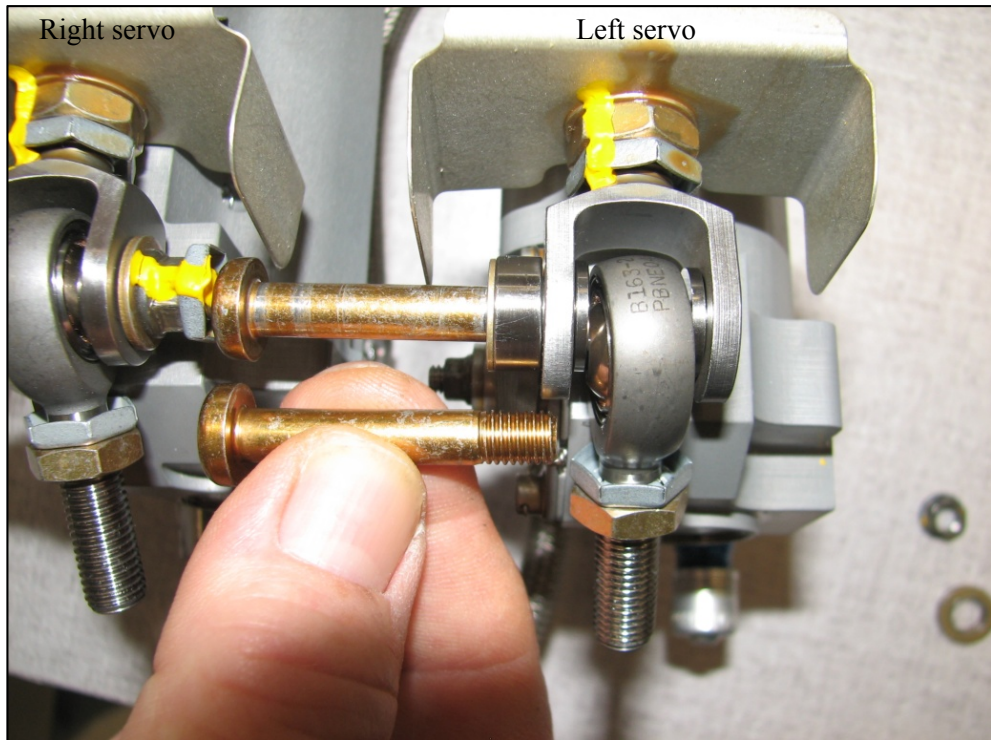
Figure 16: Front hydraulic-boost servos

The testing also identified that the relative position of the installed front servos allowed a detaching bolt from the left servo to contact the right servo (Figure 16). This permitted the movement of the right servo to interfere with the normally independent movement of the left servo.

As a result of the testing, the manufacturer considered the similarity of the behaviour of the cyclic and collective flight controls following the removal of the detached fastener, as compared to the control feel described by the pilot of VH-HFH before handing control to the instructor. The manufacturer concluded that the behaviour of the controls in that case was sufficiently similar to those associated with the disengagement of the hydraulic system to allow the conclusion by an affected pilot that the hydraulic system had failed.

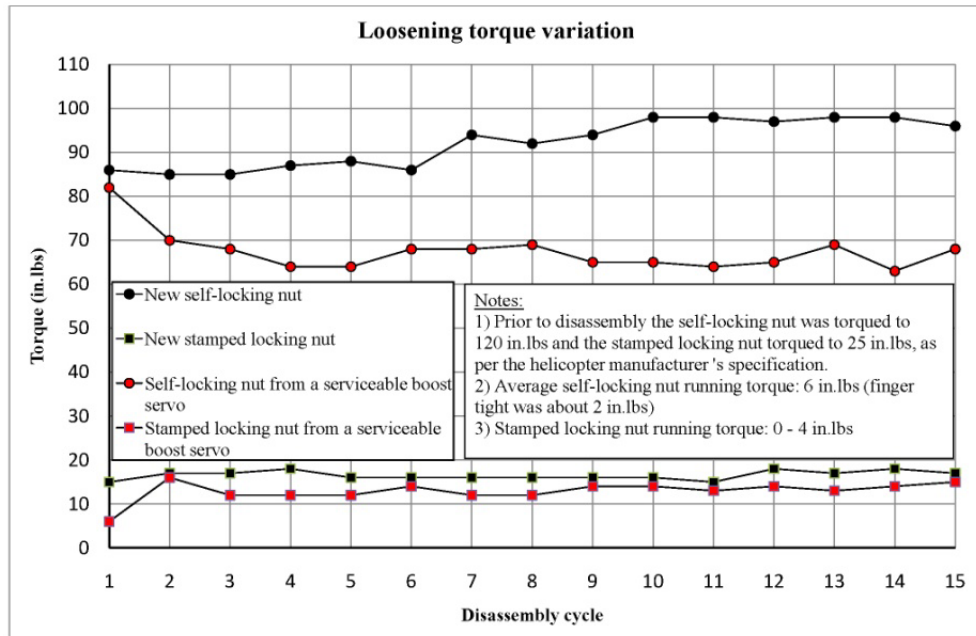
Figure 17: Loosening torque variation

- The average running torque of one of the stamped locking nuts was about 4 in.lbs. The running torque of the other stamped locking nut rapidly fell to zero within one quarter of a turn during each of the multiple assembly/disassembly cycles.
- The average running torque of the self-locking nuts was about 6 in.lbs.
