Controlled flight into terrain – Cessna Aircraft Company 310R VH-XGX

Near Bathurst Island Aerodrome, Northern Territory | 5 February 2011

ATSB Transport Safety Report
Aviation Occurrence Investigation
AO-2011-017
Final

Report No. AO-2011-017

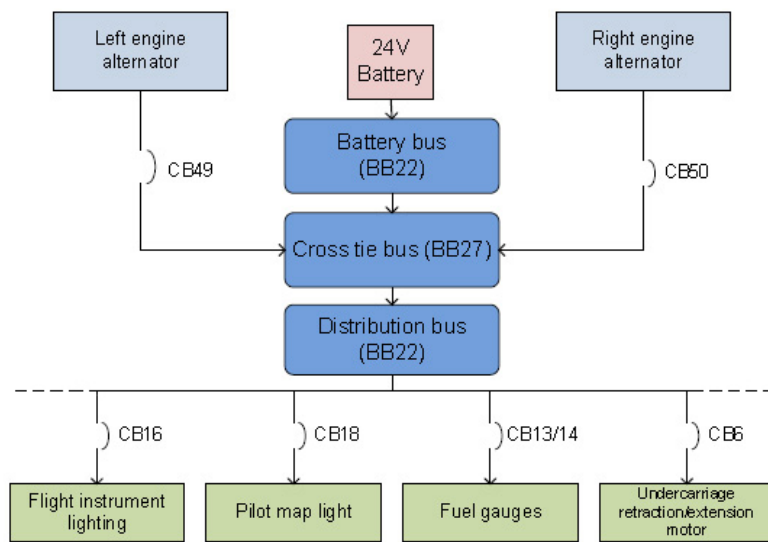
Figure 2: Simplified electrical system diagram

Generated electrical power from the engine alternators was supplied to bus bar BB27 via individual circuit breakers; CB49 for the left alternator, and CB50 for the right alternator (Figure 2).

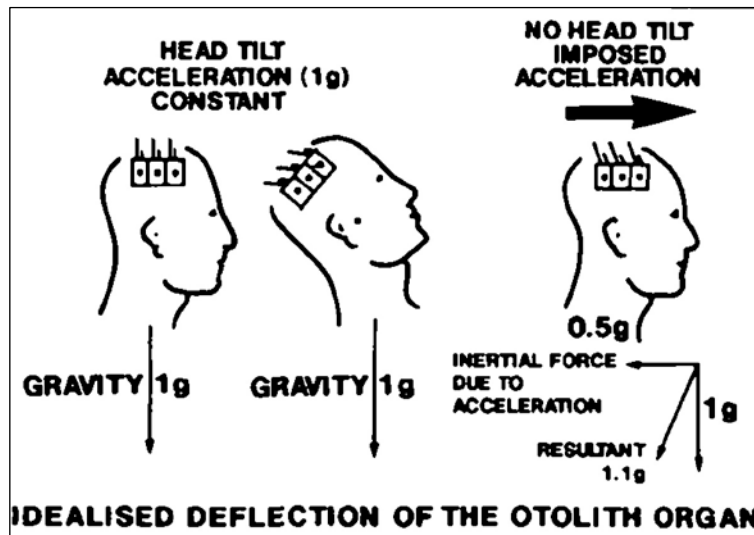
Figure 10: Tilt and acceleration as felt by the otolith organ⁸

The vestibular system consists of the semi-circular canals and the otolith organs⁶ within the inner ear. Acceleration in any direction causes the fluid within the semicircular canals to deflect the fine hairs of the otolith and stimulate nerve impulses. The vestibular nerve then transmits the impulses to the brain⁷ to interpret the motion. Due to the nature of the otolith organs, tilt and acceleration produce the same sensation (Figure 10).

The somatogravic illusion generally occurs in conditions with limited external visual cues, such as night operations or flight in instrument meteorological conditions (IMC). Under limited visibility, the brain is unable to differentiate between the sensations associated with tilt and those associated with acceleration. The illusion is generally most strongly felt at takeoff, which increases the risk of a pilot intentionally lowering the aircraft's nose in response to a sensation that the aircraft is climbing too steeply. This serves to increase the acceleration further and will compound the illusion, with the aircraft ultimately descending into terrain if the illusion is not recognised and overcome. The illusion has been linked to a number of dark night take-off accidents where the normally-operating and otherwise under control aircraft has impacted terrain a short distance from the end of the departure runway.
