# Rotor drive failure – Robinson R22 Beta II, VH-DSD

83 km NW of Julia Creek, Queensland | 9 May 2011

**ATSB Transport Safety Report**  
Aviation Occurrence Investigation  
AO-2011-060  
Final

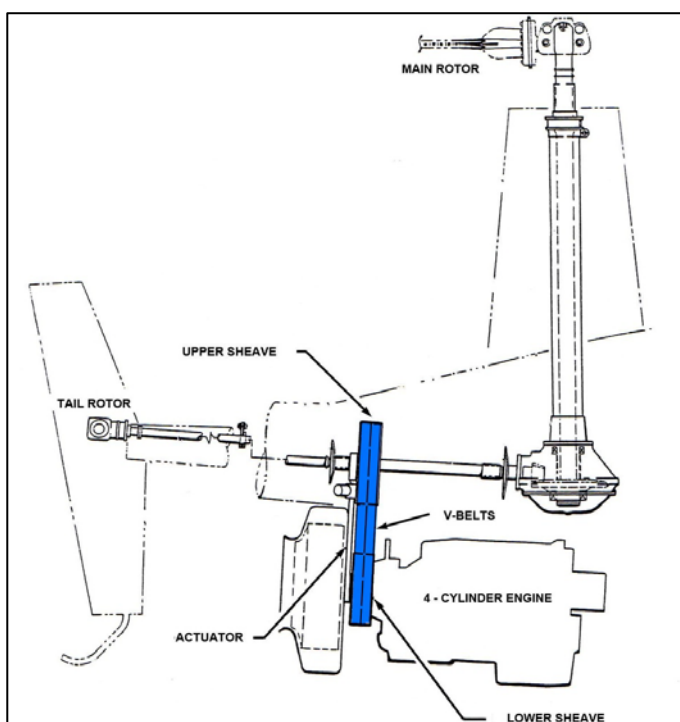
**Figure 3: R22 rotor drive system**

The ATSB found that the two v-belts that transfer torque from the engine to the rotor system had failed. The damage to the forward v-belt indicated that it had partially dislodged from the drive sheave, resulting in significant damage to the belt. At some point the v-belt fragmented, compromising the redundancy of the belt-drive system. Once the rear v-belt failed, all drive to the rotors was lost.

On the R22 helicopter, engine power was transferred to the rotor system through a drive belt system that consisted of two rubber double v-belts running on matching multi-grooved sheaves (Figure 3). Both the upper and lower sheaves were constructed of aluminium alloy with a thermally-sprayed, metallised coating to improve wear resistance. The upper drive sheave was mounted on the clutch shaft next to a flexible coupling. The upper sheave could be moved relative to the engine-mounted drive (lower) sheave by means of an electric clutch actuator. This movement had the effect of varying the tension being applied to the v-belts (for more information on the helicopter's drive-belt system, see the section titled *Component examination*).

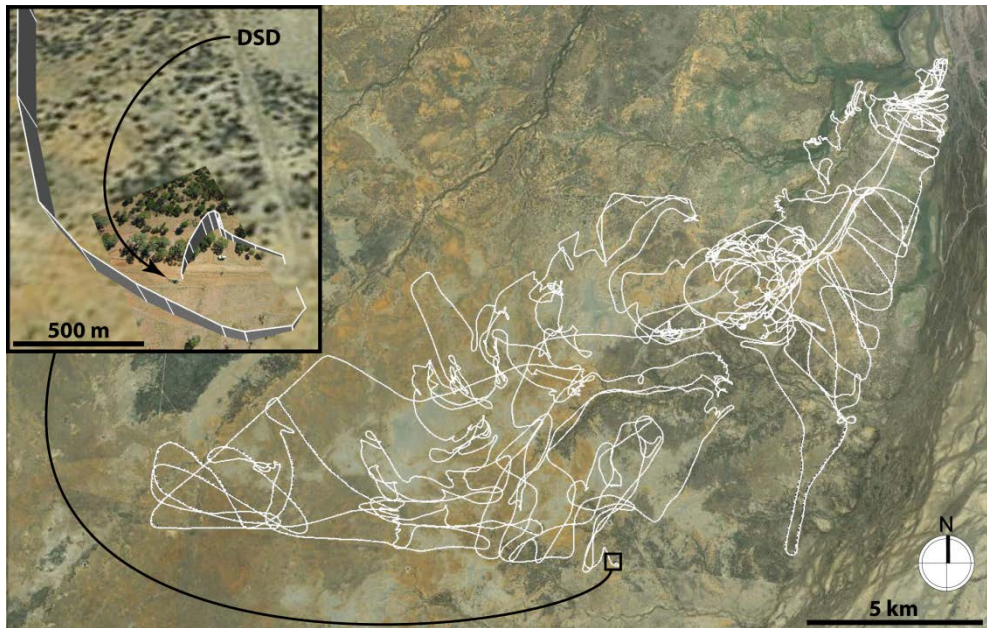
**Figure 8: GPS-recorded track**

The recovered data was recorded continuously from 0730 to the time of the accident at 1441. Over that time the pilot manoeuvred the helicopter within a defined area and generally not above 500 ft, consistent with the aerial stock mustering task (Figure 8). On seven occasions, the helicopter's position and groundspeed were static, representing landings for periods ranging from 1.5 to 6.5 minutes. Of these, two were for the pilot to refuel the helicopter.

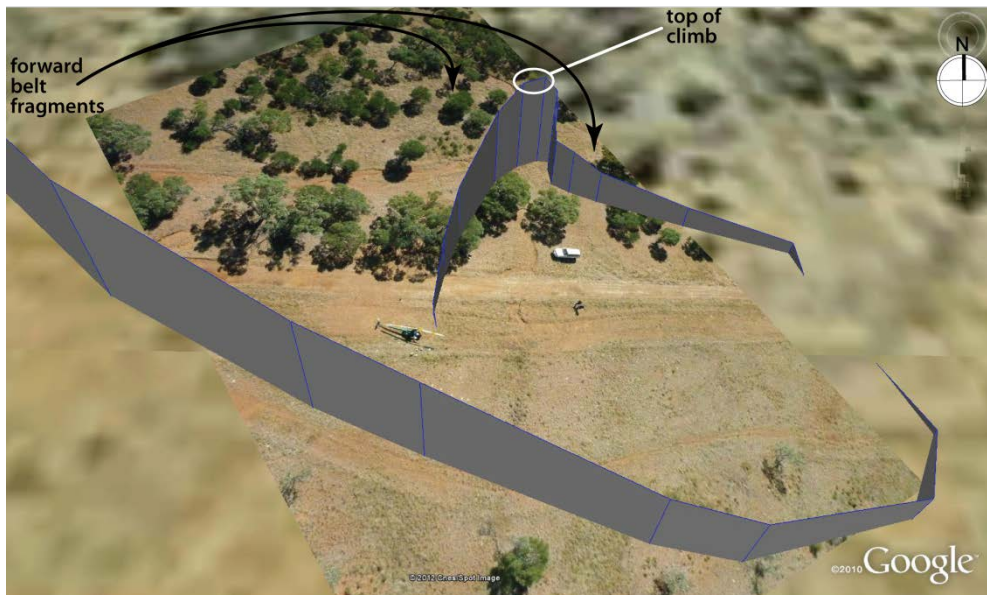
**Figure 9: Representation of the helicopter's final flightpath**

In the final 30 seconds of flight, the pilot climbed the helicopter to about 130 ft above ground level (AGL) at an average rate of 300 ft/min. At that point, when the helicopter's groundspeed was about 20 kts, the helicopter entered a steep descent to the ground (Figure 9). Based on the descent profile and the location of the forward v-belt fragments, the loss of drive occurred at or about the top of the climb.
