Loss of control involving Robinson R44 helicopter VH-HWQ

Bulli Tops, New South Wales | 21 March 2013

ATSB Transport Safety Report
Aviation Occurrence Investigation
AO-2013-055
Final – 4 June 2015

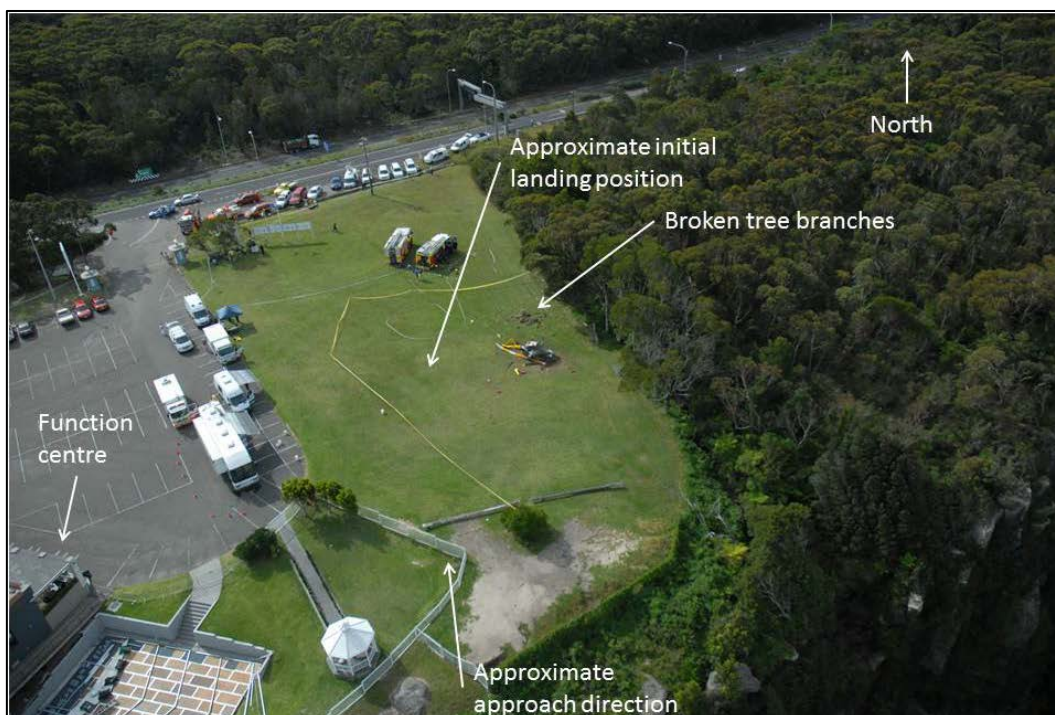
Figure 1: Bulli Tops function centre and grass landing area

The accident site was an open grassed area, orientated north-west/south-east, which sloped down to the south-east at about 4°. The area was bordered by a tarmac car park on the western side, a line of trees on the eastern side and a powerline and highway to the north (Figure 1).

The wreckage was contained within a relatively small area and all of the helicopter's major components were identified at the accident site (Figure 9). The helicopter came to rest on its right side and facing downhill on a magnetic heading of 103° (Figures 1 and 2).

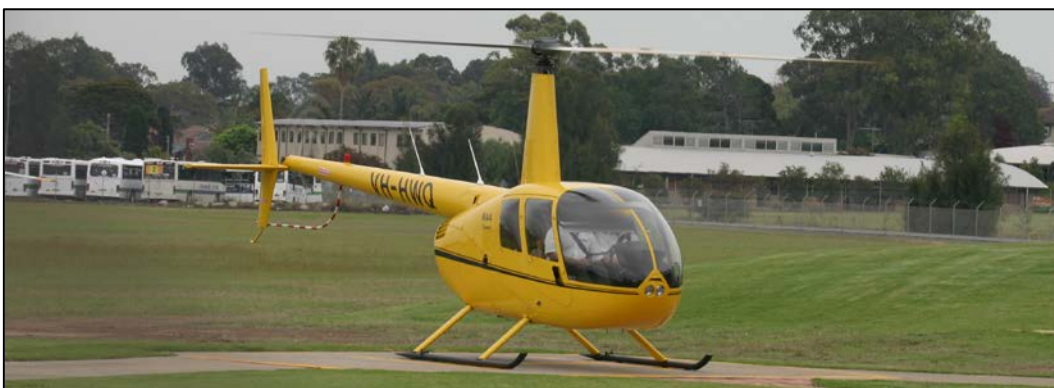
Figure 3: VH-HWQ

The R44 is a four-seat, single main and tail rotor helicopter that is powered by a six-cylinder piston-engine, and equipped with skid-type landing gear. The accident helicopter (Figure 3), a R44 Raven 1, serial number 1445 was manufactured in the United States (US) in December 2004. An Australian Certificate of Airworthiness for the helicopter was issued on 11 February 2005.

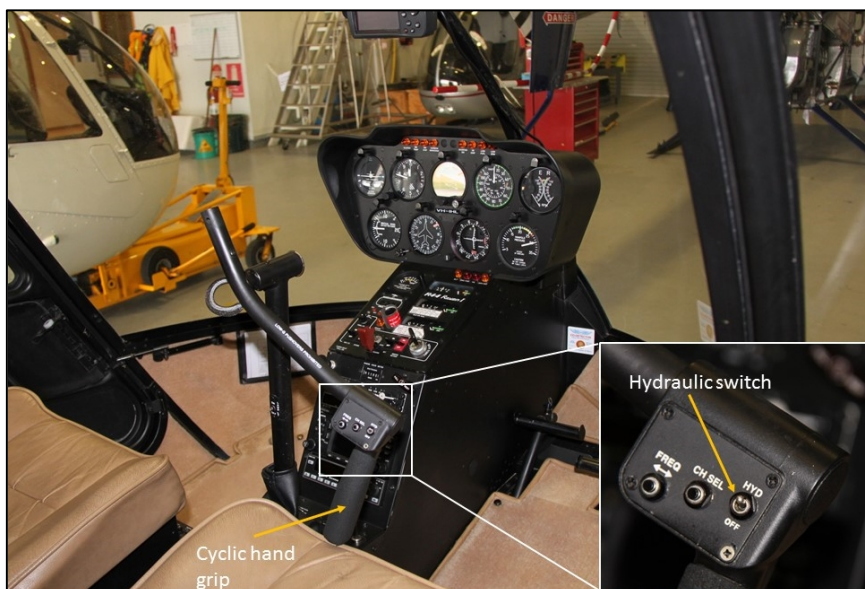
Figure 5: Typical R44 cockpit flight controls, pilot’s cyclic (left cyclic hand grip removed)

The flight controls in an R44 helicopter control the pitch angle of the main rotor and tail rotor blades through mechanical linkages. The cyclic control, operated by the respective pilot’s right hand, varies the angle of each main rotor blade individually to tilt the main rotor disc and control the attitude of the helicopter and hence the lateral direction in-flight, or the position over the ground when in the hover. Pilot movement of the cyclic hand grip is transferred via an arm to a centrally-mounted control column (Figure 5).

Hydraulically-boosted main rotor flight controls eliminate cyclic and collective feedback forces. The hydraulic system consists of a pump, three servos, a reservoir, and interconnecting lines...The pump is mounted on and driven by the main rotor gearbox to maintain hydraulic pressure in the event of an engine failure. A servo is connected to each of the three [flight control] push pull tubes that support the main rotor swashplate. The reservoir...includes a filter, pressure relief valve, and pilot controlled pressure shut off valve...The pressure shut off valve is solenoid actuated and controlled by the hydraulic switch [HYD/OFF] on the pilot's cyclic [Figure 5].

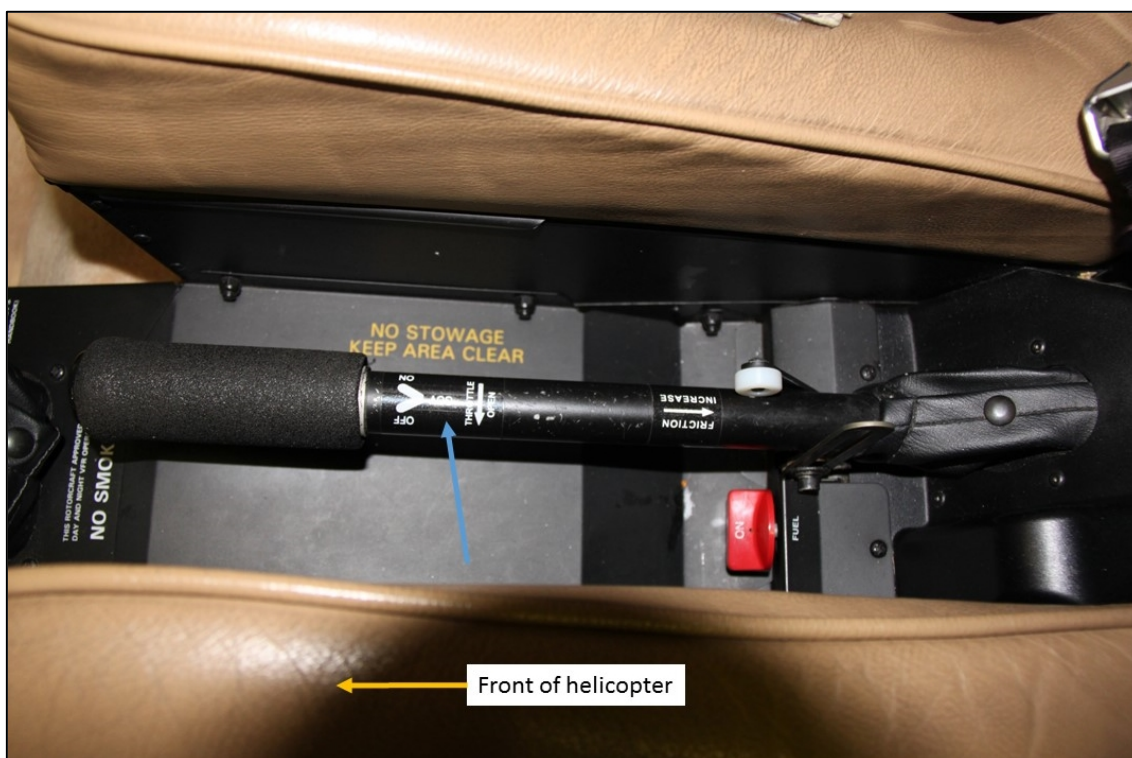
Figure 6: Typical R44 cockpit flight controls, right-seat pilot's collective lever (blue arrow)

The collective control, raised or lowered by the pilot's left hand, varies the pitch of both main rotor blades together to increase or reduce rotor thrust for climb or descent. The two interconnected pilot's collective levers are positioned to the left of each front seat and incorporate a twist-grip engine throttle (Figure 6). Raising the collective increases the pitch on the main rotor blades, resulting in an increase in the lift and drag produced. In order to overcome the increased drag, the R44 incorporates a throttle correlator device that increases the throttle as the collective is raised and reduces throttle as the collective is lowered.

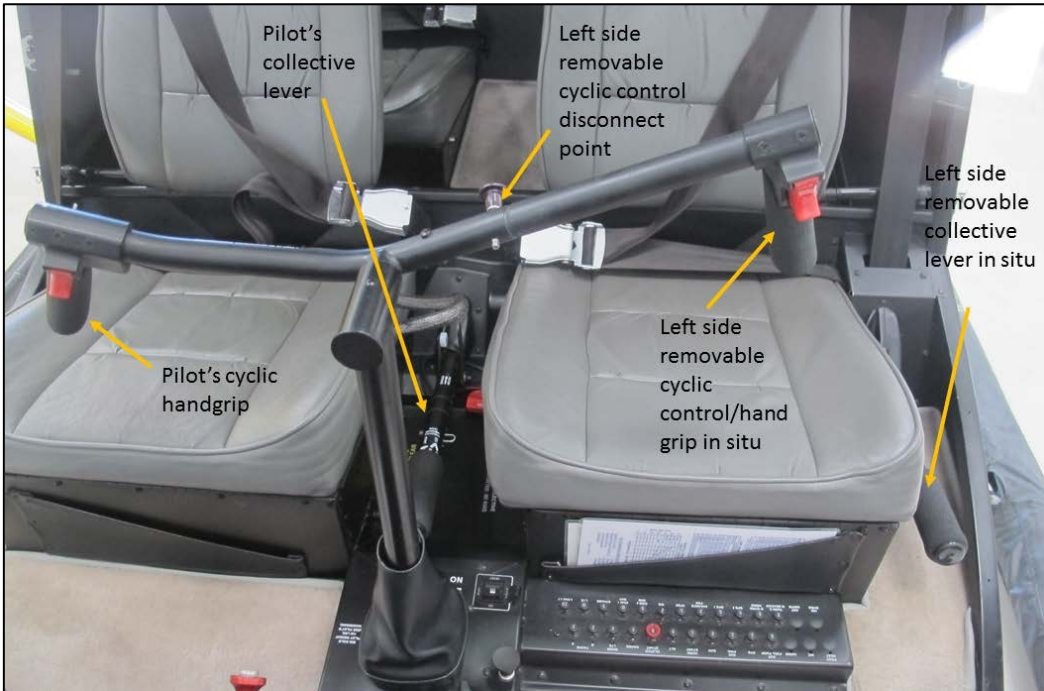
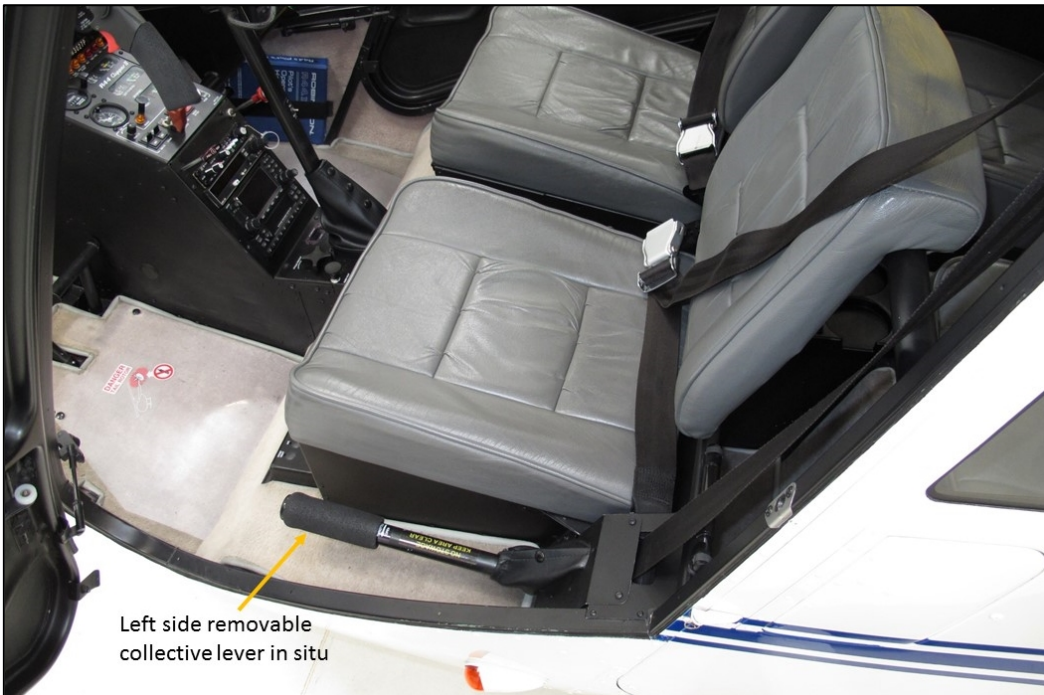
The left cockpit flight controls in the R44 can be removed from the helicopter as operationally required (Figures 5, 7 and 8). This can include when carrying a passenger in the left-front seat, with the aim of reducing the risk of this passenger inadvertently activating or otherwise fouling the controls, in order to carry additional cargo, and so on.

The left collective control is normally connected to a stub situated inside a protective dust boot (Figures 7 and 8). When the collective control is removed, the boot remains attached to an aluminium cover, limiting access to the collective control stub. The helicopter manufacturer indicated that the stub extends approximately 5 mm beyond the aluminium cover when the collective is fully-raised and 15 mm at mid position or when fully-lowered. The extension facilitated re-connection of the collective control.

At the time of the accident, the left cockpit flight controls, including the tail rotor pedals, were not fitted to VH-HWQ.

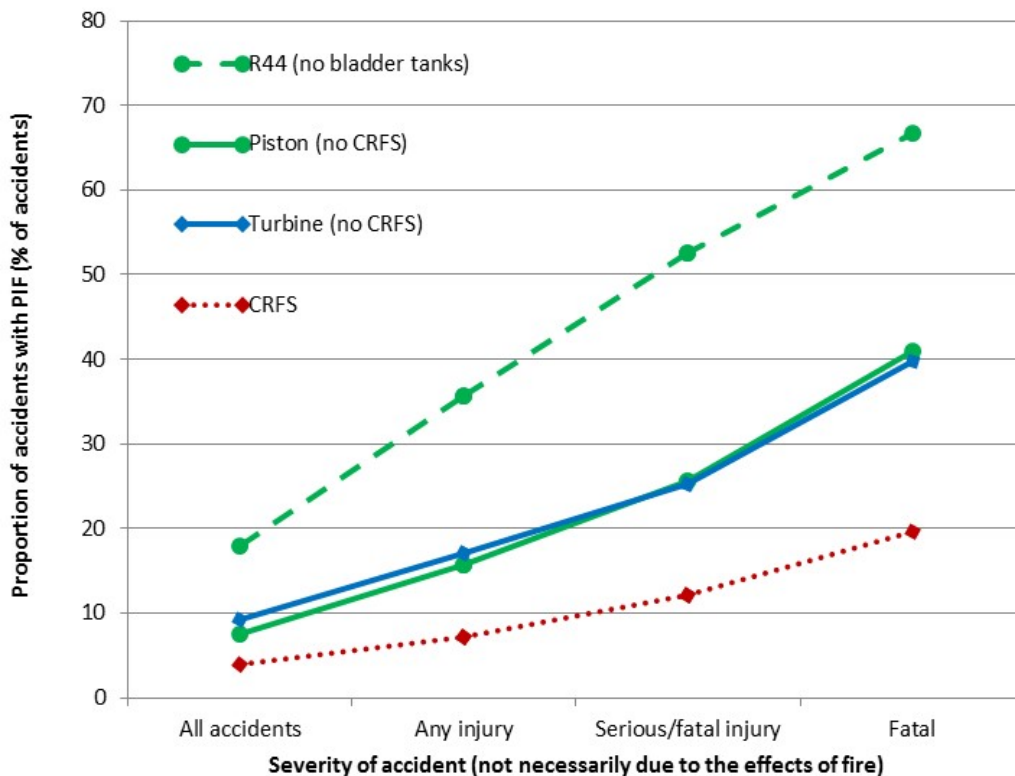
Figure 10: Post-impact fire proportions for all helicopters

Figure 10 shows the PIF proportions for piston-engine helicopters and turbine-engine helicopters without a CRFS, as well as helicopters fitted with a CRFS (almost all turbine-engine).²⁹ Helicopters with a CRFS had a significantly lower proportion of PIFs for all accidents (4 per cent) than helicopters without a CRFS (8 per cent). The proportion was also lower for accidents with different levels of severity, particularly for serious/fatal injury accidents (12 versus 25 per cent) and fatal accidents (20 versus 40 per cent). Ex-military helicopters with a CWFS had a particularly low proportion of PIF for fatal accidents (6 per cent) compared to other helicopters with a CRFS (26 per cent).

In summary, during the period 1993–2013 in Australia and the US, PIF was involved in 37 of the 206 accidents involving R44 helicopters not fitted with bladder-type tanks (18 per cent). The PIF proportion for accidents resulting in serious or fatal injuries was 52 per cent, and the proportion for fatal accidents was 67 per cent (Figure 10).

As can be seen in Figure 10, the R44 without bladder-type tanks had a significantly higher PIF proportion than the average for other piston- or turbine-engine helicopters without a CRFS at each level of accident severity. For serious/fatal injury accidents, the R44 proportion (52 per cent) was twice the average of all other helicopters not fitted with a CRFS (23 per cent). For fatal accidents, the R44 proportion was also substantially higher than the average of all other helicopters not fitted with a CRFS (67 versus 37 per cent).

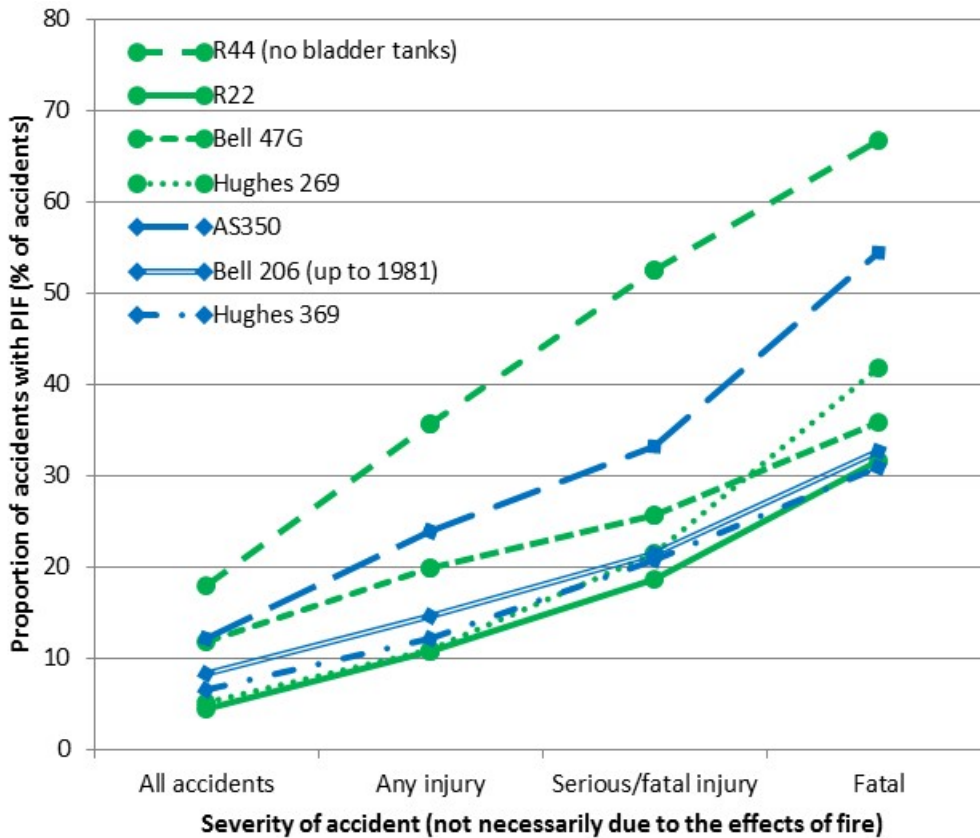
Figure 11: Post-impact fire proportions for common helicopter types

Figure 11 shows the PIF proportions for the R44 and six other helicopter types without a CRFS and with a sufficient number of accidents to conduct reliable comparisons. Key results included:

- The R44 had a higher PIF proportion for all accidents (18 per cent) than the other common types. However, the differences between the R44 and the Bell 47G piston-engine helicopter (12 per cent) and the R44 and the Eurocopter AS350 turbine-engine helicopter³¹ (12 per cent) were not statistically significant.³²
- The R44 had a higher PIF proportion for serious/fatal injury accidents (52 per cent) than all the other common helicopter types.
- The R44 had a higher PIF proportion for fatal accidents (67 per cent) than all the other common types, but the difference between the R44 and the AS350 (55 per cent) was not statistically significant.

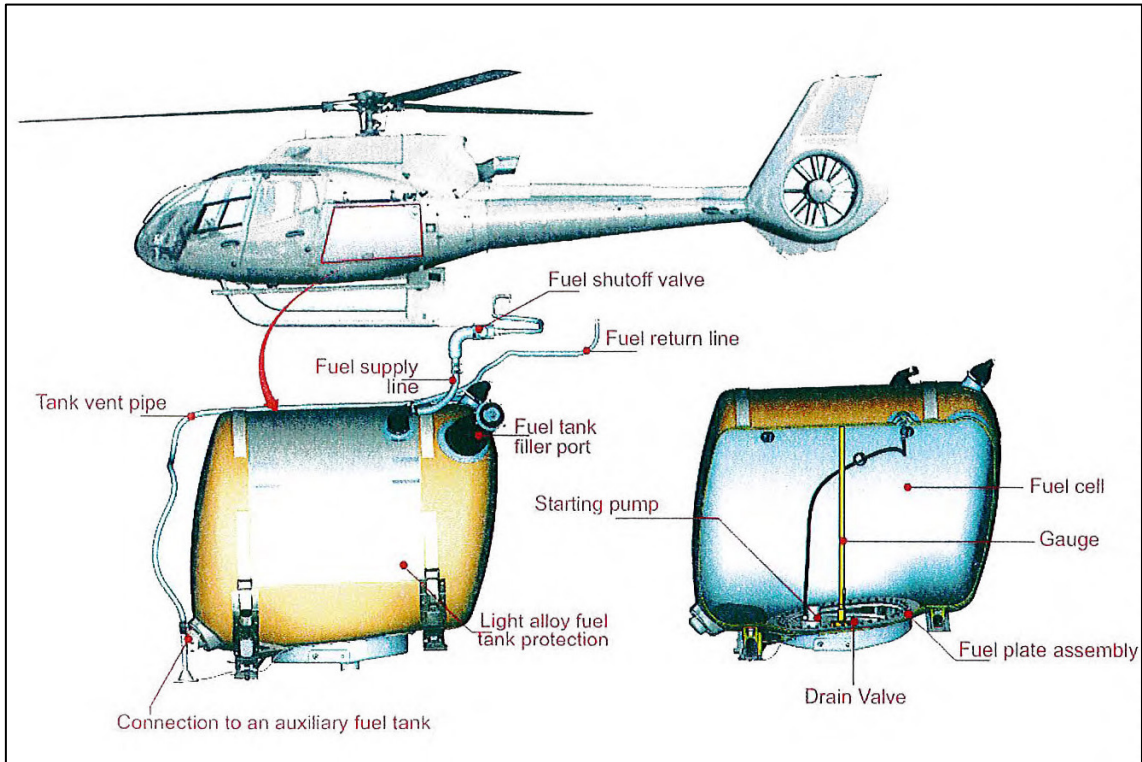
Figure 14: EC130 T2/B4/AS350B3 energy absorbing fuel tank

The Airbus Helicopters EC130 T2 was certified after 1994 and had a CRFS that is compliant with FAR 27.952. Airbus Helicopters advised that the EC130 T2's CRFS included an 'energy absorbing fuel tank' and related components (Figure 14), and that this system was also available as an option for newly-manufactured AS350 B3e models. Additionally, Airbus Helicopters reported that their intention was to have a CRFS available for all new single-engine helicopters and to be in a position to retrofit existing AS350/EC130 helicopter versions with a CRFS (see the section titled *Safety issues and actions*).
