**Departmental investigation into the  
damage sustained by the Australian tanker  
OSCO STAR  
during tropical cyclone Justin  
9 March 1997**

**Report 113**

Navigation Act 1912  
Navigation (Marine Casualty) Regulations  
investigation into the damage sustained by the Australian tanker  
**OSCO STAR**  
during tropical cyclone Justin  
9 March 1997

Published: March 1998  
ISBN 0 642 19999 X

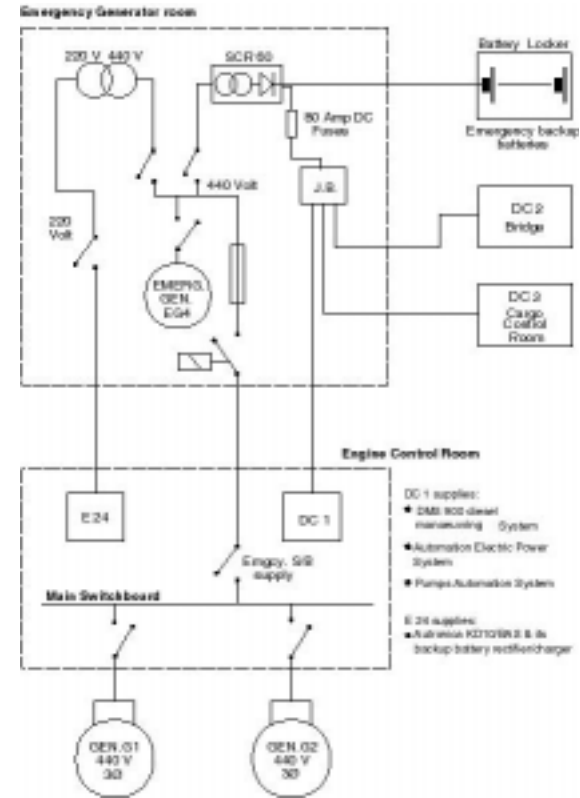
Oscostar - schematic circuit diagram

At 0620, alarm 11514 “fault 24V DC power supply SCR 60” (the rectifier/charger unit for the 24 volt emergency batteries) was activated and the Chief Engineer realised there was a common earthing problem, with everything indicating there must be water in the emergency generator room. However, the weather conditions were extreme and seas were breaking over the poop, so that it was too dangerous to venture out to investigate the problem fully. Because of the cyclone conditions, the Chief Engineer decided to initiate normal sea watches in the engine room.

Upon opening the emergency switchboard panel doors, the Chief Engineer found the lower terminal strips to be sparking and smouldering. The ceramic terminals were blackened and there was sparking within the wiring looms. The emergency generator was switched from 'automatic' to 'hand' start, in case it should start automatically, and the terminals were sprayed with contact cleaning fluid in an attempt to dry them. The 24 volt charger/rectifier (SCR 60) cabinet, which had also suffered from an ingress of water, was similarly treated and blown control fuses were changed. Two 80 amp main fuses were also removed and checked. At about 0841, these fuses were replaced and, at that instant, the vessel experienced a blackout. The main engine, which had been running until this moment, stopped. At this time, *Oscostar* was 37 miles to the north of Lihou Reefs.
