**Departmental  
investigation into  
switchboard fire aboard  
the Australian flag bulk  
cement carrier Goliath at  
Devonport, Tasmania on  
23 August 1997**

investigation into the switchboard fire aboard the Australian flag  
bulk cement carrier GOLIATH at Devenport Tasmania on 23 August 1997

Published: May 1997

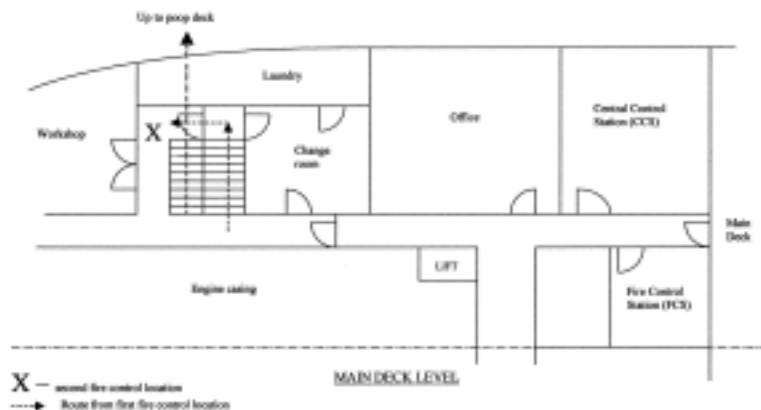
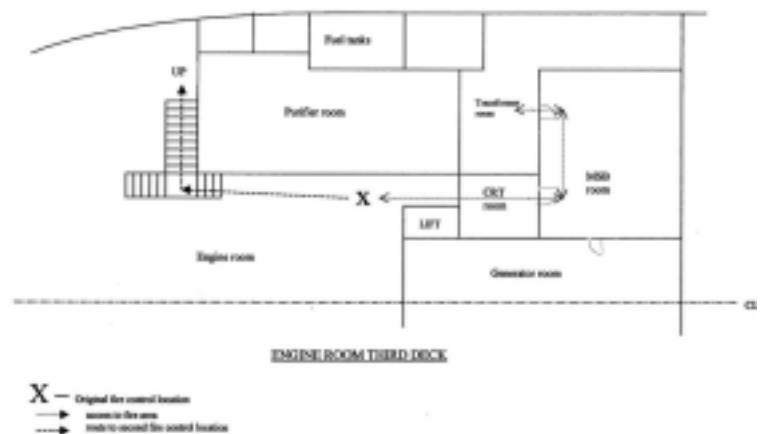
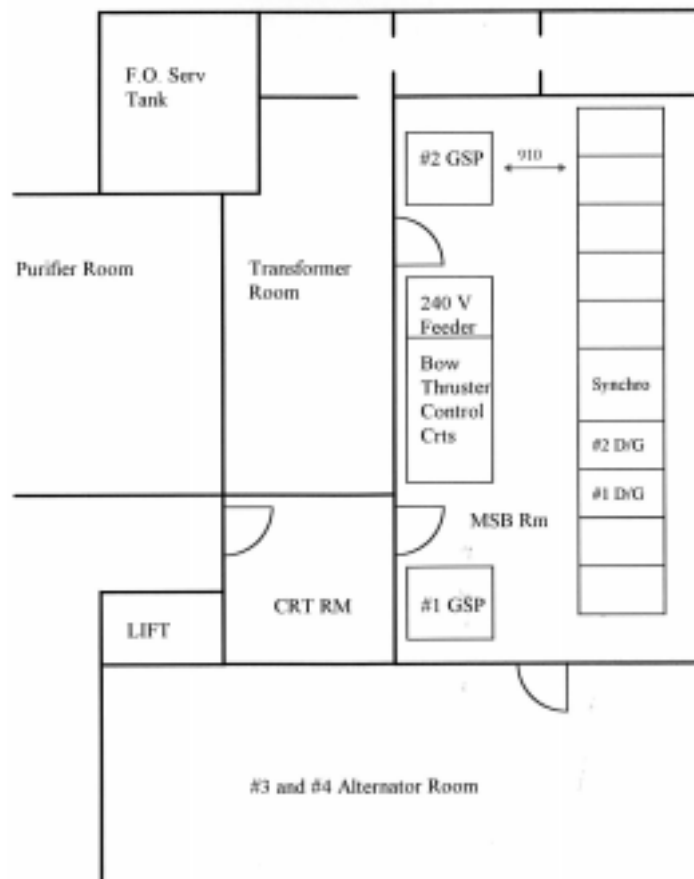
Sketch plans Port of main deck and Third deck

Sketch Plan forward port side of third deck

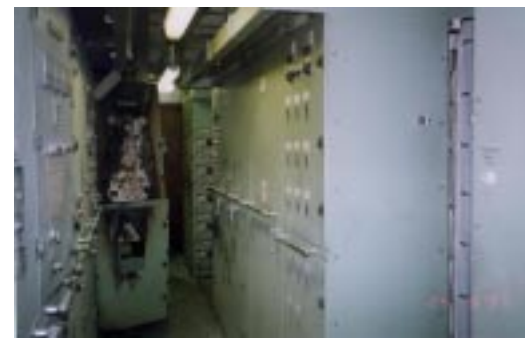
**View of main switchboard room**

The fire destroyed the circuit breaker and its associated control equipment. Heat damage had affected the adjacent cubicles either side of No.2 cubicle. These cubicles contained the circuit breaker for No.1 generator and the generator synchronising panel. Neither No.1 generator, nor No.2 generator, could be connected and the synchronising panel was inoperative. The remainder of the main switchboard had suffered some smoke damage. See photographs pages ....
