Departmental investigation into the
collision between the Australian fishing vessel
TERESA
and the Cypriot bulk carrier
ATLANTIS TWO

off Termination Island, WA on 28 September 1997

Report No. 125

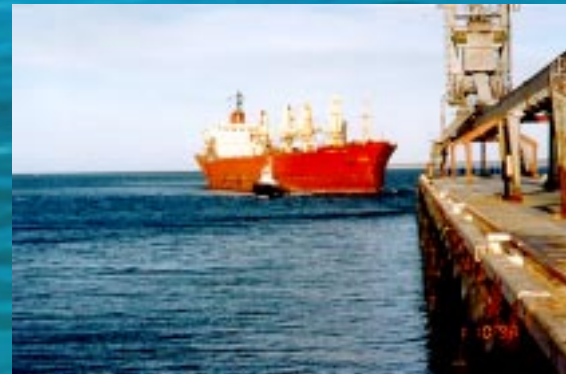
Teresa was found to have sustained considerable damage to the bulwark at the bow. As the anchor rope had snagged the timber on the port bow, the rope was buoyed and cut loose and the Skipper decided to return to Esperance.

When *Atlantis Two* berthed at Thevenard on the morning of 1 October 1997, the vessel bore a recent contact mark on the hull, low down on the starboard bow. Under scientific examination, particles of red paint taken from this contact mark matched the hull paint of *Teresa* and particles of paint deposited on the damaged bow of *Teresa* matched the boot-topping paint of *Atlantis Two*.

An officer of the Western Australian Police took samples of paint from the damaged area of *Teresa's* bow and also of a "foreign" red-brown paint believed to have come from the vessel that had caused the damage.

Teresa. Damage to bow.
