**Departmental investigation into  
the grounding of the Panamanian cargo vessel  
Pine Trust  
in Denham Channel, Shark Bay,  
Western Australia, on 13 October 1997**

**Report No. 126**

**Australia**  
Department of Workplace Relations  
and Small Business

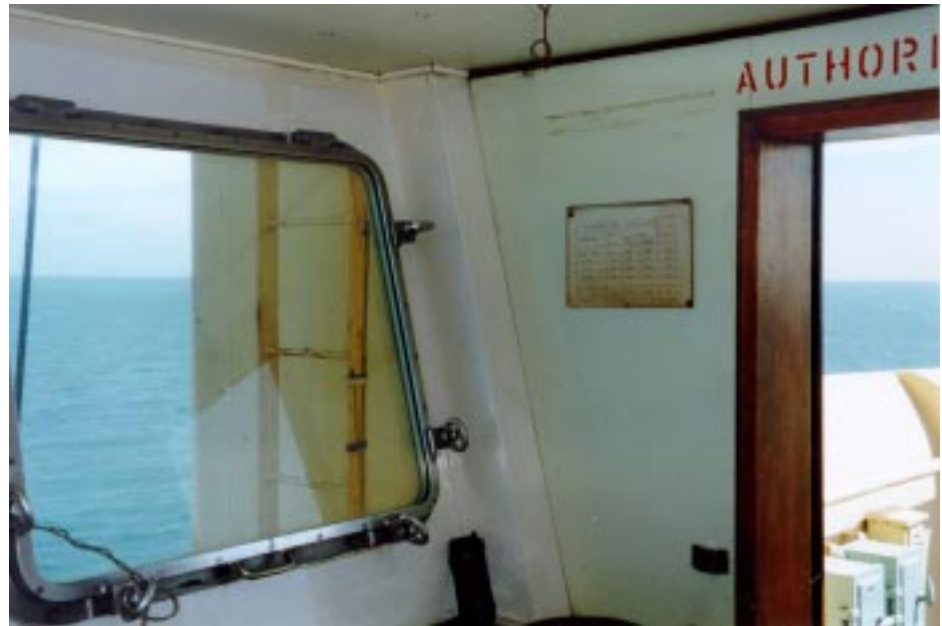
### **Starboard View**

View to starboard view obscured by mast and wheelhouse structure

The Pilot became distracted by his conversations with the Master and was preoccupied with various documents they were examining. He did not move around the wheelhouse frequently enough to negate the effects of blind sectors caused by the ship's cargo gear and mast arrangement. Later on, he totally lost track of time.
