Departmental investigation
into the accidental release of the free-fall lifeboat
and injury to a crew member aboard the Bahamas flag
geared bulk carrier
MAERSK POMOR
at Gladstone, Queensland on 2 January 1998

Report No. 128

Australia
Department of Workplace Relations
and Small Business

Published: August 1998

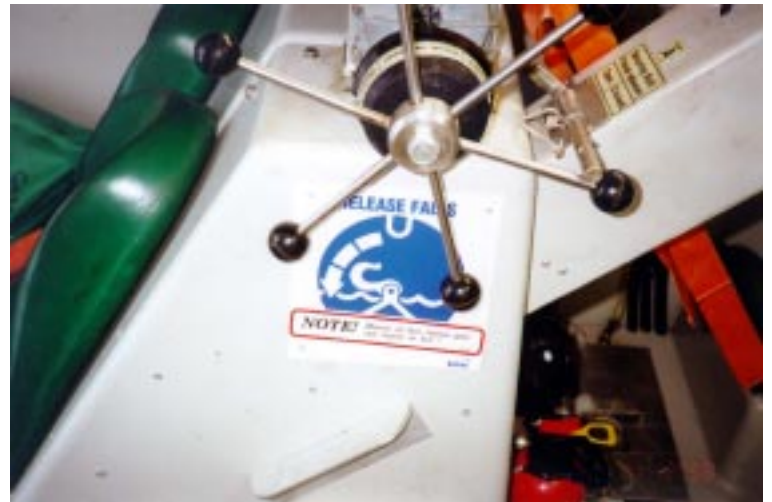
Lifeboat release gear

The release gear, for launching the lifeboat, incorporates a spoked, rimless wheel, located adjacent to the inboard side of the coxswain's seat. To prevent accidental operation of the release gear, the wheel is locked by a stainless steel slip bolt, passed between the spokes, and in turn is prevented from accidental removal by a locking pin.
