Incidents at sea

Departmental investigation into
the contact by the
Panamanian container ship
MSC KATIE
with the container ship
DL D SYDNEY
in Swanson Dock, Melbourne
on 18 June 1998

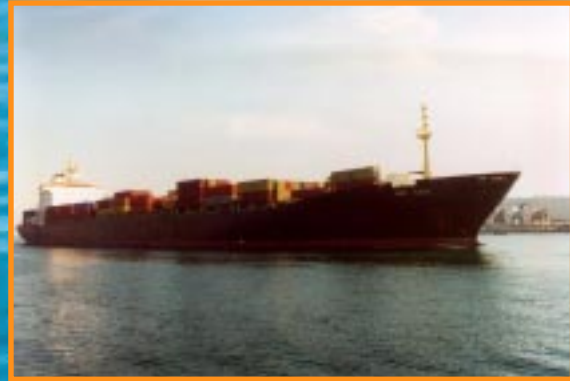
MSC Katie sustained damage to the shell and deck plating right aft on the port quarter, also to deck fittings and to container support pillars and access platform in that area. *P&O Nedlloyd Sydney* sustained scratching and indentations on the stem plating, plus a 280 mm vertical fracture in the plating and damage to the gangway, which came in contact with a bollard on the wharf as the ship was pushed astern.

MSC Katie damage to port quarter
