Departmental investigation  
into the fire aboard the  
Australian flag oil tanker  
*TASMAN*  
in the port of Melbourne,  
Victoria on  
19 December 1998

## **Navigation Act 1912 Navigation (Marine Casualty) Regulations investigation into the fire aboard the Australian flag oil tanker *TASMAN* in the port of Melbourne, Victoria on 19 December 1998**

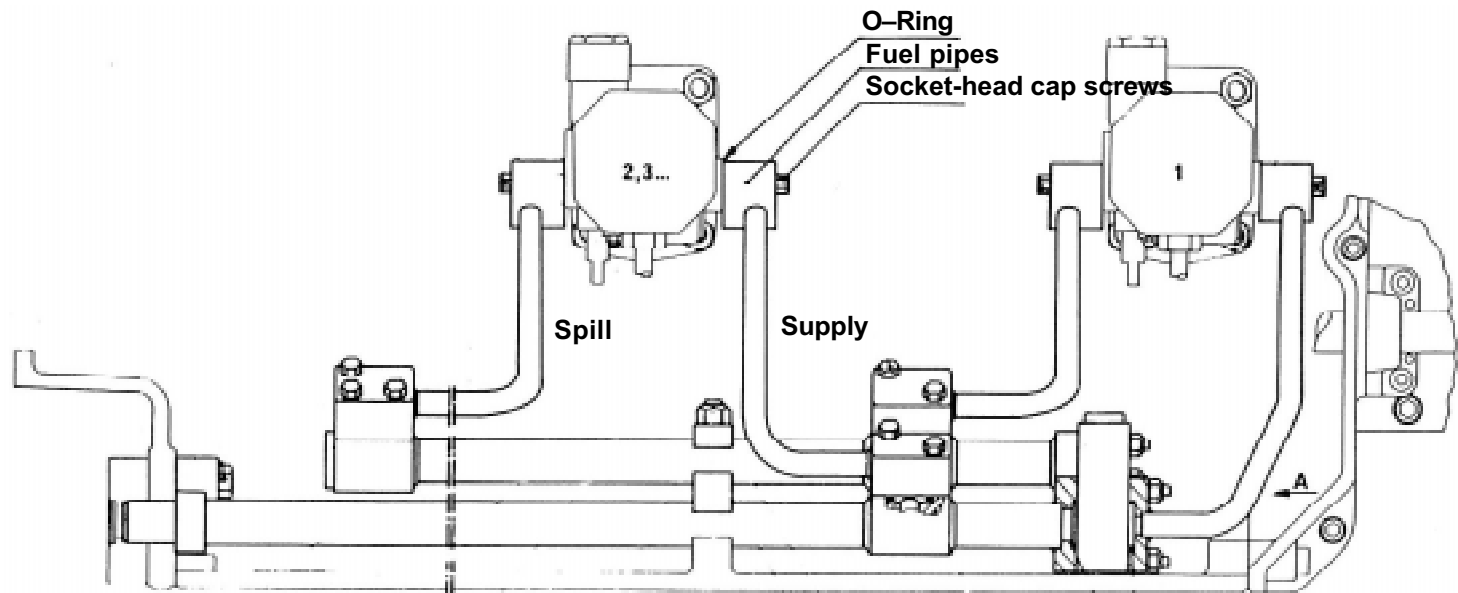
FIGURE 10

It was later found that the fire had been started by a fuel pipe on no. 1 generator, the securing screws for which had become loose allowing fuel to spray into the hot-box and leak to the bilge, before igniting on the exhaust pipes. The fire had then spread to the oil in the bilge. The fire caused some damage to no.1 generator, but the most significant damage was that sustained by electric cables in cable trays beneath the deckhead.

**Plan of fuel pumps, supply and spill pipework in 'hot box'**

The units have individual 'L'Orange' fuel injection pumps. Fuel is supplied to each injection pump via a separate pipe connecting from the fuel supply rail. The end of this pipe is attached to the fuel pump body with a flanged joint, sealed by a  $19.2 \times 3$  mm O-ring, recessed into the flange. (fig. 11). The flange is secured to the pump body by two 8 mm dia.  $\times$  45 mm long allen screws. On the opposite side of the fuel pump, the fuel spill port is connected to the spill rail by a similar pipe and flanged joint. A diagram showing the arrangement of the fuel supply and spill pipework is shown as figure 10.
