Report No 146

investigation into the near collision

*Olympic Symphony*

Australian Transport Safety Bureau

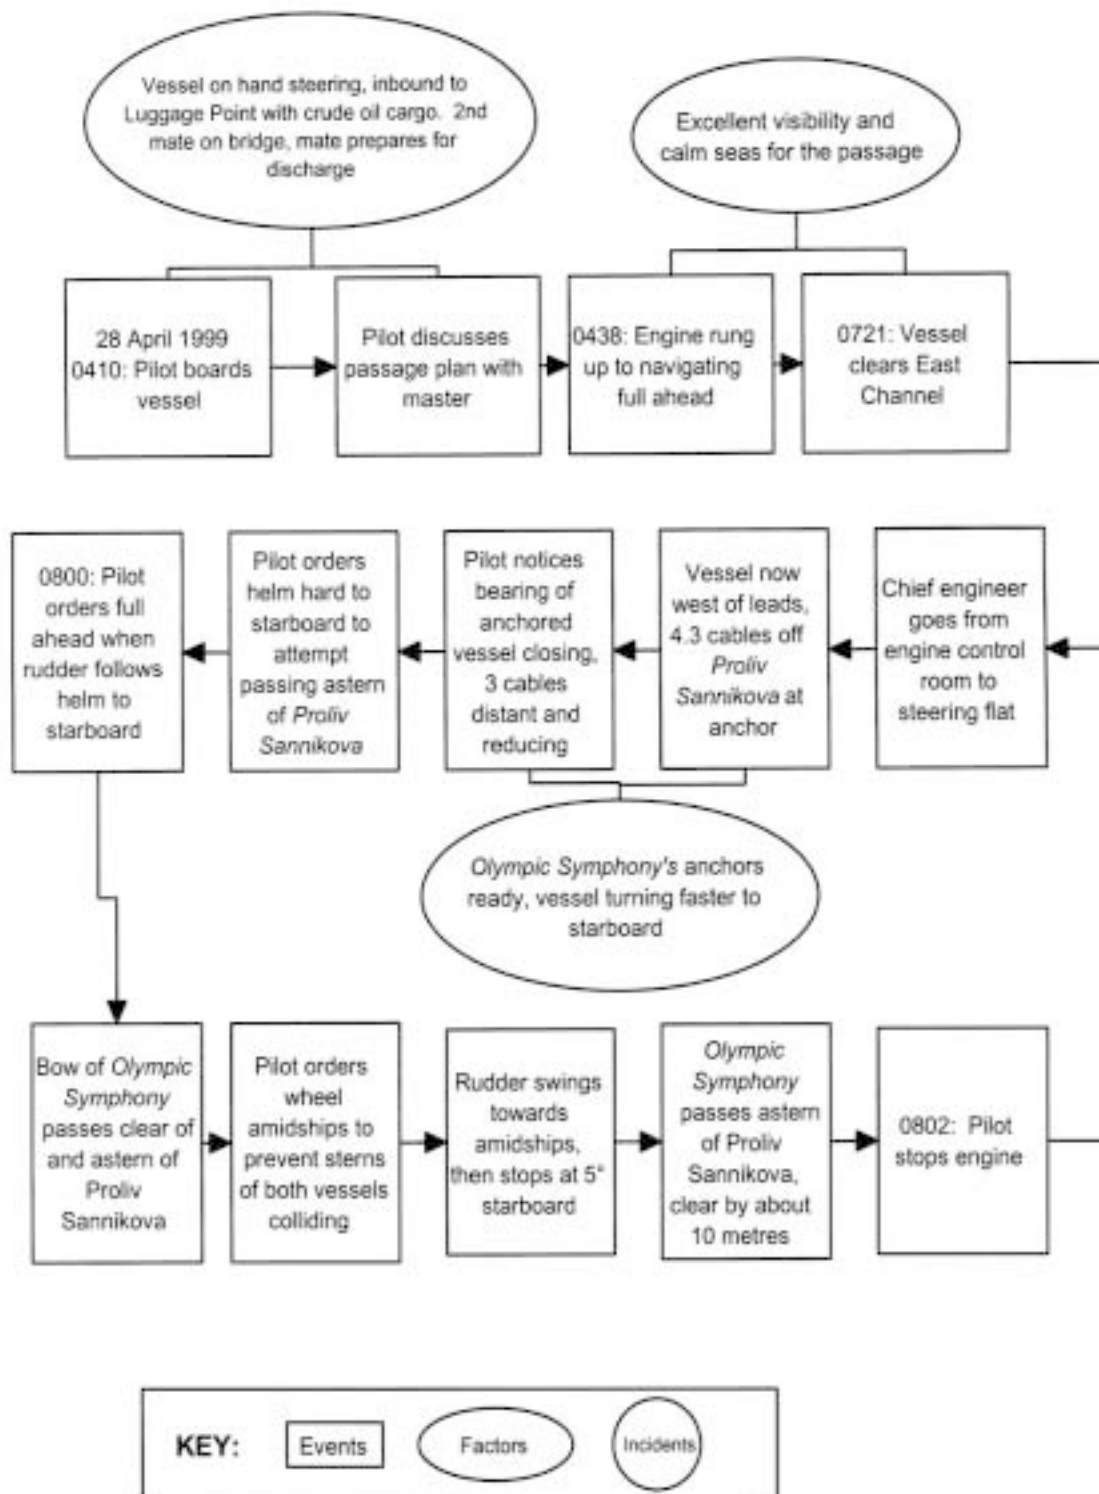
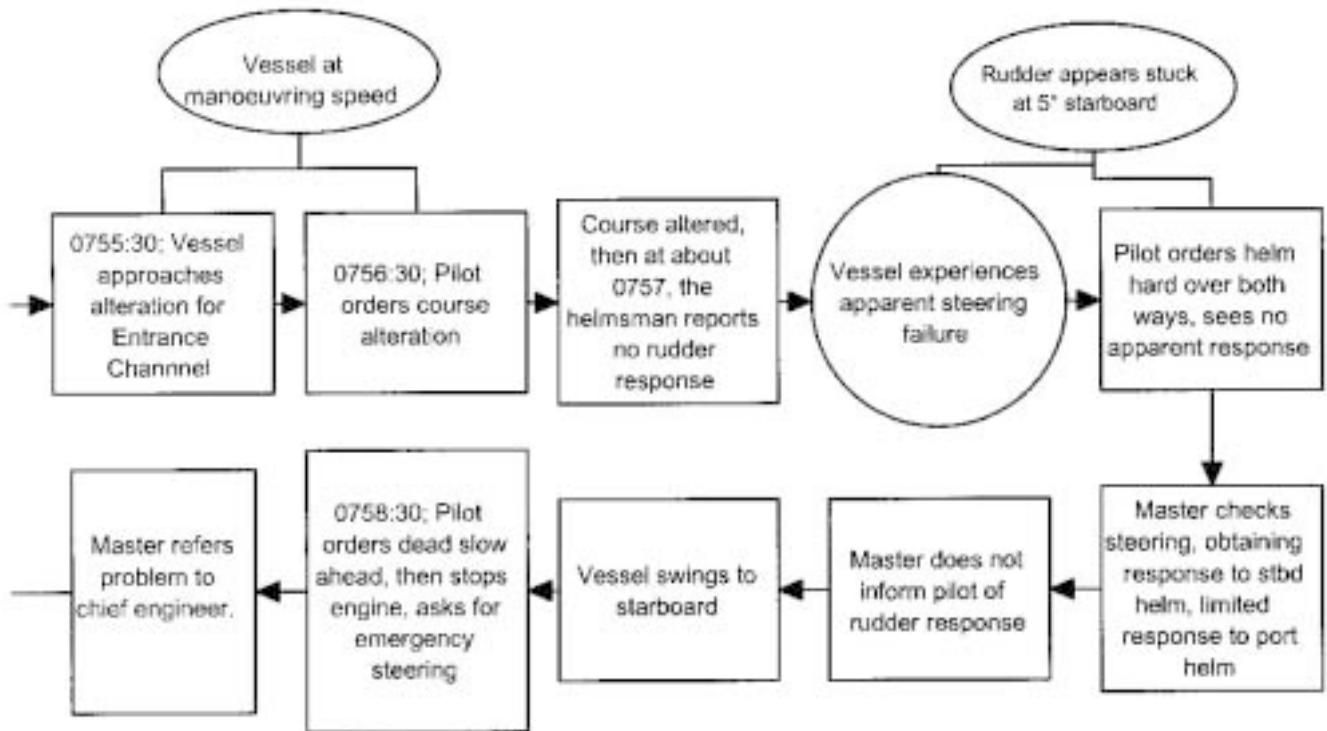
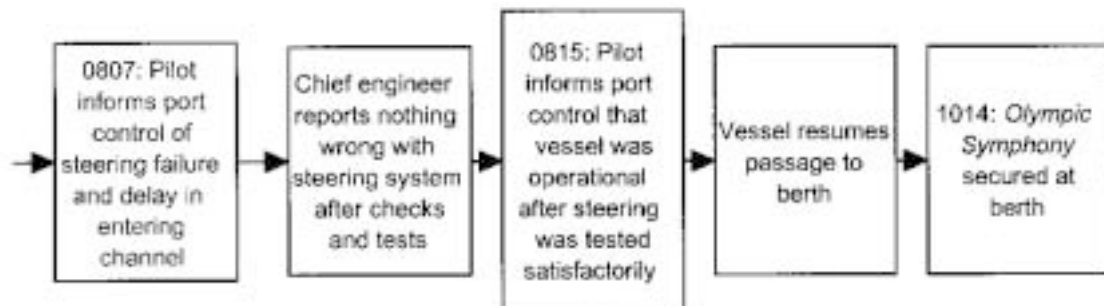
FIGURE 6  
**Events and causal factors chart**

Taken as promptly as they were, the actions of the pilot averted a collision.

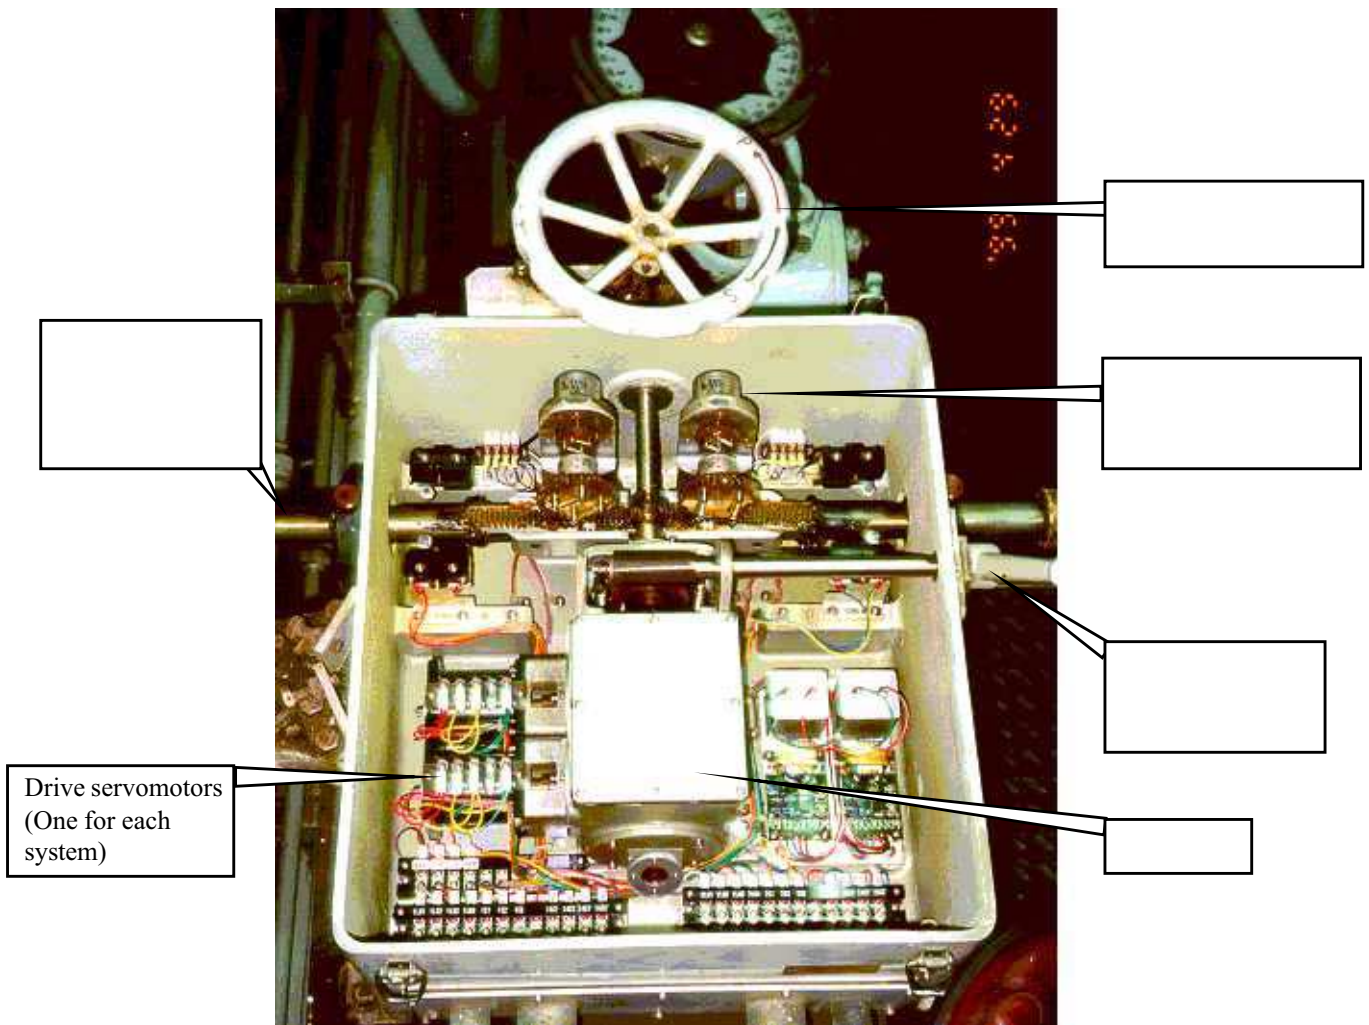
**Picture 3 – Telemotor drive unit at steering gear**

2. Gear wheel drives helm order indicator and also two synchronous transmitters.
3. An error signal is generated proportional to the difference between the positions of the synchronous transmitters in the helm transmitter unit and synchronous transmitters in the telemotor drive unit at the steering gear. The synchronous transmitters in the telemotor unit are geared to the telemotor output shaft (See picture 3).

4. The telemotor drive unit uses the error signal to generate a drive signal to the servomotors (See picture 3) which drive through the gearbox to position the output shaft.
5. When the output shaft position is such that there is no further error signal between the synchros in the helm and telemotor units, the servomotor stops.
6. The output shaft from the telemotor unit drives, via a hunting arrangement, the swashplate controls of the two main steering gear hydraulic pumps. (See picture 4, below)
