Departmental investigation into
the grounding of the Panama flag
general cargo ship
NEW REACH
on Heath Reef,
Great Barrier Reef
on 17 May 1999

Navigation Act 1912 Navigation (Marine Casualty) Regulations investigation into the grounding of the Panama flag general cargo ship NEW REACH

On Heath Reef, Great Barrier Reef on 17 may 1999

Published: October 1999

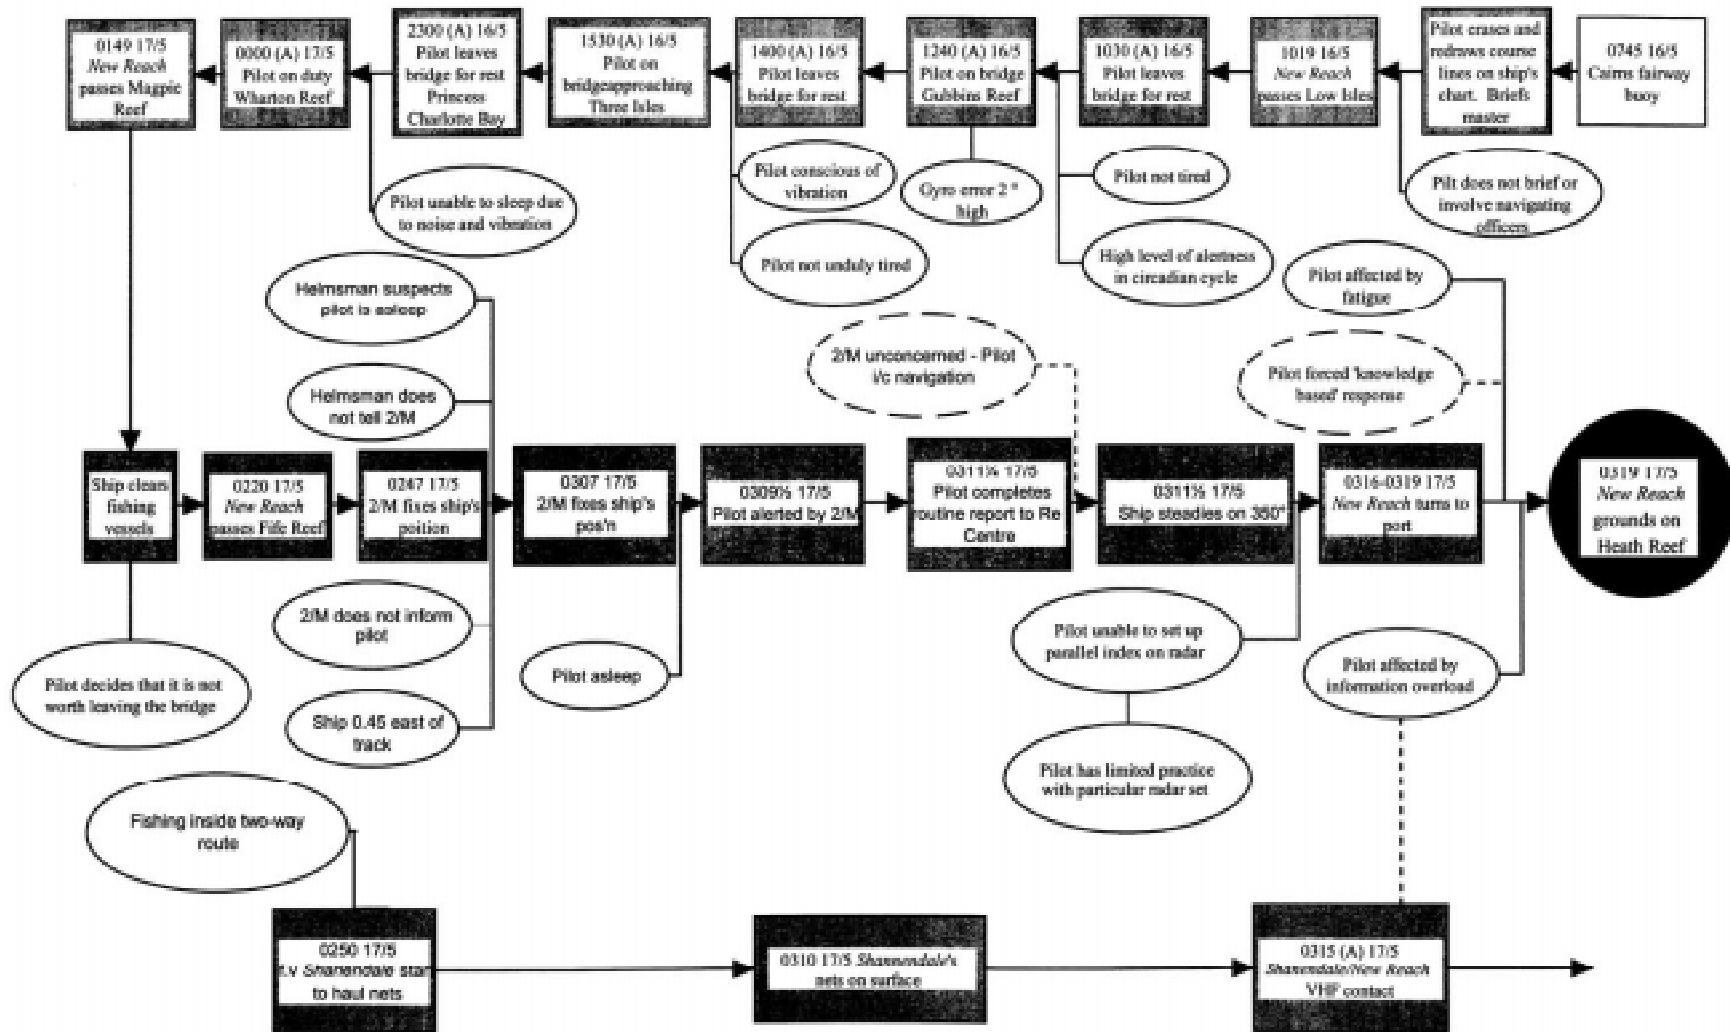
New Reach - simplified event and factor chart

A simplified version of the flowchart used in the analysis of the casualty, identifying events and causal factors.
