**Departmental investigation
the release of oil from the
Italian flag motor tanker
LAURA D'AMATO
at Gore Bay, Sydney Harbour
on 3 August 1999**

Navigation Act 1912
Navigation (Marine Casualty) Regulations
investigation into
the release of oil from the
Italian flag motor tanker
Laura D'Amato
at Gore Bay, Sydney Harbour
on 3 August 1999

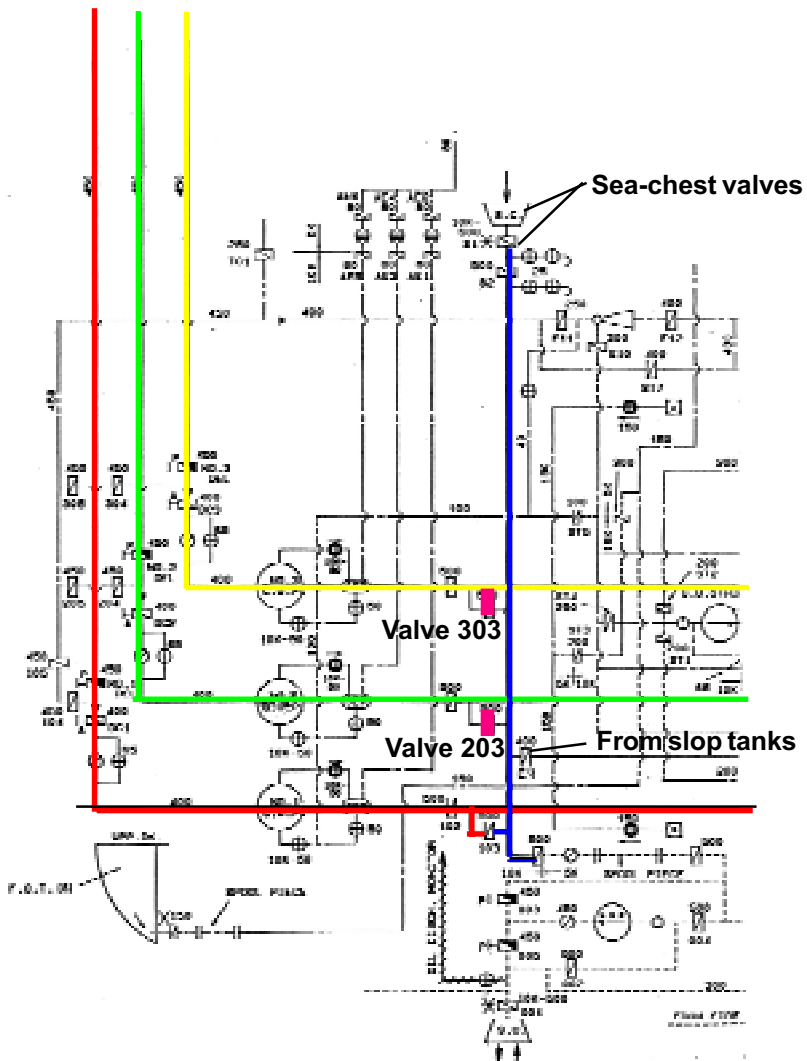
FIGURE 2
Section of *Laura D'Amato* cargo system schematic

The cargo system is connected directly to a sea chest on the port side of the pumproom, about 2 m above the keel, by a sea suction line. The sea suction line permits water to be pumped into the cargo system, either to provide a water plug between grades, to wash tanks and lines, or to ship extra ballast in extreme weather conditions. Any one pump can be used on another cargo line by means of crossover valves in the pump room, using the sea suction line as the crossover line. In addition to the crossover arrangement between the cargo lines and the sea suction line there is a direct connection to the slop tanks, used during crude oil washing (COW).

73/78. In submission, the ship managers emphasised the point that the crossover arrangement conformed to the rules and was an arrangement found on new and existing tankers (submission page 29). A section of *Laura D'Amato's* cargo piping system line diagram is shown in fig.2.
