MARINE SAFETY INVESTIGATION  
REPORT 150

Independent investigation into the shift of  
cargo aboard the general cargo vessel

# Sun Breeze

off the West Australian port of Bunbury  
21 August 1999

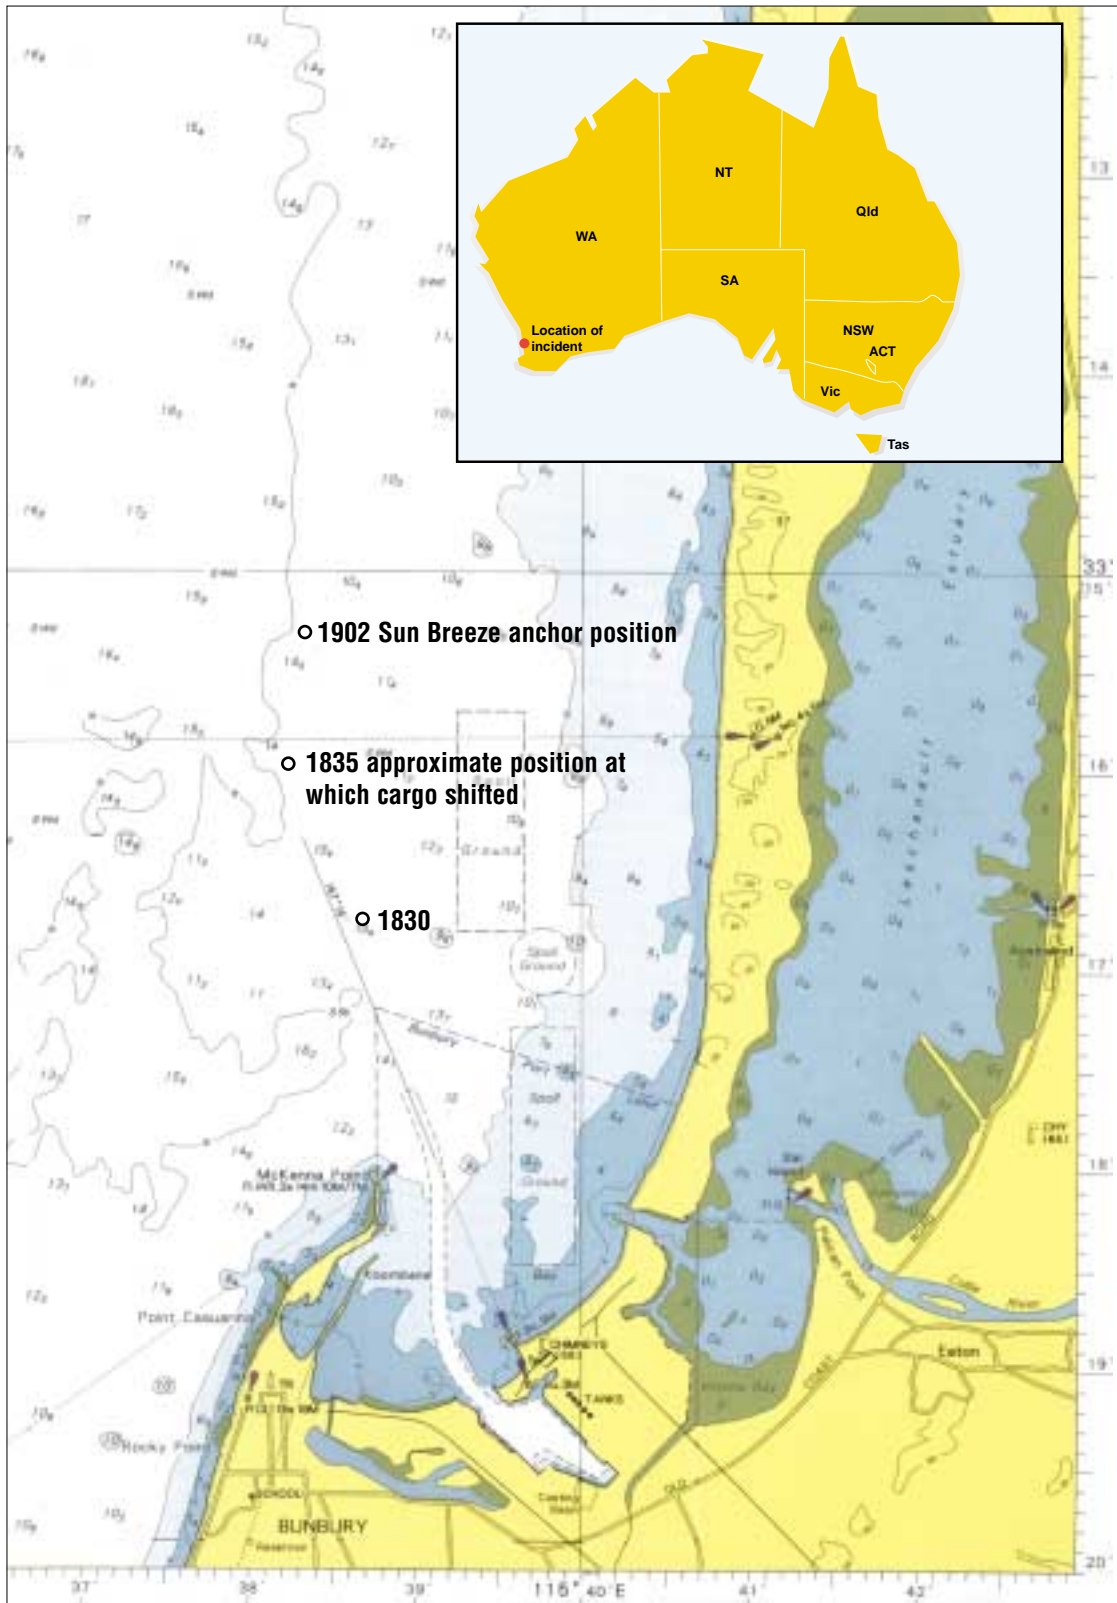
**Figure 6:**  
Chart showing positions of *Sun Breeze* after departing from Bunbury

The harbour master was trying to work out the best course of action and to estimate the deepest draught. From the pilot boat, lying off the ship, he estimated that the freeboard on the starboard side was about two metres.

The draught at that freeboard would have been about 11.75 metres.

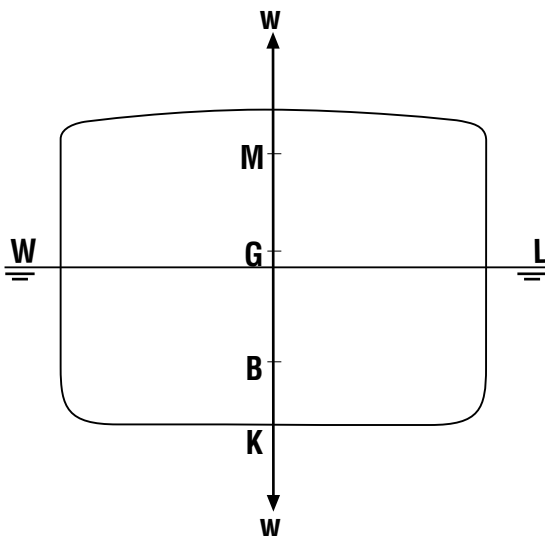
Figure a

Figure (a) represents a vessel floating upright in still water. The centre of gravity is shown as point 'G' and the centre of buoyancy is at point 'B'. The letter 'K' denotes the keel.

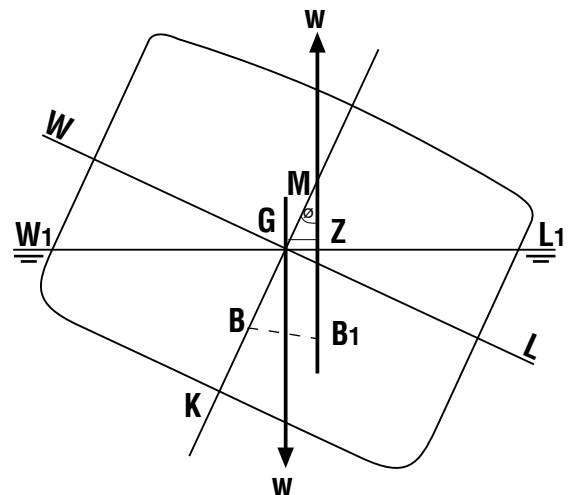
Figure b

If the vessel is inclined by an external force to a small angle as shown in Figure (b) the centre of gravity will remain at G and the weight of the vessel 'w' is considered to act vertically through this point. The centre of buoyancy, being the centre of gravity of the underwater volume, will move from B to B1.

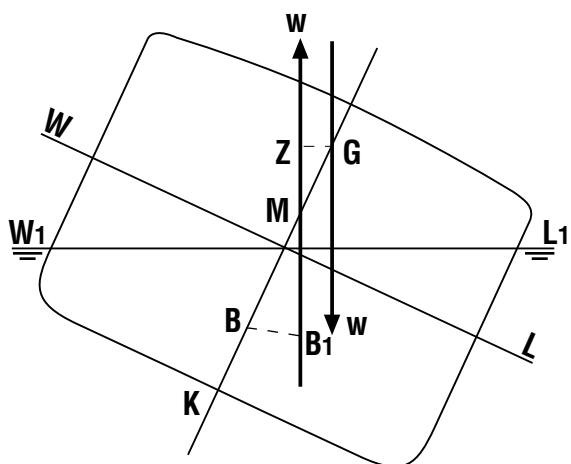
Figure c

Figure (c) shows a vessel in unstable equilibrium. While G stays above M the lever GZ forms a capsizing lever.
