Navigation Act 1912
Navigation (Marine Casualty) Regulations
investigation into the serious injury to a crew member
on board the Bahamas flag bulk carrier
CSL Pacific
at sea, south of Portland Victoria
on 18 February 2002

Report No 175

January 2003

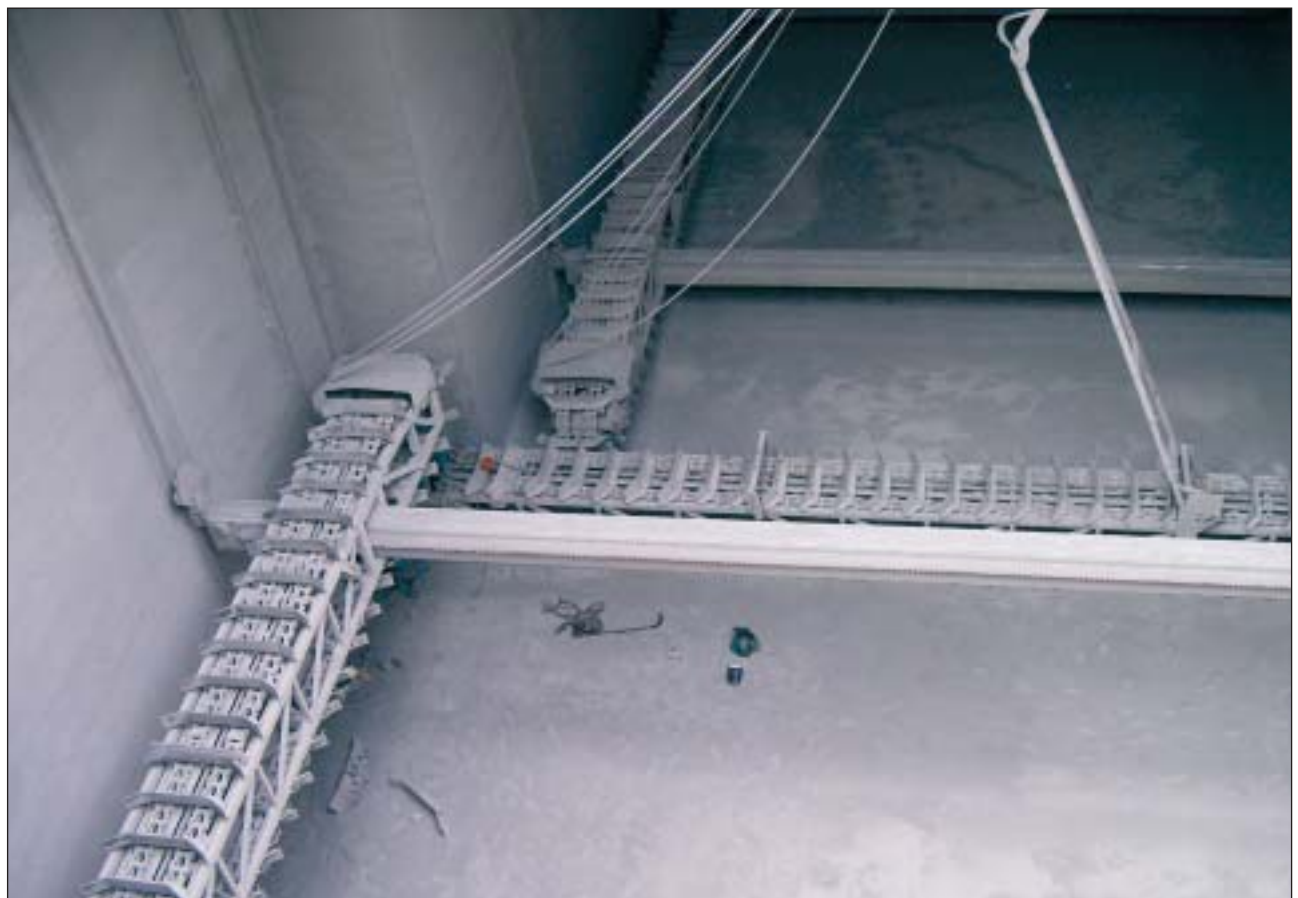
FIGURE 3:

The cargo is discharged from each hold from the top downward with the reclaimers working on the surface of the cargo. Each reclaimer is mounted on support beams, suspended by wires and winches, which allow the reclaimers to be progressively lowered as cargo is discharged. The longitudinal reclaimers also traverse from port to starboard and ‘sweep’ the cargo to the transverse reclaimer mounted athwartships in the centre of each hold. The cargo is then ‘swept’ by the transverse reclaimer to a series of gates on each bucket elevator housing located on the starboard side of the hold (figure 3). The gates control the admission of cargo to the elevator depending on the level of the cargo in the hold.

Longitudinal and transverse reclaimers in hold
