MARINE SAFETY INVESTIGATION
REPORT 184

Independent investigation into the grounding of the
Korean flag bulk carrier

Hanjin Dampier

at Dampier, Western Australia
25 August 2002

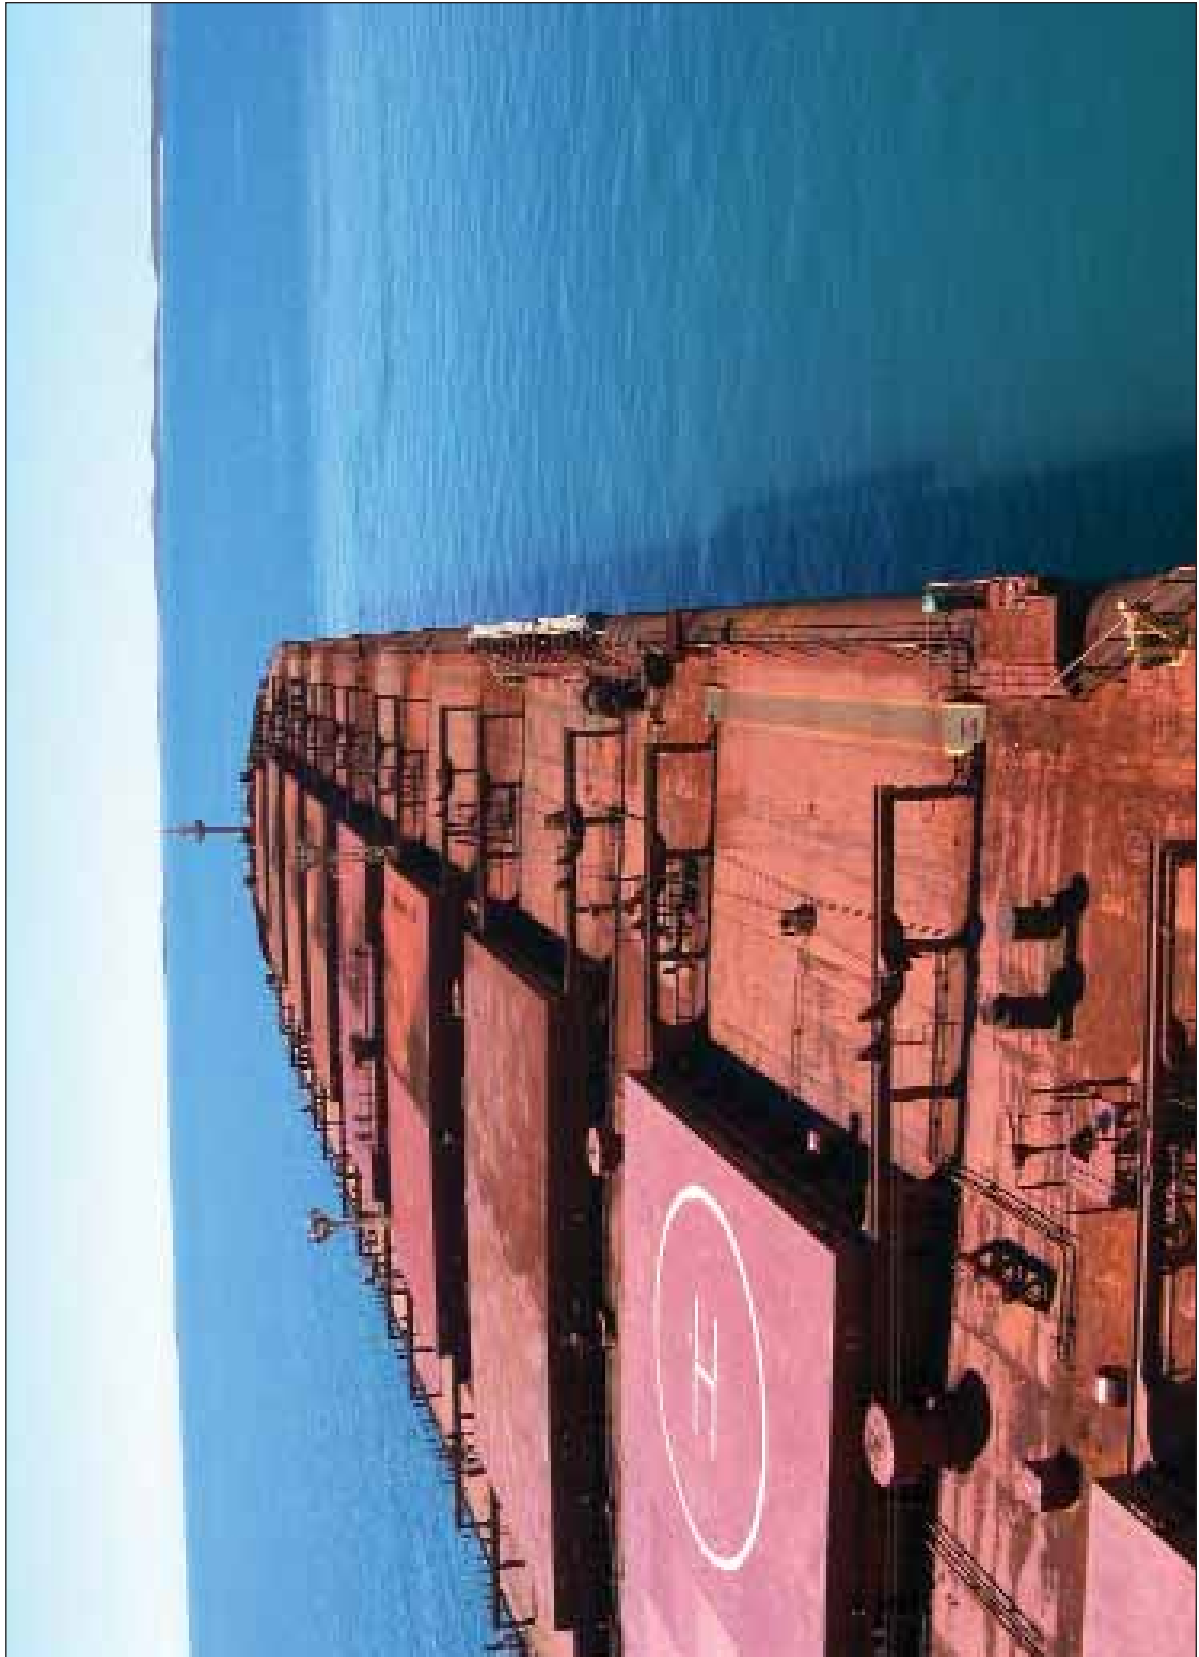
FIGURE 1:
Hanjin Dampier

Hanjin Dampier, (figure 1), is a Korean flag, capesize, bulk carrier of 207 346 deadweight tonnes at its summer draught of 18.02 m. The ship is owned and managed by Hanjin Shipping Company of Seoul in South Korea. It is classed with the Korean Register of Shipping, as +KRS 1¹ Bulk Carrier ESP² with +KRM 1³ and UMA⁴ notations.
