Loss of the NSW registered vessel *Tamara* – 1 September 2002

ATSB
Australian Transport Safety Bureau

Tamara: Lost at sea

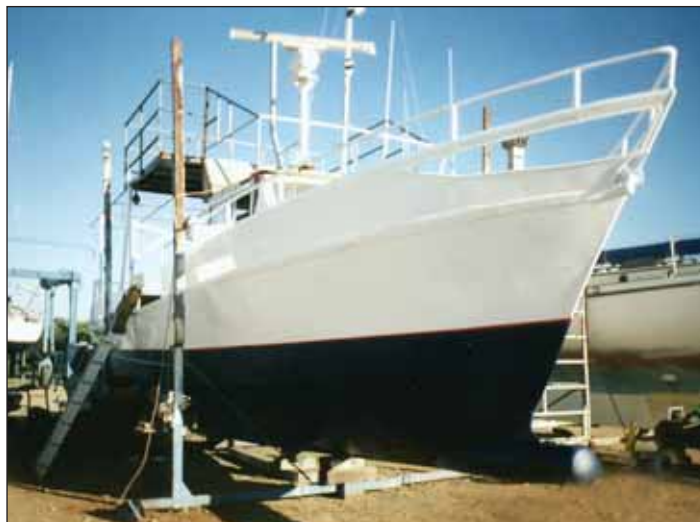
FIGURE 1:
Tamara at Hastings

Tamara (figure 1), was a 12.4 m steel vessel built in Gippsland, Victoria in 1980. The vessel had a beam of 4 m and a depth of 1.2 m. Originally used for commercial fishing off the Victorian coast, *Tamara* was purchased in late 2000 by a group intending to use it for commercial fishing in Western Samoa. Their plan was to refit the vessel and sail it to Western Samoa via Noumea and Fiji.

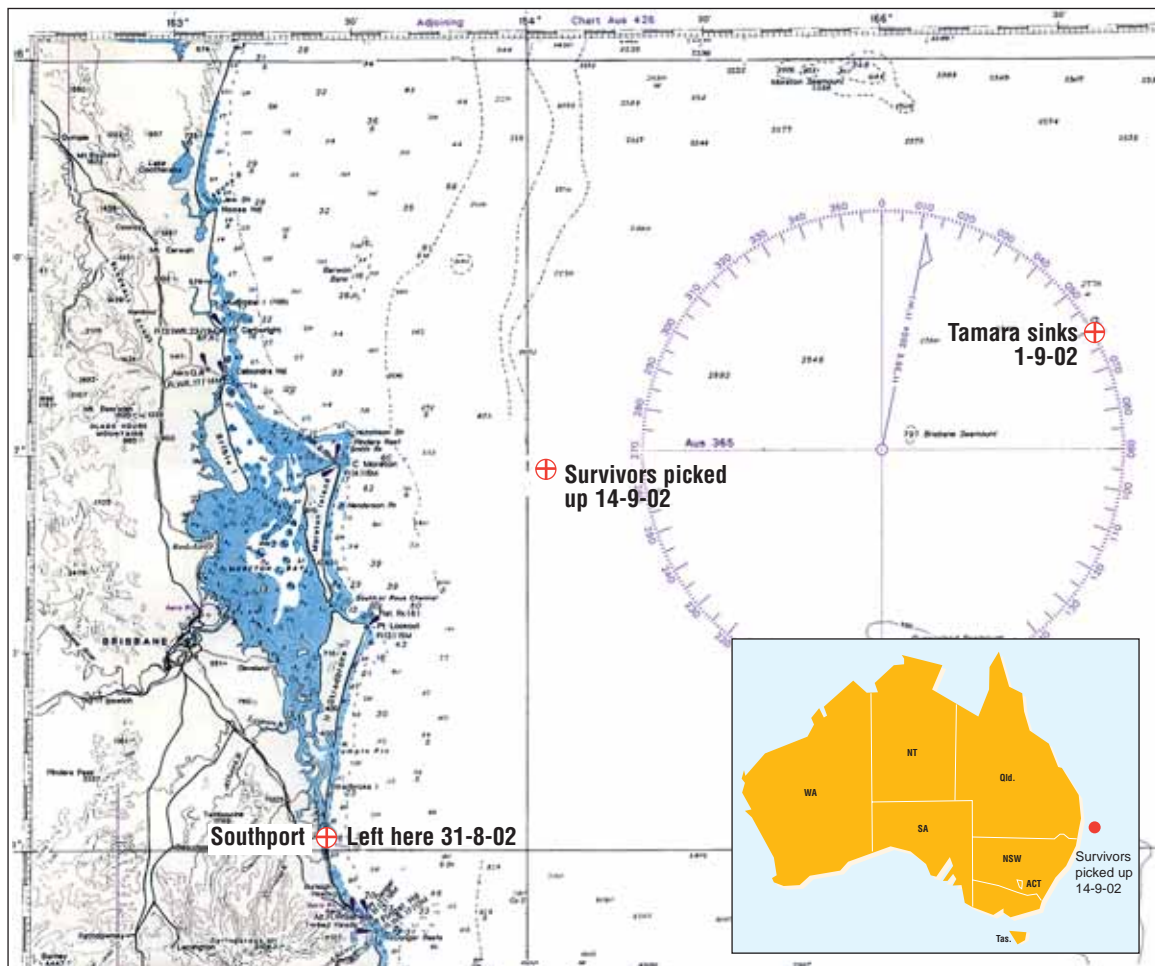
FIGURE 3:
Chart showing *Tamara's* approximate last position and the position where the survivors were picked up

On 14 September the men were found drifting in the liferaft 30 miles east of Moreton Island by the fishing vessel *Devocean*. The fishing vessel took them aboard and contacted the authorities. The men were subsequently airlifted to Brisbane's Princess Alexandra Hospital where they were treated for sunburn, exposure, dehydration and infected lesions on their legs and buttocks.
