ATSB TRANSPORT SAFETY INVESTIGATION REPORT
Marine Occurrence Investigation
No. 186 and 191
FINAL

**Independent investigation into the
equipment failure on board the
Australian registered bulk cargo carrier
*Goliath***

in Bass Strait on 22 September 2002 and
off Jervis Bay, New South Wales, 12 February 2003

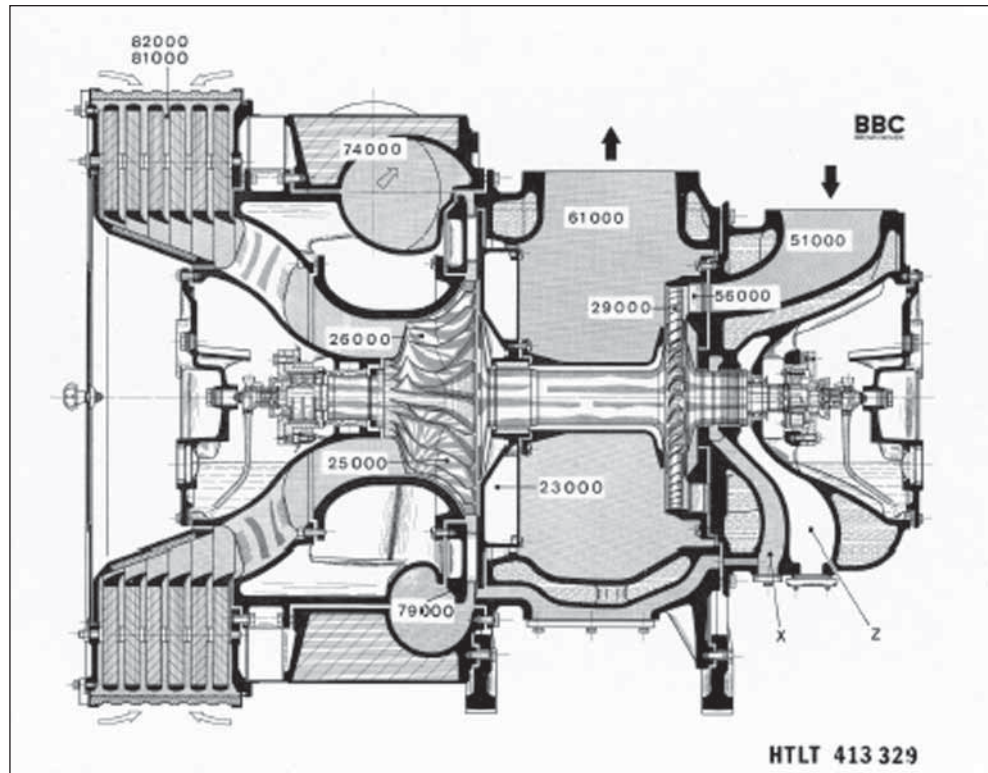
Figure 1: Diagrammatical view of the VTR 454 turbocharger type

An inspection of the turbocharger wreckage recovered from the *Goliath* was made in a progressive manner, examining each primary section for evidence of the failure mechanism/s.
