MARINE SAFETY INVESTIGATION  
No. 196

# Lancelot

# Jenabar

14 nautical miles east of Diamond Head, New South Wales,  
21 August 2003

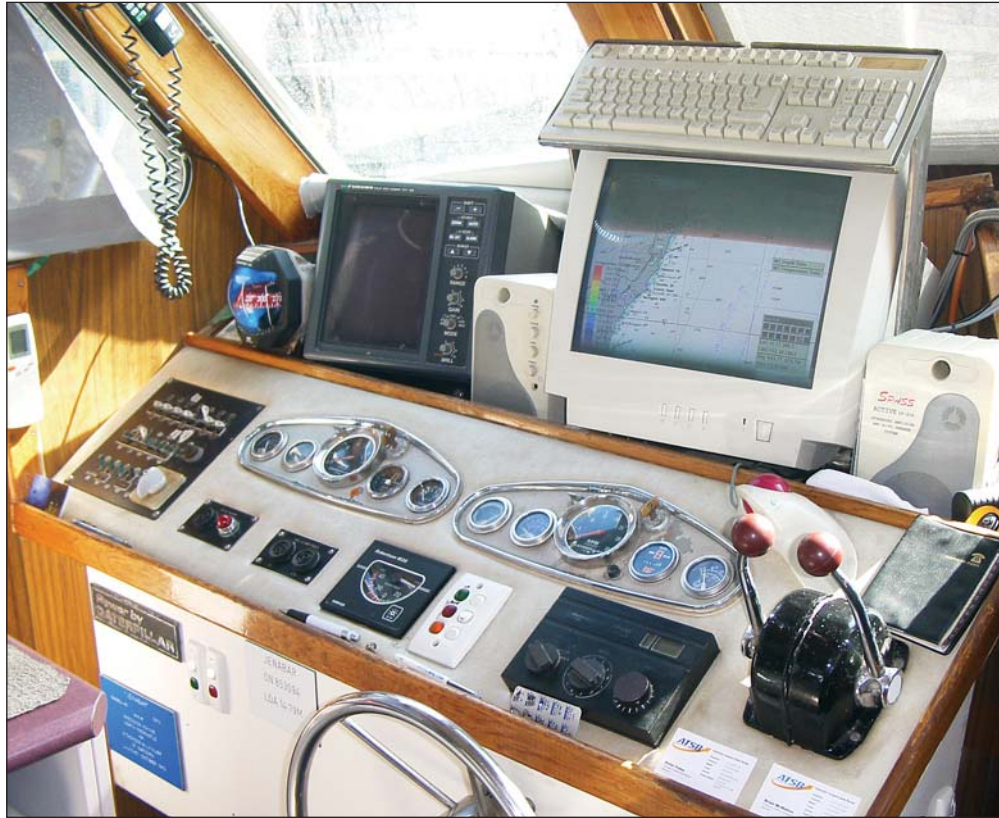
**FIGURE 3:**  
Steering and control console of *Jenabar*

The engine and other controls and the helm are mounted on a console on the port side of the wheelhouse (see fig. 3). Immediately to starboard of the console are steps leading down to the sleeping quarters. The radar is mounted on a console at the starboard side of the wheelhouse. Behind the radar console is a table with seating against the starboard side of the wheelhouse as well as aft of the table (see fig. 4).
