ATSB TRANSPORT SAFETY INVESTIGATION REPORT
Marine Occurrence Investigation No. 204
Final

Independent investigation into the knockdown of the
Australian sail training vessel

Windeward Bound

3 June 2004

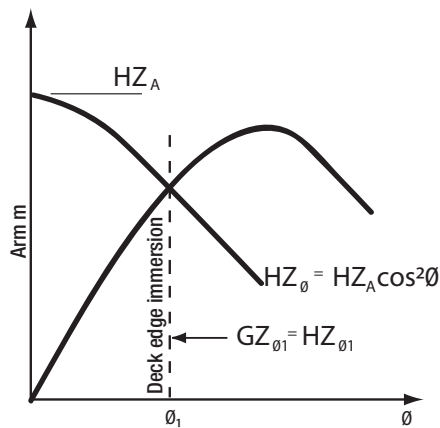
Figure 6: Excerpt from USL Code showing wind heeling arm and righting lever curves for deck edge immersion

The wind heeling arm (HZ) curve (Figure 6) should be plotted so that the point of intersection with the vessel's righting lever (GZ) curve is at the angle of deck edge immersion. The wind heeling arm curves for down flooding and knockdown should also be plotted so that for HZ_B , for example, the area under the righting arm curve equals the area under the heeling arm curve both taken to the down flooding angle.

The purpose of performing these calculations and including the information in the vessel's stability book is to inform the master what margins are available in terms of wind strength and the sail set in the prevailing weather conditions before the vessel reaches the three conditions (deck edge immersion, down flooding or knockdown). For example, the master can look at the current wind conditions and the vessel's sail configuration, compare it with the sails used for the wind heel curve calculations and assess whether or not the strongest gust of wind the vessel is likely to experience will result in deck edge immersion.
