MARINE SAFETY INVESTIGATION
No. 205

Independent investigation into the grounding
of the passenger vessel

True North

in the approach passage to
St. George Basin, Western Australia
7 August 2004

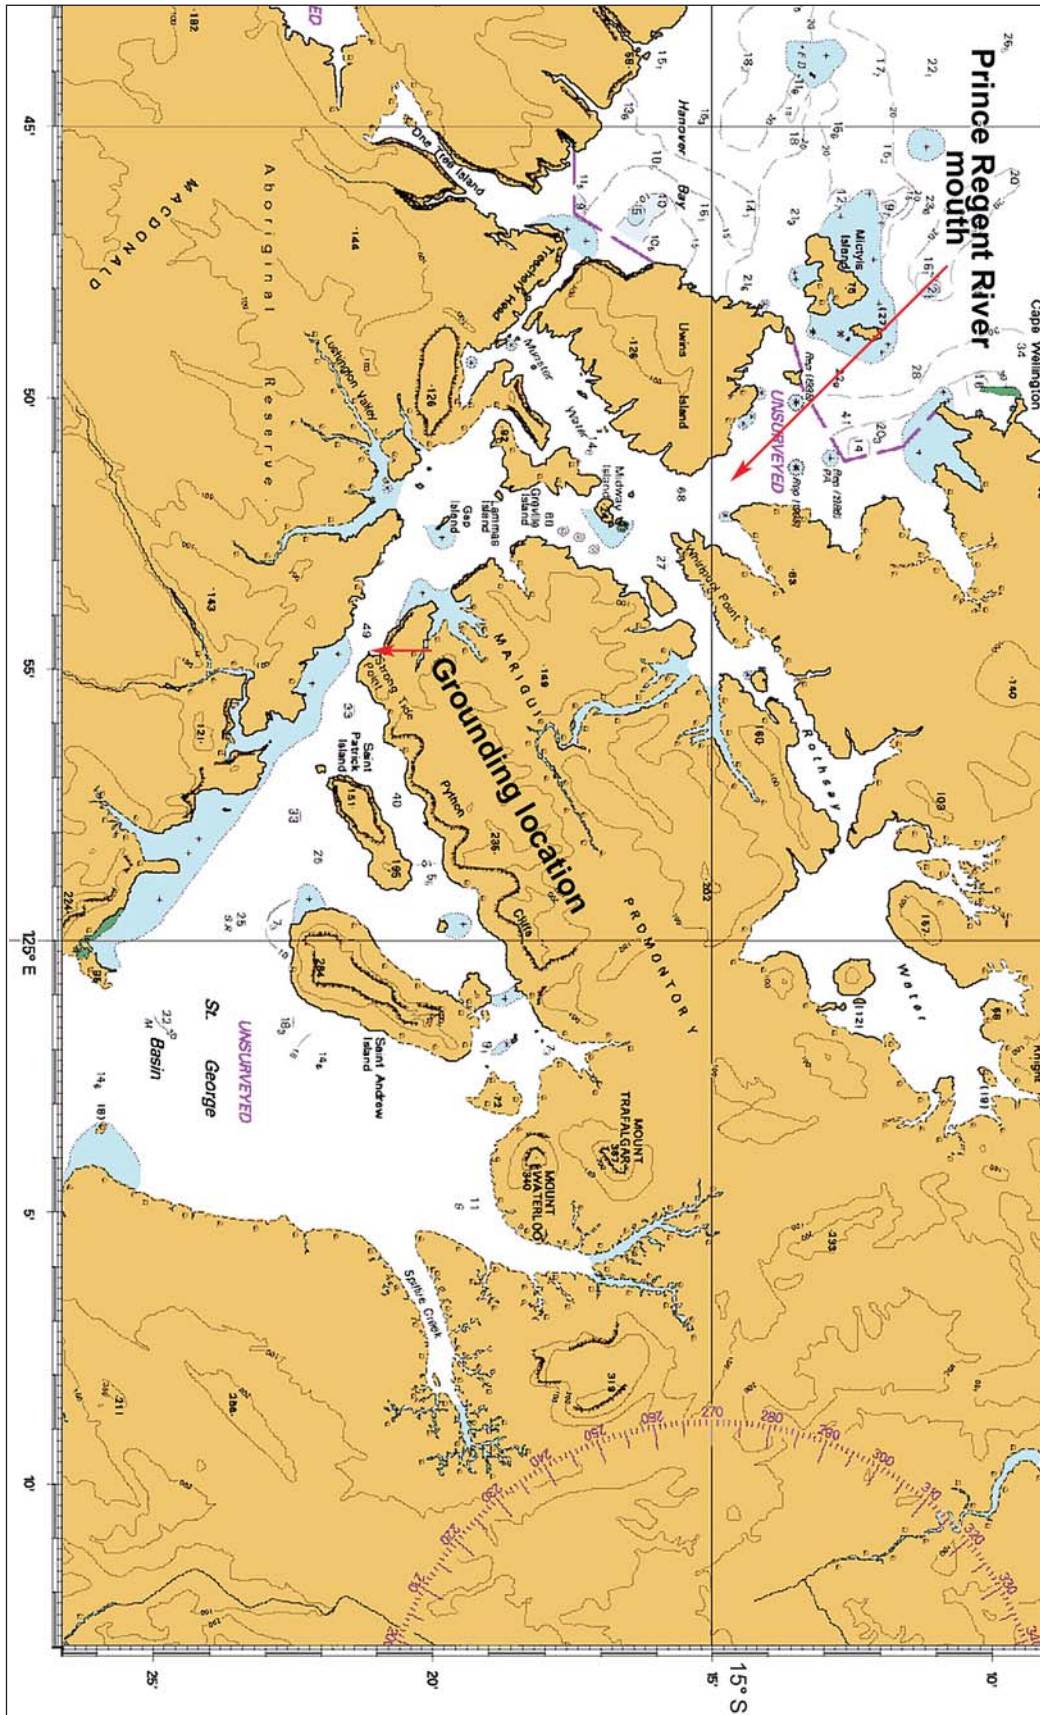
FIGURE 6: Portion of chart Aus 730 showing St. George Basin and approach passage

As *True North* approached Strong Tide Point, the master stated he took a radar range off the point, which was 4.5 cables. The vessel appeared to be on the track to pass through the most restricted section of the passage (five cables of navigable water). According to his statement, he moved to the port wheelhouse door, and looked out. He could not clearly see the land features on the port side of the vessel. He then moved out of the wheelhouse to the front of the upper deck, forward of the wheelhouse, for a 'look around'. As he was returning to the port door of the wheelhouse, he could see and feel the vessel turning and sensed that something was not right. He hurried back into the wheelhouse and looked at the radar. As soon as he saw the radar display, he could see a large area of 'green' (being the land) coming at the vessel from port. *True North* was now steering directly for Strong Tide Point at a speed over the ground of about 14 knots. The master quickly made his way to the centre console and was only able to bring the engine controls to stop when, at 2304, *True North* took the ground. The vessel struck with enough force that, according to the master, a 'loud crunching' sound could be heard in the wheelhouse and the entire vessel shuddered on impact.
