ATSB TRANSPORT SAFETY INVESTIGATION REPORT
Marine Occurrence Investigation No. 209
Final

Independent investigation into the man overboard fatality
and subsequent lifeboat accident on board the
French registered Antarctic support vessel

L'Astrolabe

27 January 2005

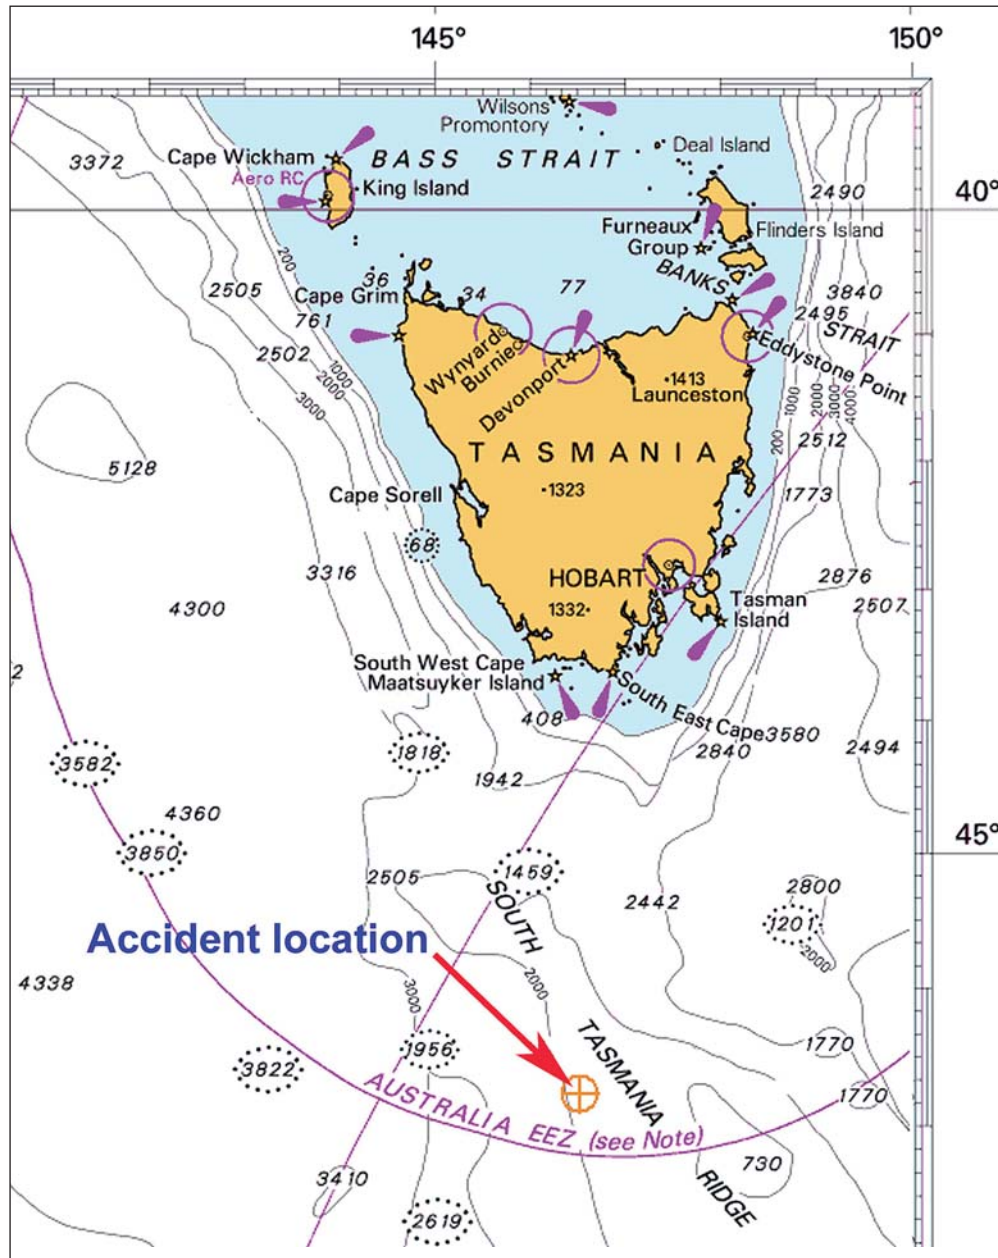
Figure 4: Portion of chart Aus4074 showing location of man overboard

At about 0530, the search for the missing 4–8 crew member began while the master took the vessel to the area in which he went missing. The master’s intention was to take the vessel about two nautical miles south of the 0400 position and alter course to resume the original heading and conduct a more formal search of the sea.

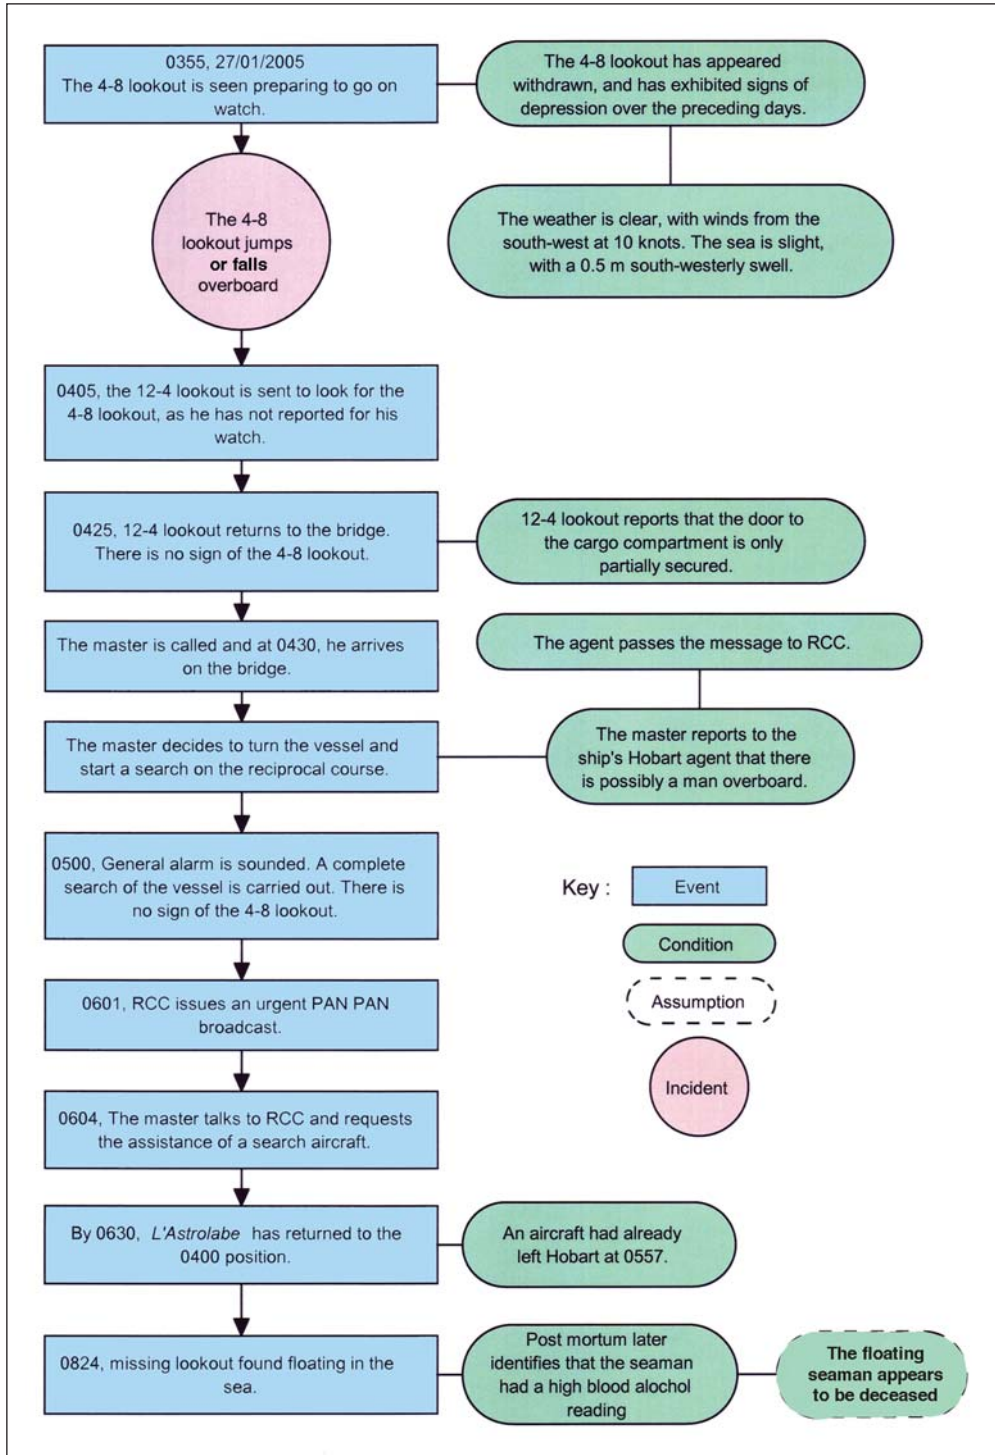
Figure 15: Man-overboard events and causal factors chart

- The crew member had died as a result of drowning before the vessel was able to locate him.
- A very high blood alcohol level found during the post mortem examination of the deceased crew member was probably highly significant in the circumstances of his death.

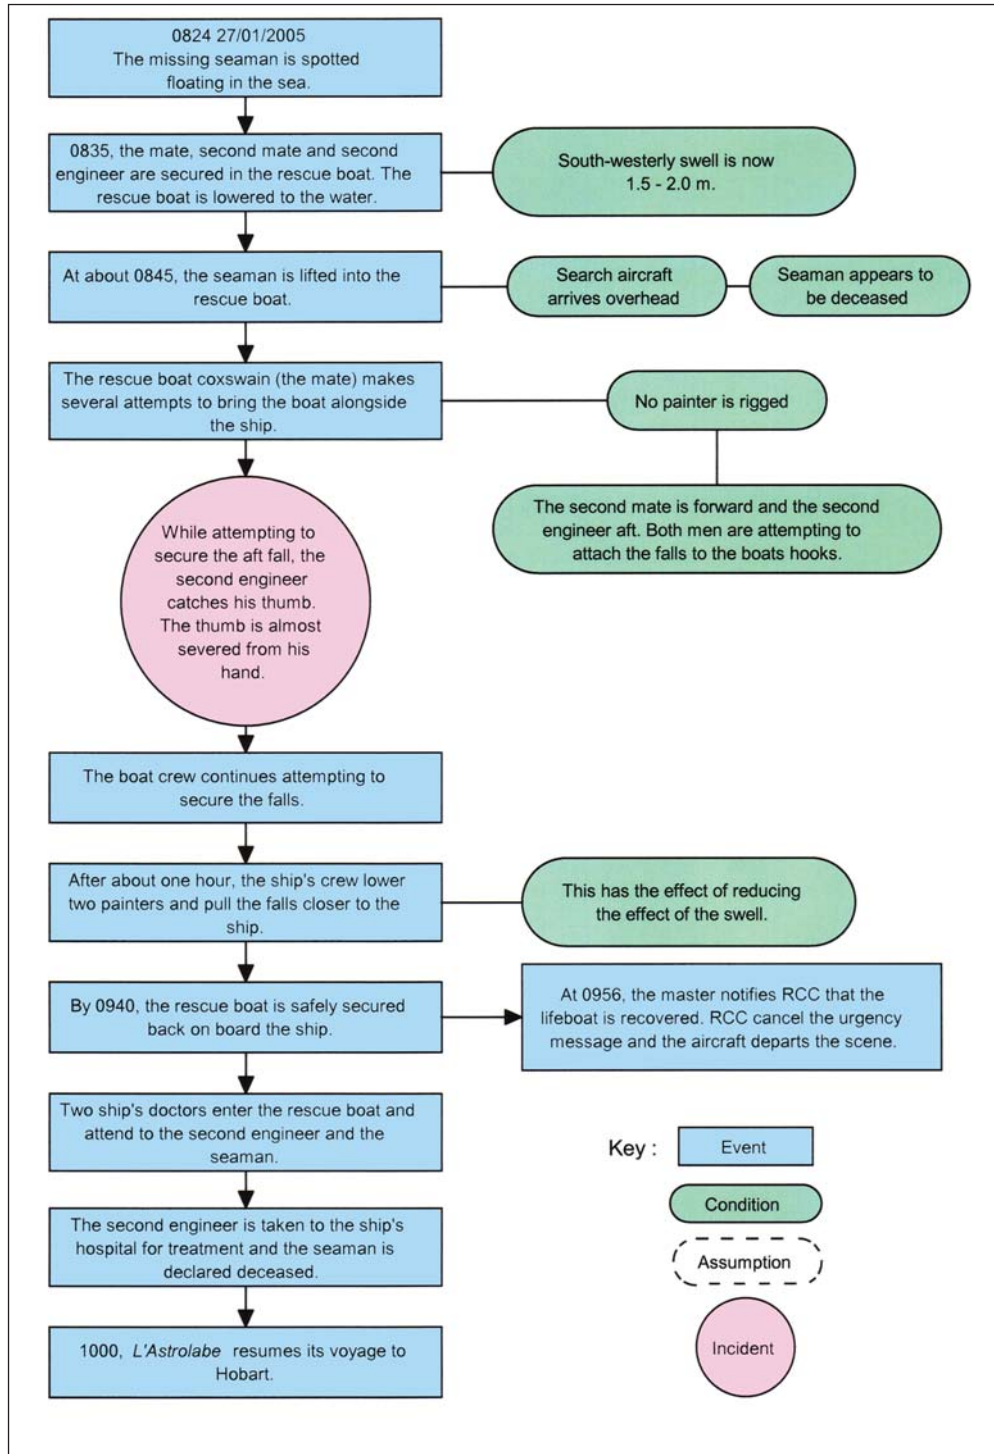
Figure 16: Lifeboat accident events and causal factors chart

- A painter was not left attached to the forward fall block when the lifeboat departed *L'Astrolabe* to recover the deceased crew member.
- The vessel's movement in the seaway made the lifeboat recovery operation difficult, and resulted in damage to the lifeboat and its fittings.

During the recovery operation, the lifeboat suffered a significant amount of damage from both the swinging fall blocks and from contact with the hull of the ship.

Given the area of operation of the vessel, and the inherent risks associated with a crew member safely handling a fall block from a restrictive access hatch, it would have been prudent for the operators of *L'Astrolabe* to have provided the vessel with recovery strops for both lifeboats.
