**ATSB TRANSPORT SAFETY INVESTIGATION REPORT**  
Marine Occurrence Investigation No.222  
Final

# **Malu Sara**

in Torres Strait, Queensland, Australia  
15 October 2005

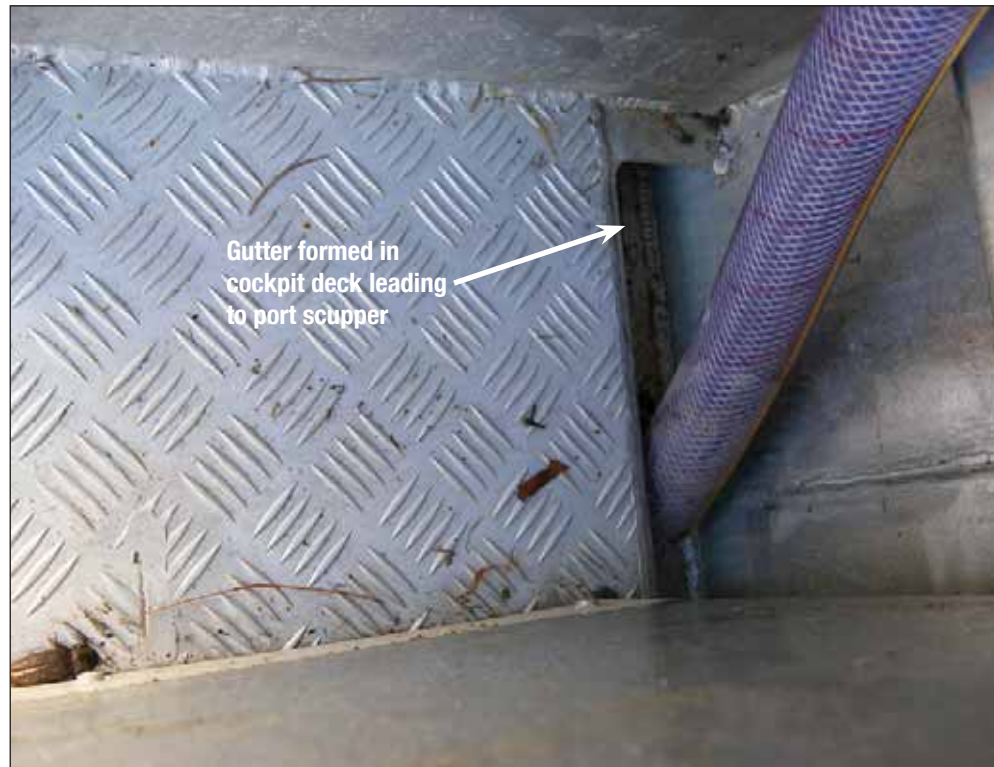
**Figures 3: Scupper**

The cockpit deck formed the weather deck and was designed to be watertight and self-draining. It was arranged to drain any water shipped into the cockpit, first to the motor-well through two scuppers<sup>4</sup> port and starboard in the cockpit transom (Figure 3), and then overboard through a single freeing port<sup>5</sup> located centrally in the motor-well transom (Figure 4). Located below the raised foredeck, cockpit floor and outboard motor-well was a void space. The void space contained the vessel's longitudinal and transverse framing and a watertight casing surrounding the fuel tank. The watertight below-deck void space was designed to provide the vessel with a specified volume of reserve buoyancy.

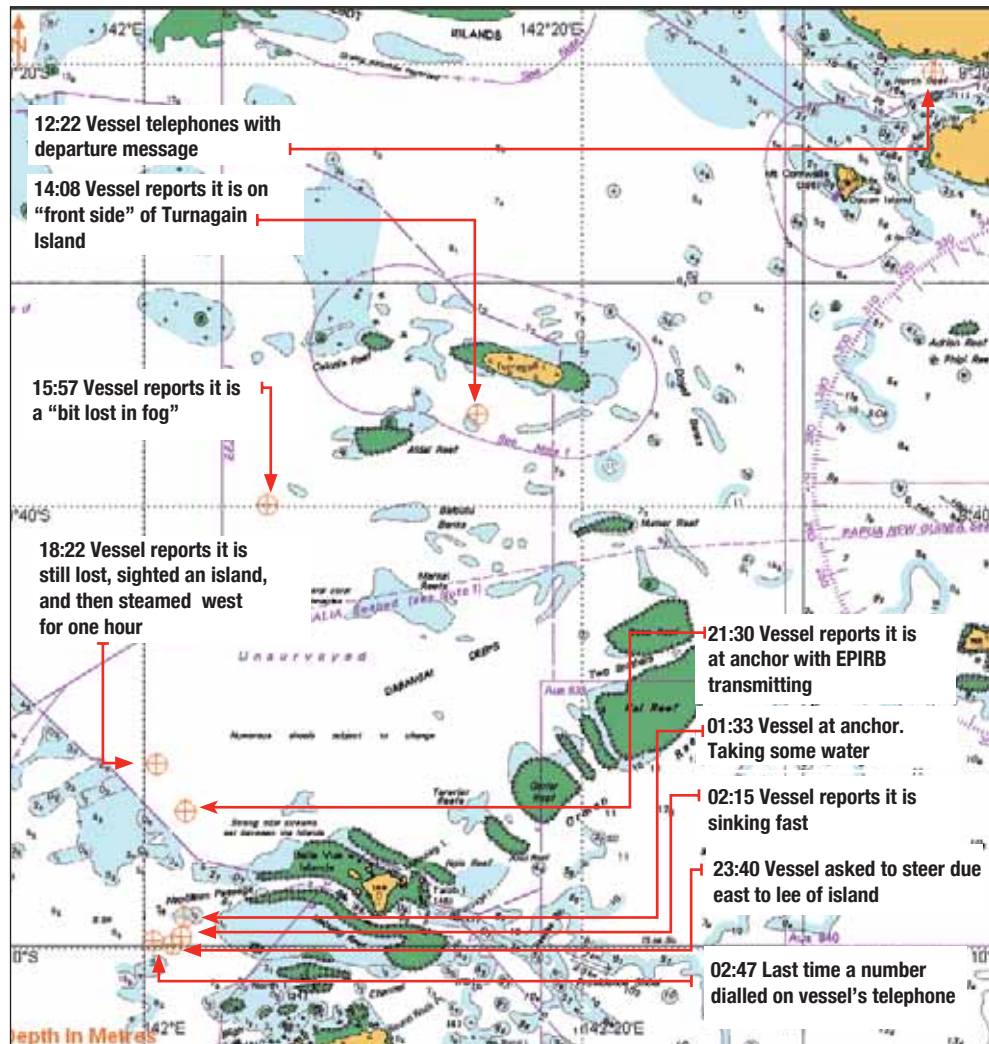
**Figure 7: Portion of chart AUS 376 showing positions of Malu Sara triangulated from satellite telephone data at the times of significant calls. (Accuracy in the range of 810 to 9400 metres)**

The last call to the telephone while it was potentially operational was at 0403 on 15 October within 3.6 miles of 09°59'S 142° 01' E. Thereafter, from 0432, all attempted calls were diverted to the voicemail service.

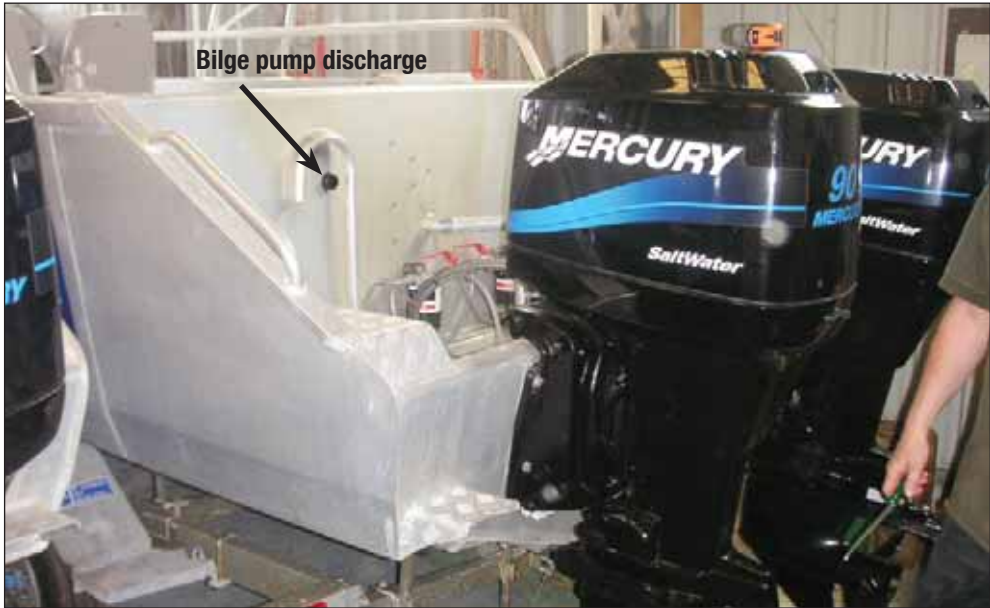
**Figure 20: Bilge pump discharge**

The vessels were fitted with a hand operated bilge pump, which whilst meeting the requirements of both the USL Code and AS 1799, was inadequate for the purpose of pumping the vessel dry. The bilge pump discharge line (Figure 20) led into the motor-well and relied on the water then draining from the well through the freeing port. As discussed earlier, the freeing port arrangement is not adequate for clearing the build up of water in the motor-well when the vessel is stationary and the bilge pump would simply be circulating water from the cockpit to the motor-well.

In addition, the bilge pump two-way suction valve is counter intuitive and potentially confusing. The position of the valve handle does not clearly indicate from which line the pump is drawing (Figure 21). The evidence is that the skipper was apparently familiar with operation of the valve as he had used it on at least one occasion during the Saibai Island workshop. However, when the vessel was taking on water in darkness in the early hours of 15 October, it may have created needless confusion as it would not have been immediately clear whether water was being pumped from the void space or cockpit.

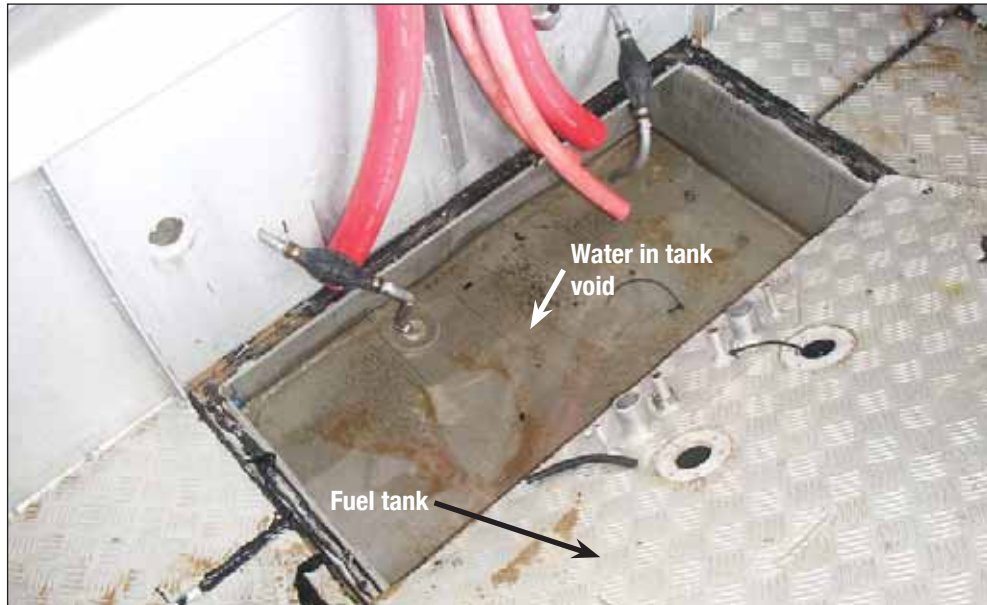
**Figure 22: Fuel storage tank and void arrangement**

The IRV's fuel storage arrangement consists of a single fuel tank divided into two sections (each 150 litres). The fuel tank space is recessed into the cockpit deck on the centreline aft, and is contained in a 'casing' arrangement forming a void space that is designed to be watertight. The tank is constructed as a separate welded aluminium module with the top of the tank forming the cockpit deck with the tank installed (Figure 22).

The tank has a flange around its upper edge which rests on the top of the surrounding cofferdam. The flange, which was sealed with mastic and screwed down, supports the weight of the tank and its contents as the bottom of the tank casing does not make contact with the bottom tank plating.

The casing is fitted with a gooseneck type breather mounted outside the cockpit transom on the port side. A fume detector sensor is also fitted to the casing on the starboard side aft with a wire connection via a cable conduit to the console where an audible alarm unit is fitted. Each section of the tank is provided with a combined filler/breather, a suction line that leads to the motors via a filter, and a fuel level gauge. The filler, breather and suction lines are attached to welded alloy up-stands at the aft end of each tank. The fuel gauge is flush mounted directly onto the chequer plate tank top.
