ATSB TRANSPORT SAFETY INVESTIGATION REPORT
Marine Occurrence Investigation No. 225
Final

Independent investigation into the crew member fatality
on board the Bahamas registered passenger ship

Pacific Sun

5 February 2006

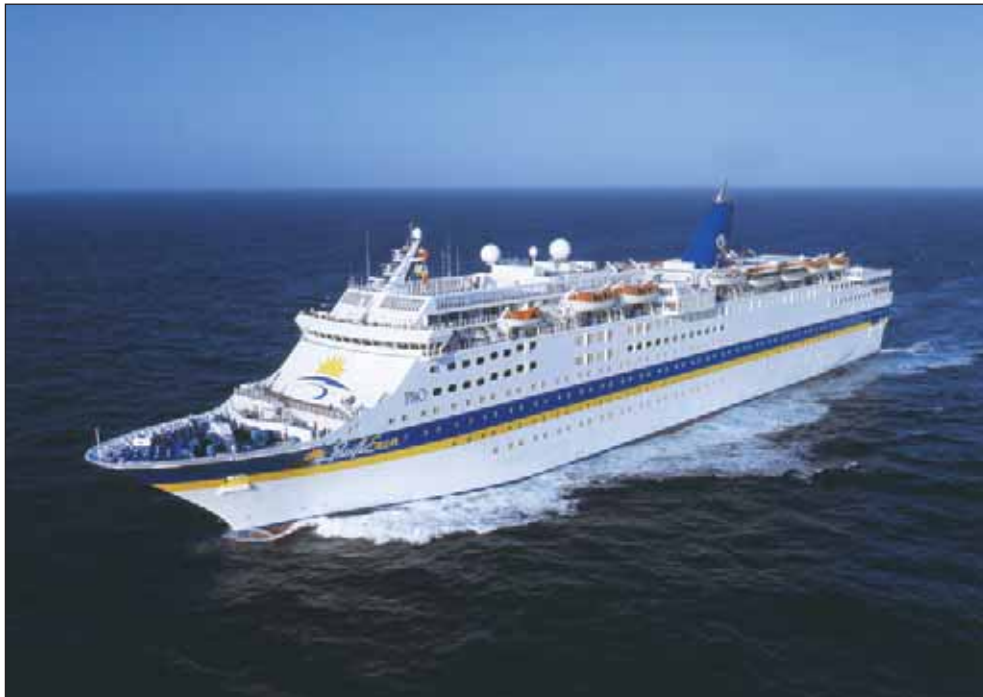
Figure 1: *Pacific Sun*

Pacific Sun is a passenger ship (Figure 1) registered in Nassau, Bahamas. The ship is owned by Carnival PLC and operated by P&O Cruises Australia. It is classed with Lloyds Register of Shipping (LR).
