ATSB TRANSPORT SAFETY INVESTIGATION REPORT
Marine Occurrence Investigation No. 232
Final

Independent investigation into the breakaway and grounding
of the Hong Kong registered bulk carrier

Crecente

at Port Hedland, Western Australia
12 September 2006

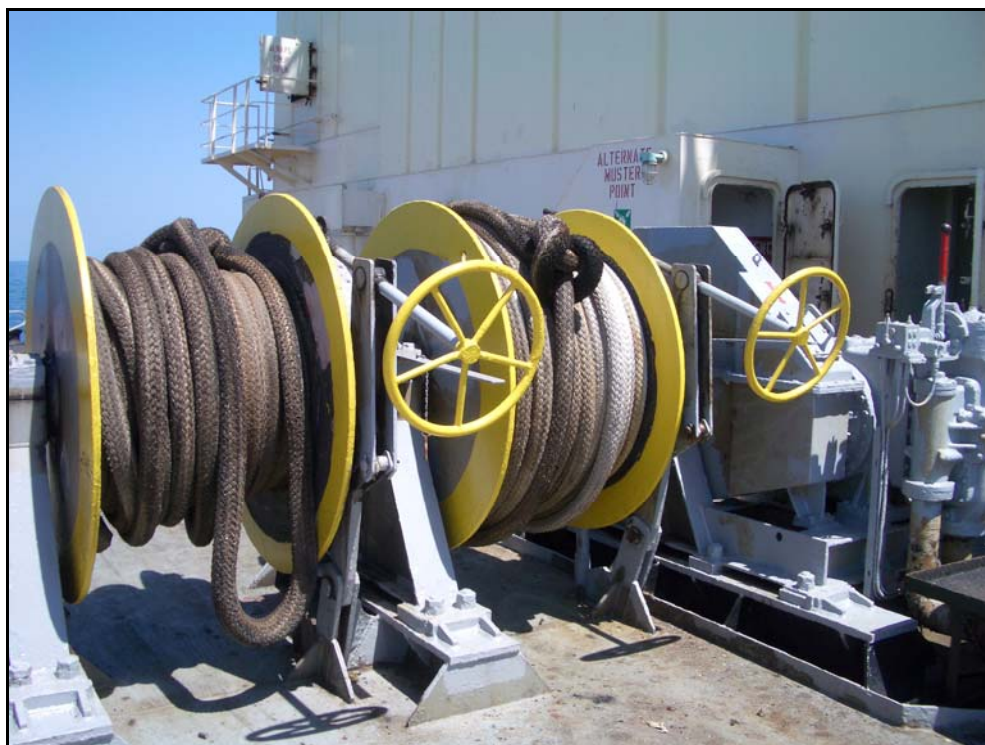
The winches and windlasses are hydraulically driven and fitted with a length of 65 mm diameter, double braided nylon mooring line that had a mean breaking strain of 90 tonnes when new. The windlasses have a heaving capacity of 40.5 tonnes and the winches a heaving capacity of 20 tonnes. None of the mooring winches are self-tensioning and each winch is fitted with a band brake with a specified maximum holding capacity of 67.6 tonnes.

Figure 2: *Creciente's* aft breast line mooring winch

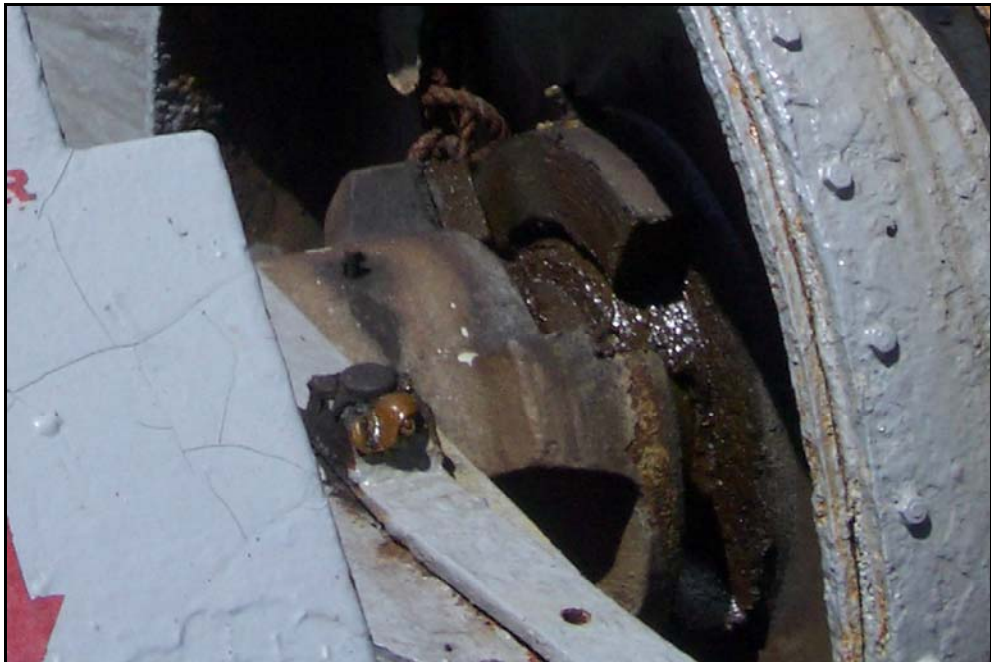
Each mooring winch consists of two separate winch drums on a common shaft that is driven by a single hydraulic motor. Each drum can be connected to the shaft by way of a dog clutch (Figure 3) and has a separate band brake (Figure 4).

Figure 3: Mooring winch dog clutch

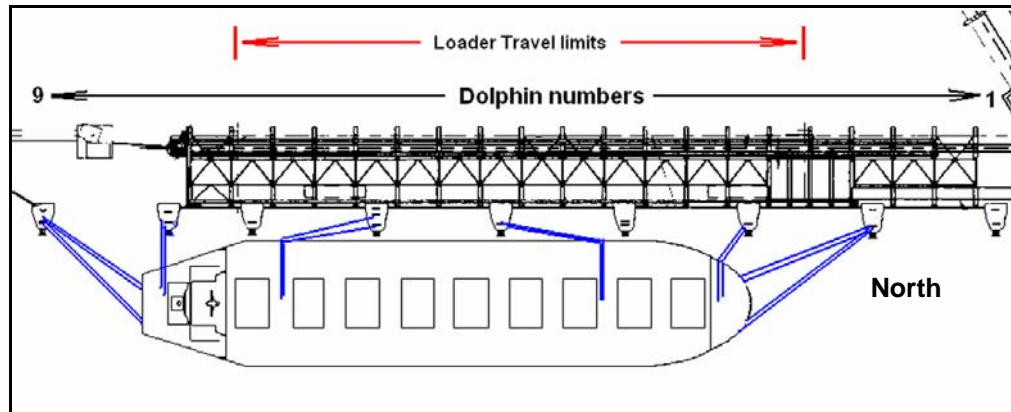
The usual mooring arrangement for a cape-sized ship, like *Creciente*, at Finucane Island berth D is for the ship to be located with the bridge marker approximately 12 m from the southern end of the wharf. The mooring lines would normally have consisted of four headlines run to number two mooring dolphin, two forward breast lines led to number three dolphin and two forward springs led to number five dolphin. Four stern lines would be run to number nine dolphin, two aft breast lines to number eight dolphin and the two aft springs to number six dolphin (Figure 7).

Figure 7: Normal mooring arrangement at Finucane Island berth D

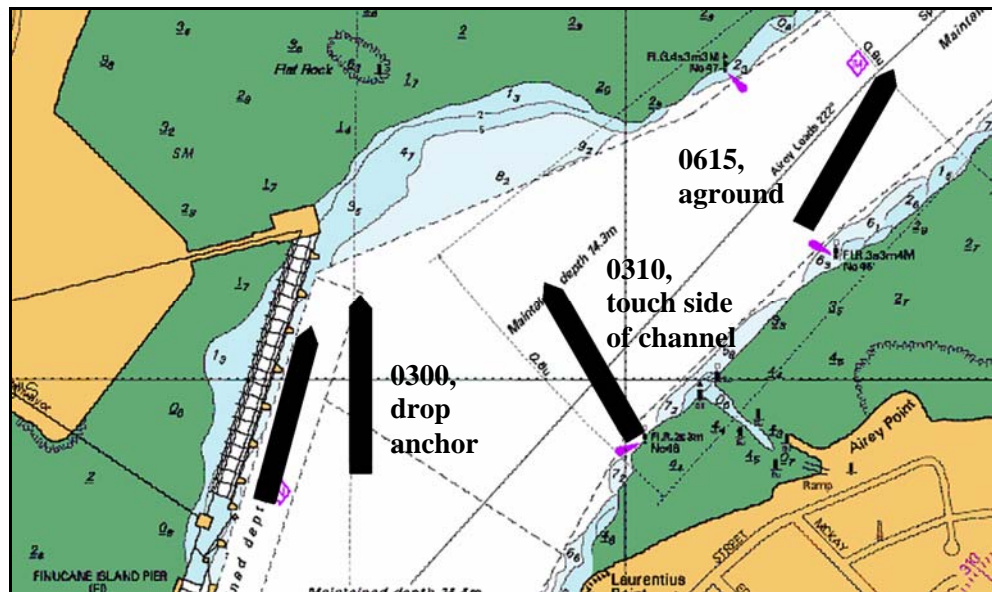
Figure 9: Section of navigational chart Aus 54 showing *Creciente's* approximate movement inside Port Hedland harbour

At 0310, the first tug, *Indee*, left its mooring and went to assist *Creciente*. The tug began pushing on the starboard midships section of the ship in an attempt to push it back into the channel. At about the same time, *Creciente's* master realised that the ship's rudder was stuck hard over to port (Figure 9). At about 0314, *Creciente* was moving back into the channel and the master ordered the anchor to be recovered.

At 0615, *Creciente*'s engine was stopped when the ship stopped moving back towards the centre of the channel. The ship's forward draught was now 16.4 m and its bow was not in the middle of the channel where there was deep water. The ship's stern was 10 m away from beacon number 46, on a line between 46 and 47 beacons (Figures 9, 10 and 16). The ship's heading was 029° (T).

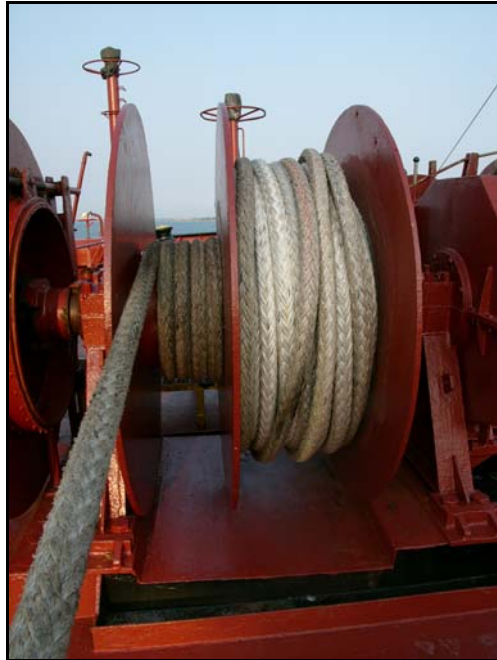
Creciente was fitted with conventional mooring winches that did not have a split drum (Figure 13). With no split drum, all of the rope not required for mooring the ship was stored on the single drum and the layers of unused rope effectively increase the diameter of the drum (Figure 14). If a split drum is fitted, one side of the drum is used to provide tension on the mooring line and the excess rope is stored on the other side of the drum.

Figure 13: Typical split winch drum
